**WEST VIRGINIA OFFICE OF MINERS' HEALTH, SAFETY AND TRAINING**

**REPORT OF FATALITY**

**BELT FATALITY**

**MARSHALL COUNTY COAL COMPANY**

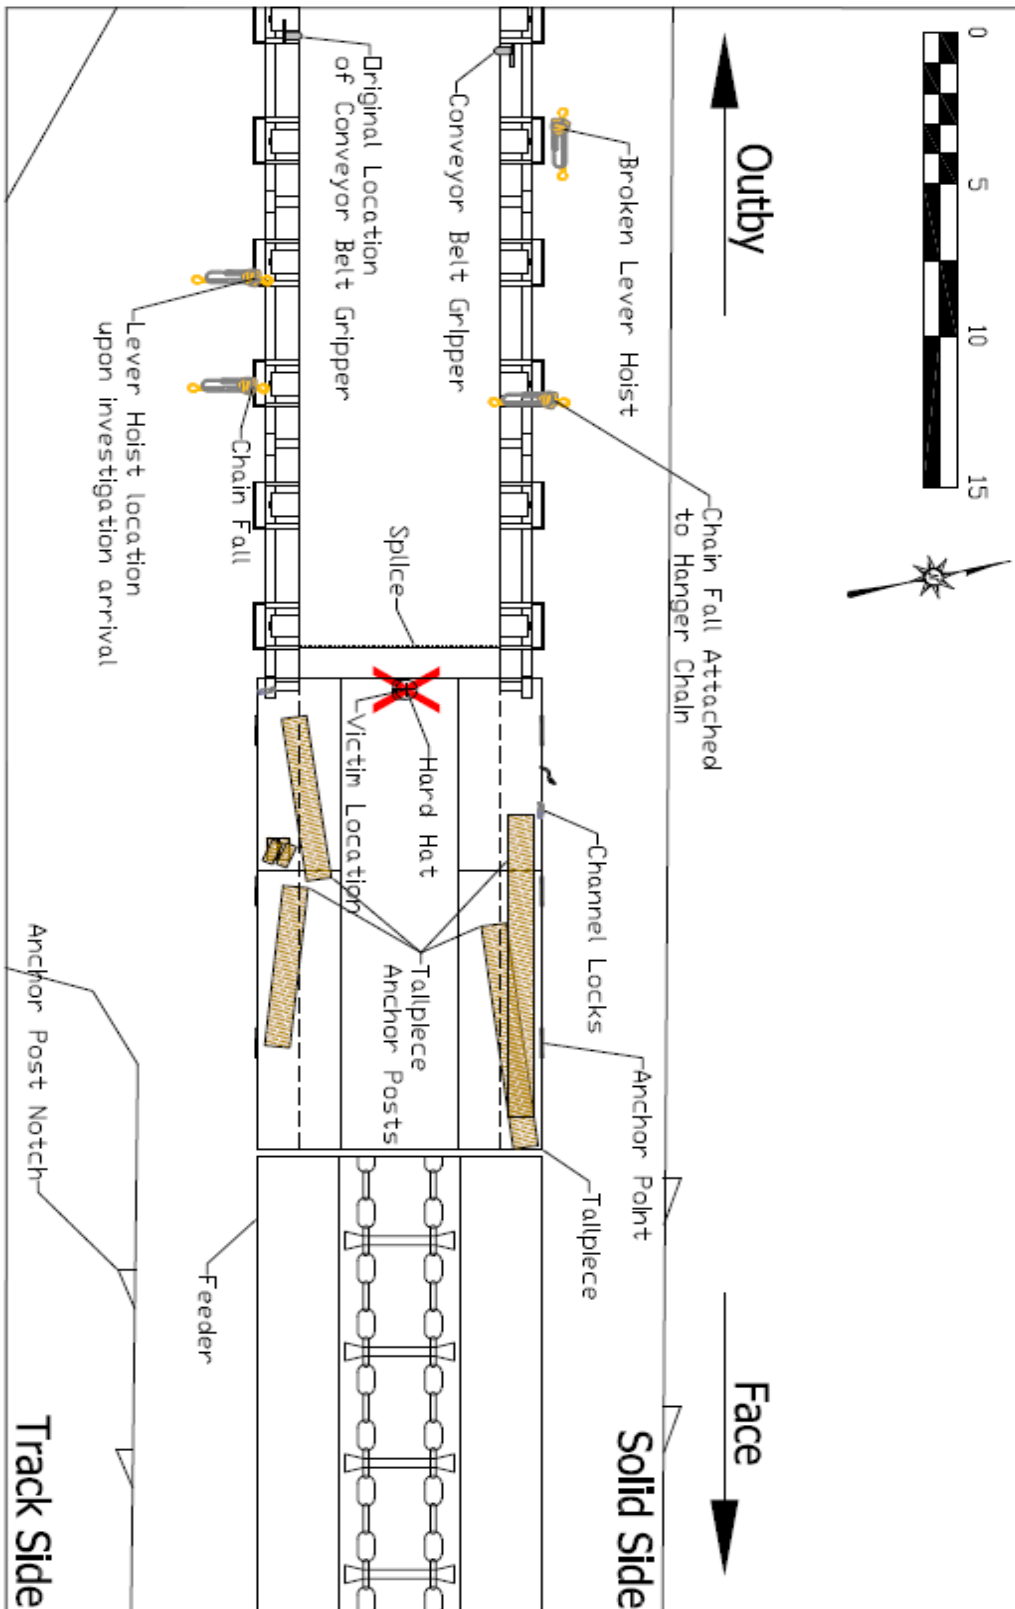
DIAGRAM OF ACCIDENT ..... 1

On December 23, 2019, at approximately 4:15 p.m., Raymond L. Starkey Jr. 21 years of age, was fatally injured while assisting in the installation/advancement of the Cameron Corridor continuous miner section conveyor belt. This accident occurred in the #1 entry, #67 wall, on the Cameron Corridor. Mr. Starkey had a total of 2 years and 4 months mining experience with 8 months and 28 days at the Marshall County Mine.

Mr. Stephenson returned with a 6-foot bolt, using it to apply pressure on the bottom belt. At this time, the miners near the scene heard a loud noise and saw suspended dust in the air. The equipment being used to hold the belt splice in position had failed. Mr. Starkey was pinned between the belt and an outby support beam of the tailpiece.

Mr. Starkey was fatally injured while assisting with the installation/advancement of the Cameron Corridor continuous miner section conveyor belt on December 23, 2019, at approximately 4:15 p.m. The victim was positioned between the bottom belt and the outby support beam of the tailpiece in an attempt to remove a belt splice pin. There was a failure of the equipment that restrained the bottom belt, which resulted in a release of stored energy in the belt. This caused a sudden, unexpected violent upward and outward movement of the bottom belt that pinned the victim.
