WEST VIRGINIA OFFICE OF MINERS' HEALTH, SAFETY AND TRAINING

**REPORT OF FATALITY
MOBILE EQUIPMENT
FEBRUARY 27, 2020**

**PHOENIX FED. NO. 2 MINING LLC.
FEDERAL NO. 2 MINE
PERMIT NO. D00004563B**

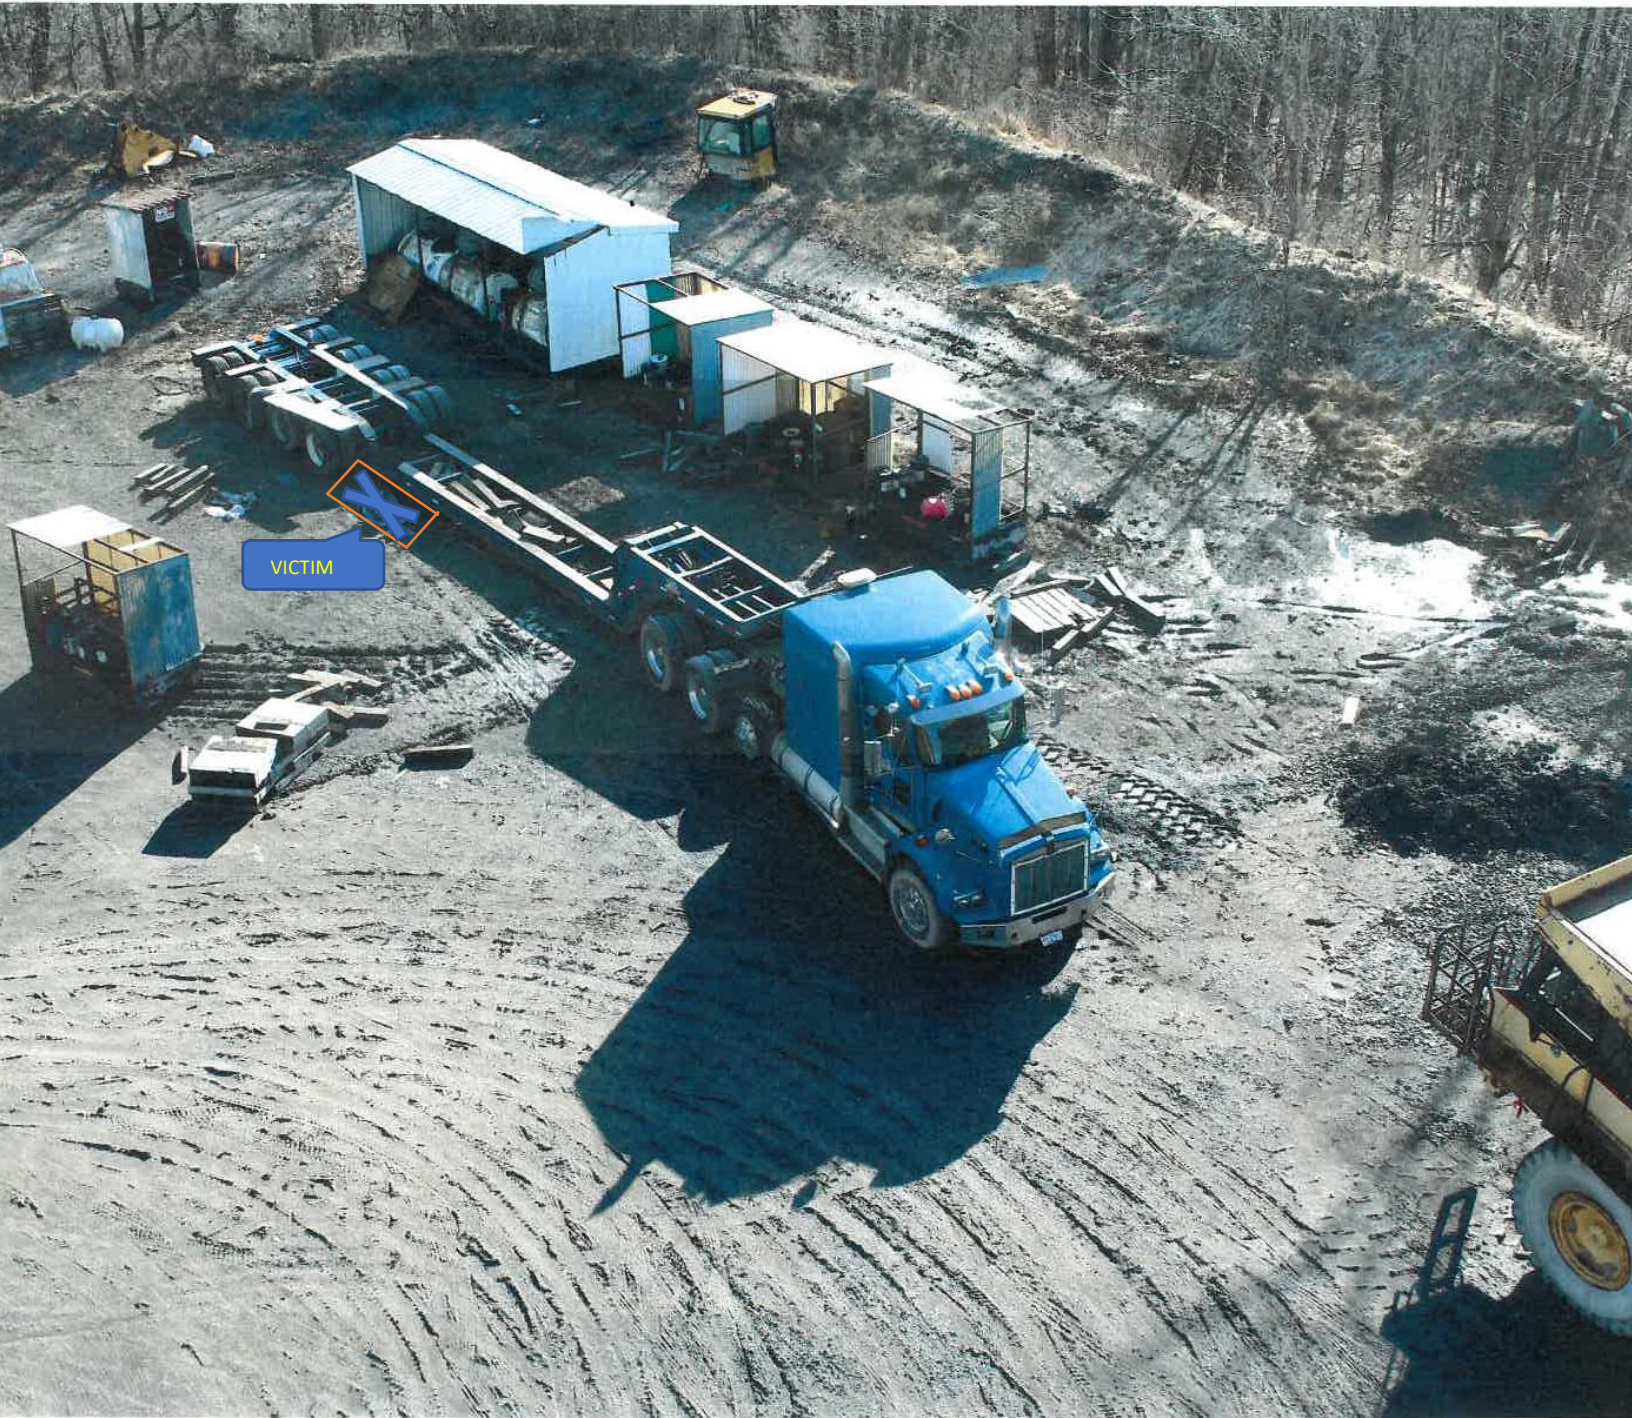
PICTURE OF ACCIDENT 1

Mr. Campbell received fatal injuries when he was assisting in the positioning of a lowboy/trailer on February 27, 2020. Mr. Campbell was located on the passenger side, near the dual tandem front axle, beside the trailer frame rail of the lowboy/trailer. Mr. Campbell was struck and the lower part of his body was run over by the dual tandem tires on the front axle of the trailer while the truck moved forward.

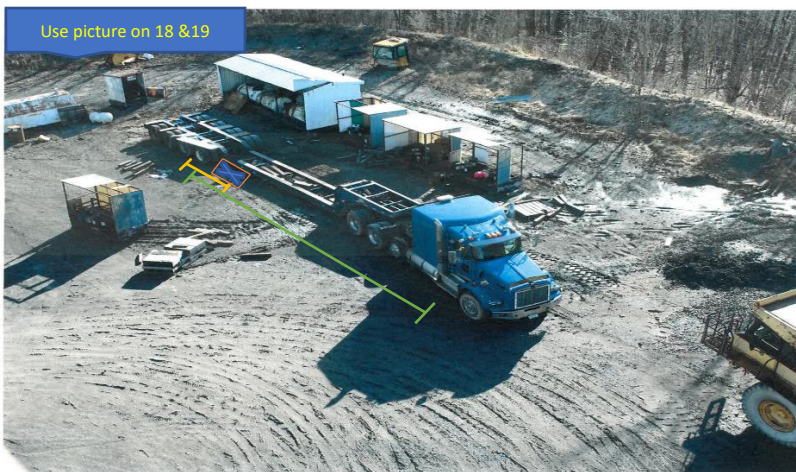
20. The trailer traveled forward a total of **eight (8) feet** before coming to a stop with the tires of the trailer on the victim. (I—|) (see photo below)

21. The measurement from the front axle of the Talbert trailer to the truck mirrors is **fifty-two (52) feet**.

(I—|) (see photo below)
