THE STATE OF WEST VIRGINIA OFFICE OF MINERS' HEALTH, SAFETY & TRAINING

FATAL RIB FALL ACCIDENT

**CONSOLIDATION COAL COMPANY
LOVERIDGE MINE
PERMIT NO. D-403**

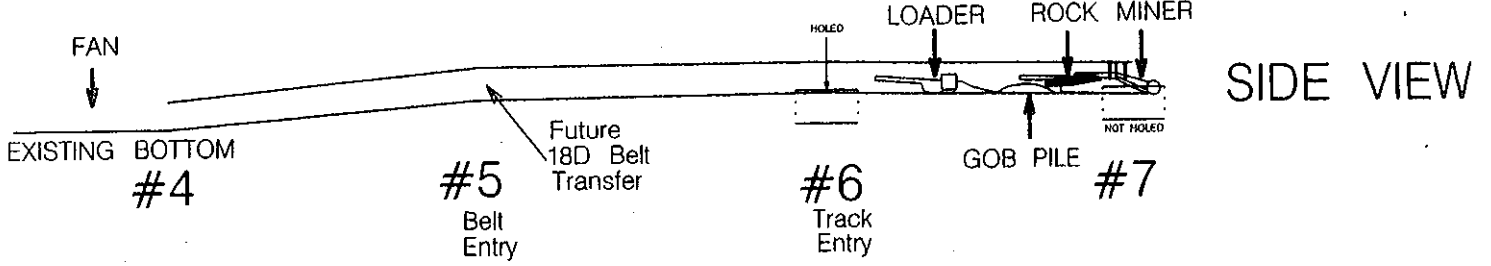
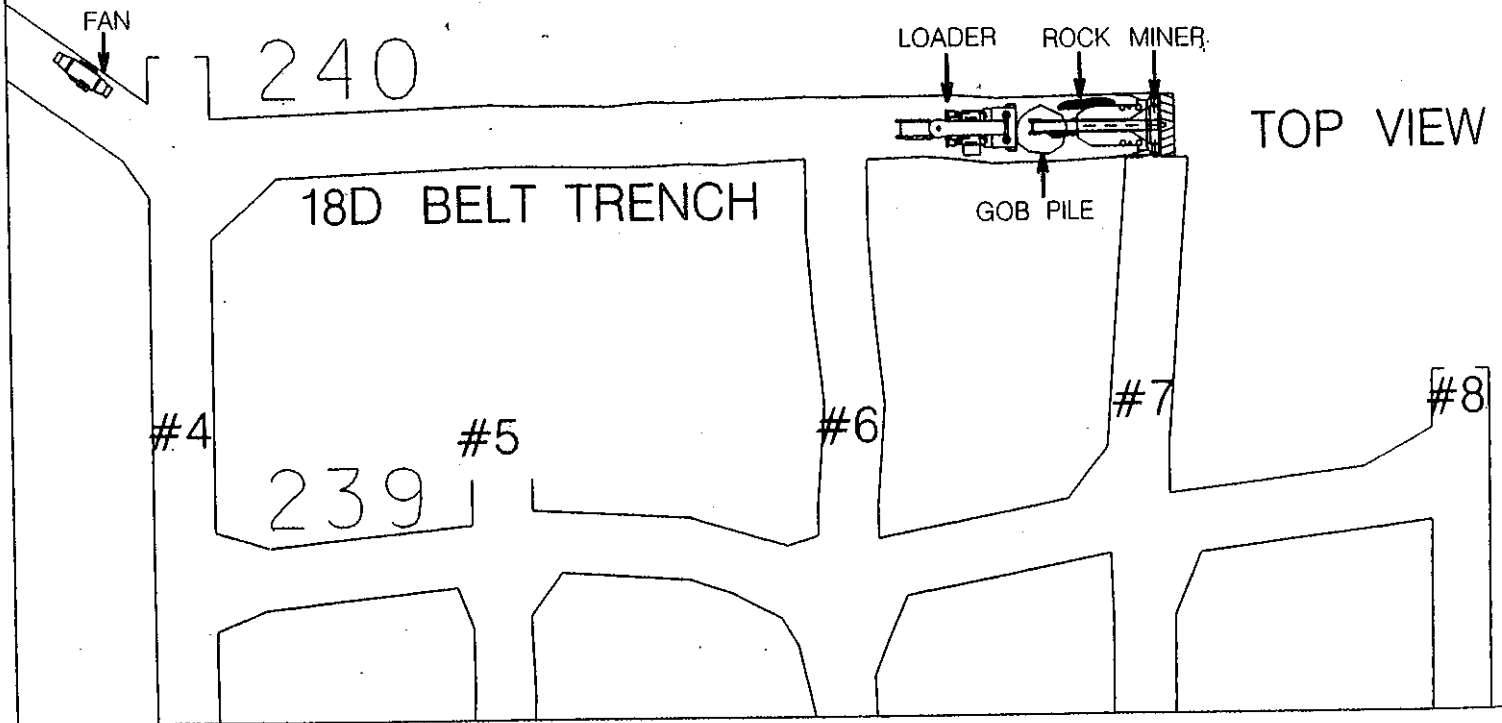
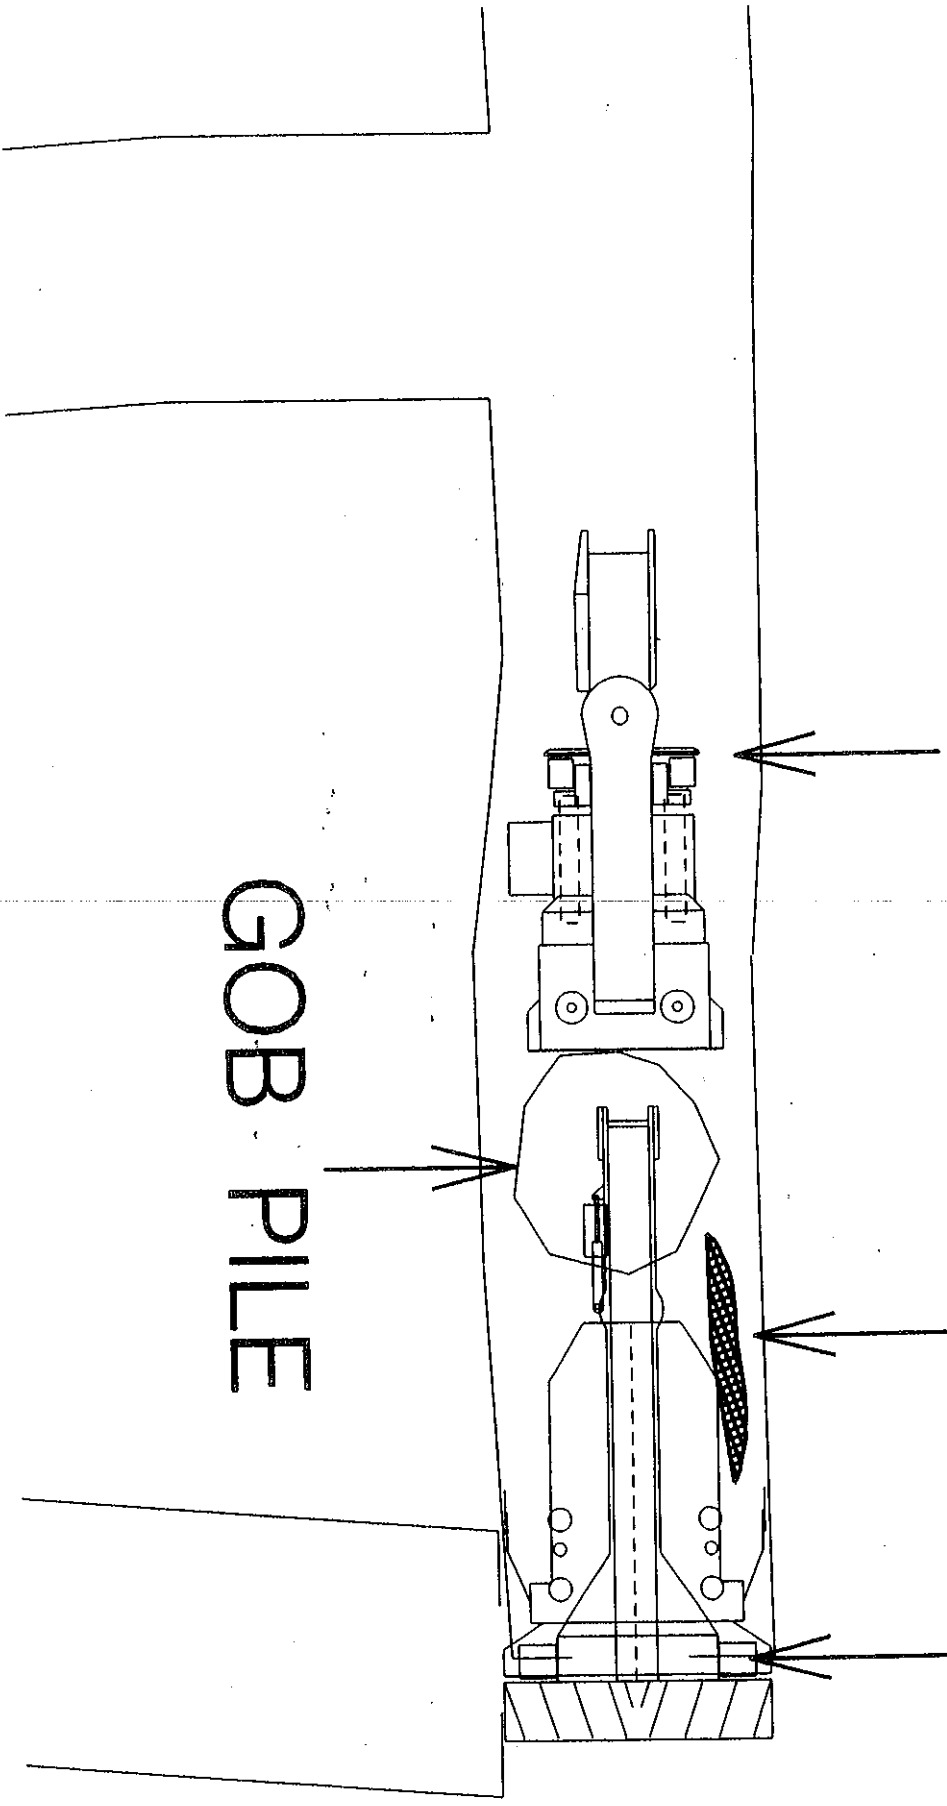
18D BELT TRENCH

LOADER ROCK MINER

GOB PILE

4) The rock that fell from the left rib was six (6) inches to sixteen (16) inches thick, ranging from twenty-four (24) inches to fifty-five (55) inches in height and approximately twenty-three (23) feet long.

6) The rock extended five and one half (5½) feet outby and extended seventeen and one half (17½) feet inby the bumper of the continuous miner. This was the location of the victim prior to the accident.
