West Virginia Office of Miners' Health, Safety and Training

May 17, 2012

**Report of a Fatality by Fall to a Lower Level
Liberty Processing**

**Independence Coal Company
Liberty Processing
L-699**

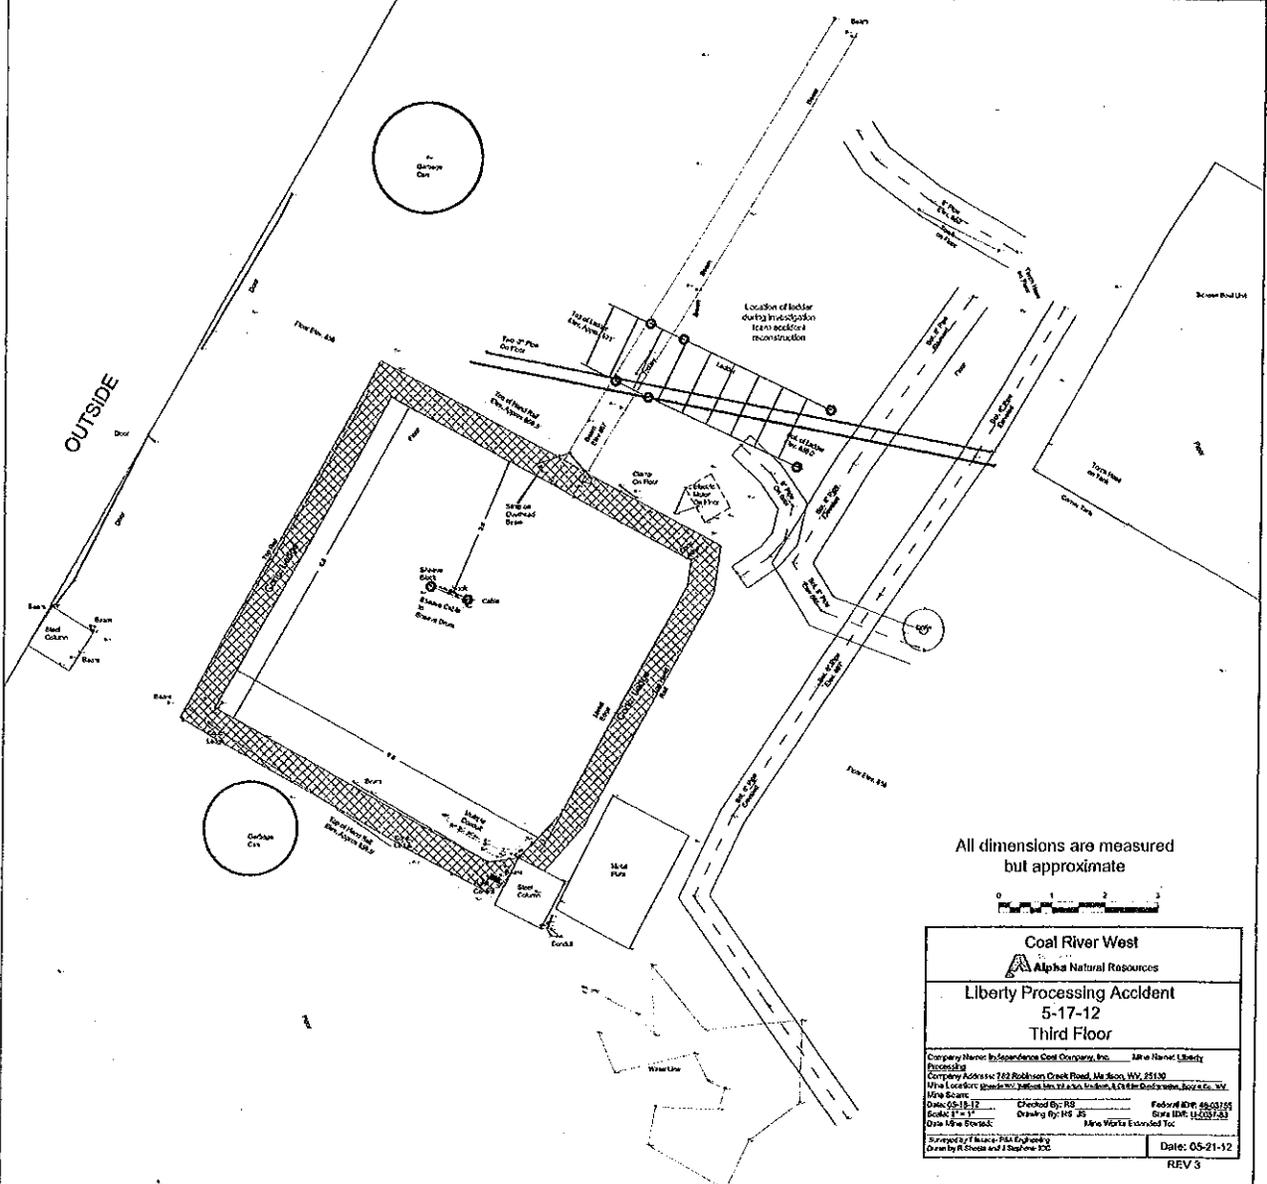
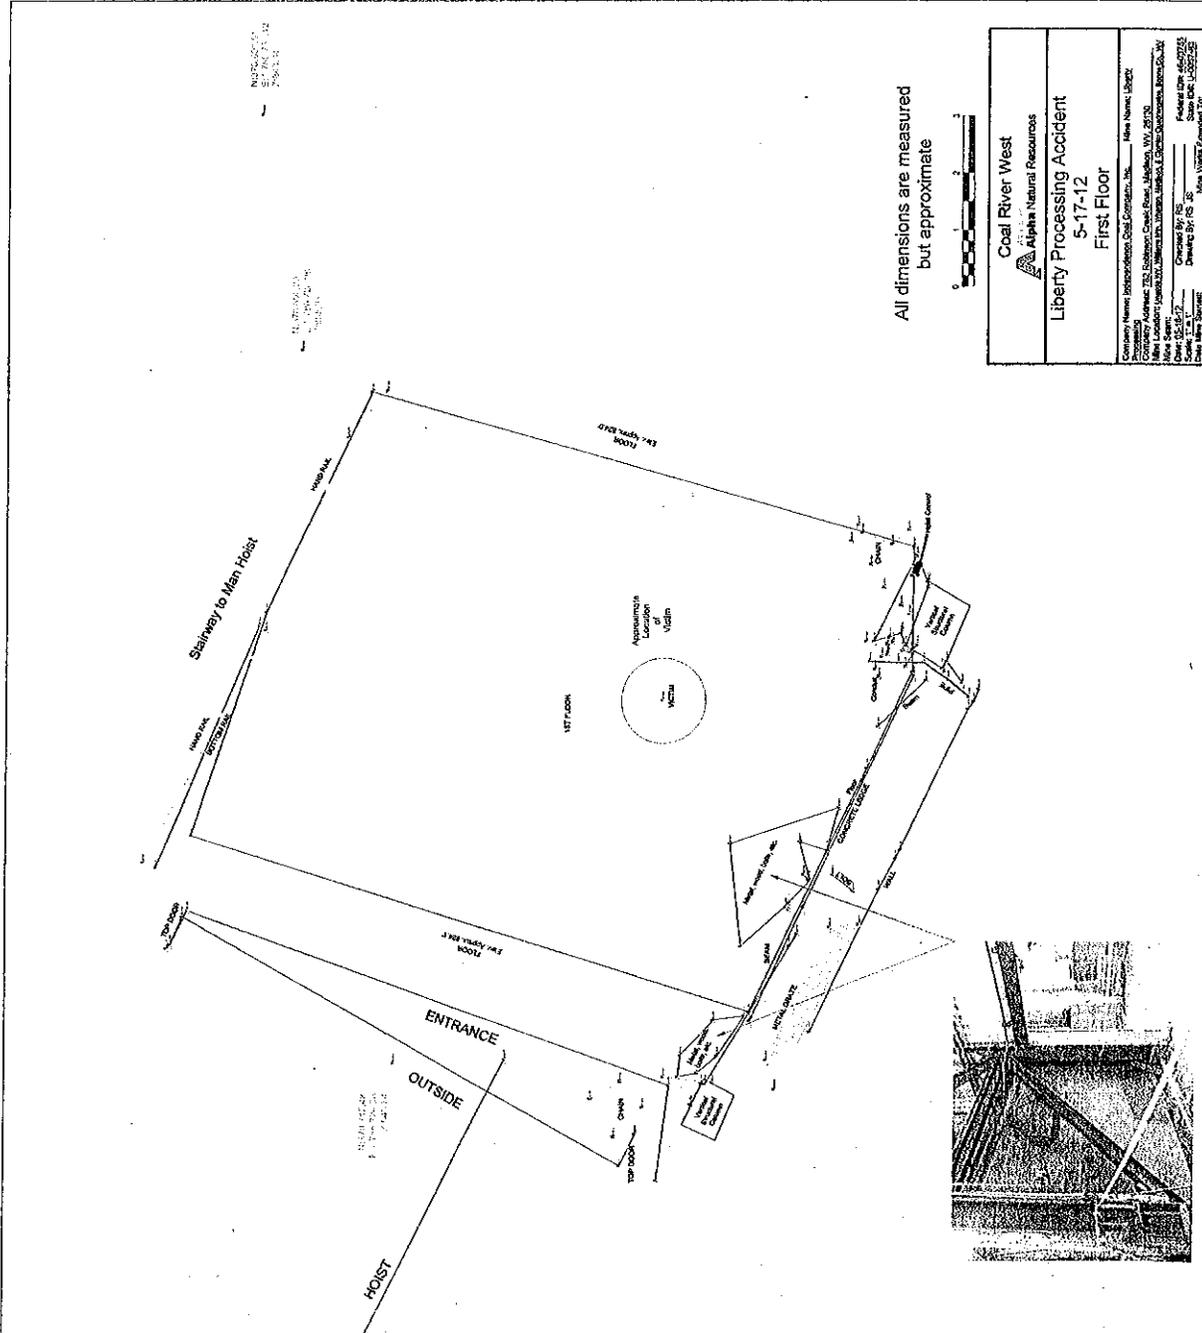
All dimensions are measured but approximate
