**WEST VIRGINIA OFFICE OF MINERS' HEALTH, SAFETY AND
TRAINING**

REPORT OF FATALITY

Rubber Tire Haulage Equipment

**Century Mining, LLC, Longview Mine
PERMIT NO. U00201512**

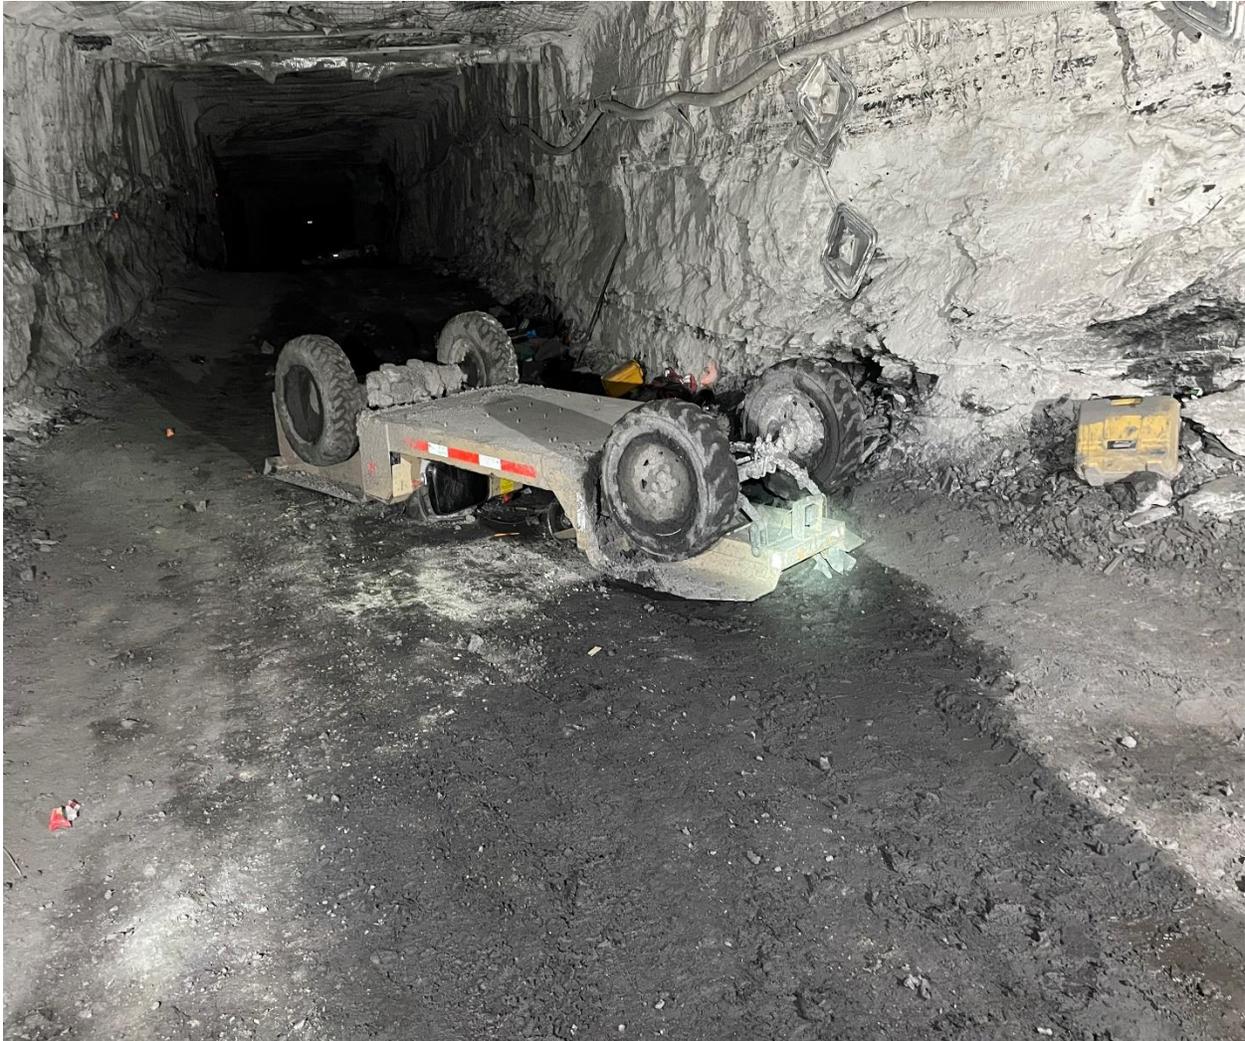
Photo of the accident scene located at tailgate section #2 entry, 17 block.

Mr. Barker was fatally injured after the rubber tire #2 Stryker 72 personnel carrier rolled backward down the #2 entry from #15 block to #17 block on the tailgate section where it contacted the rib and overturned entrapping Mr. Barker under the #2 Stryker 72 personnel carrier.
