West Virginia Office of Miners' Health, Safety and Training

**Report of Fatality
Track Haulage Equipment
August 5, 2024**

**ACI Tygart Valley
Leer Mine
Permit No. U00200406A**

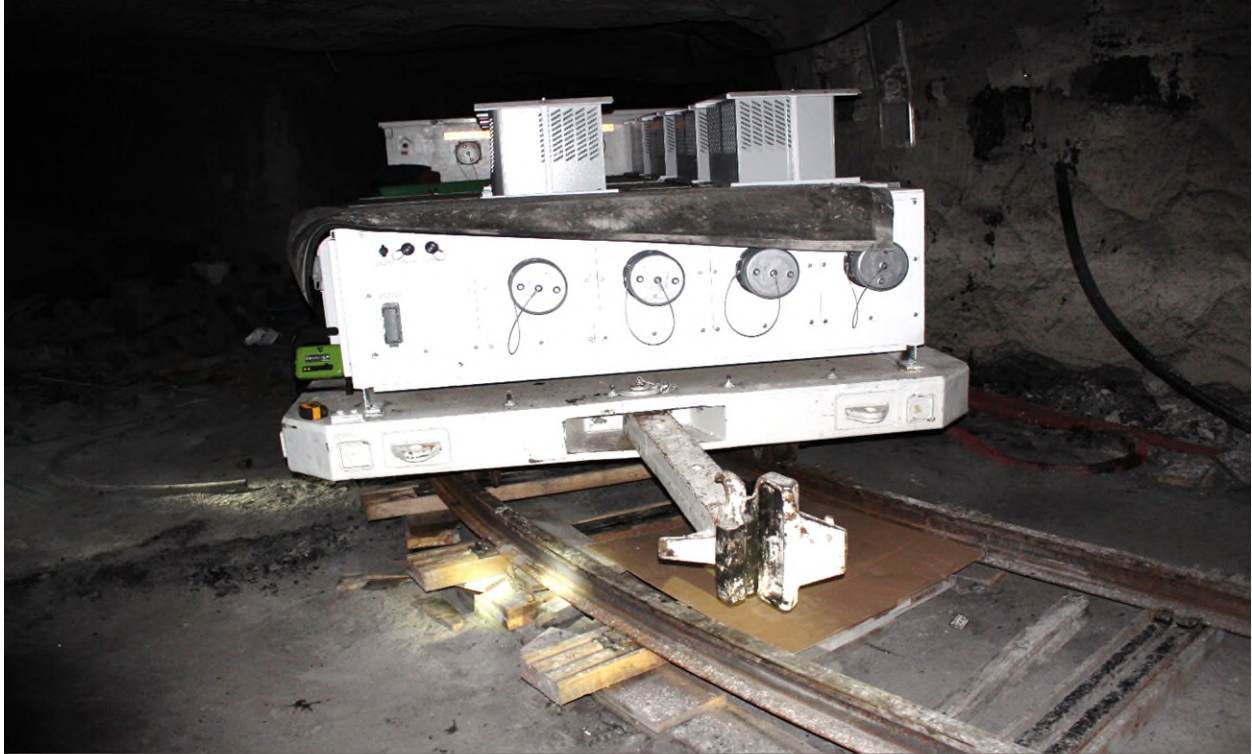
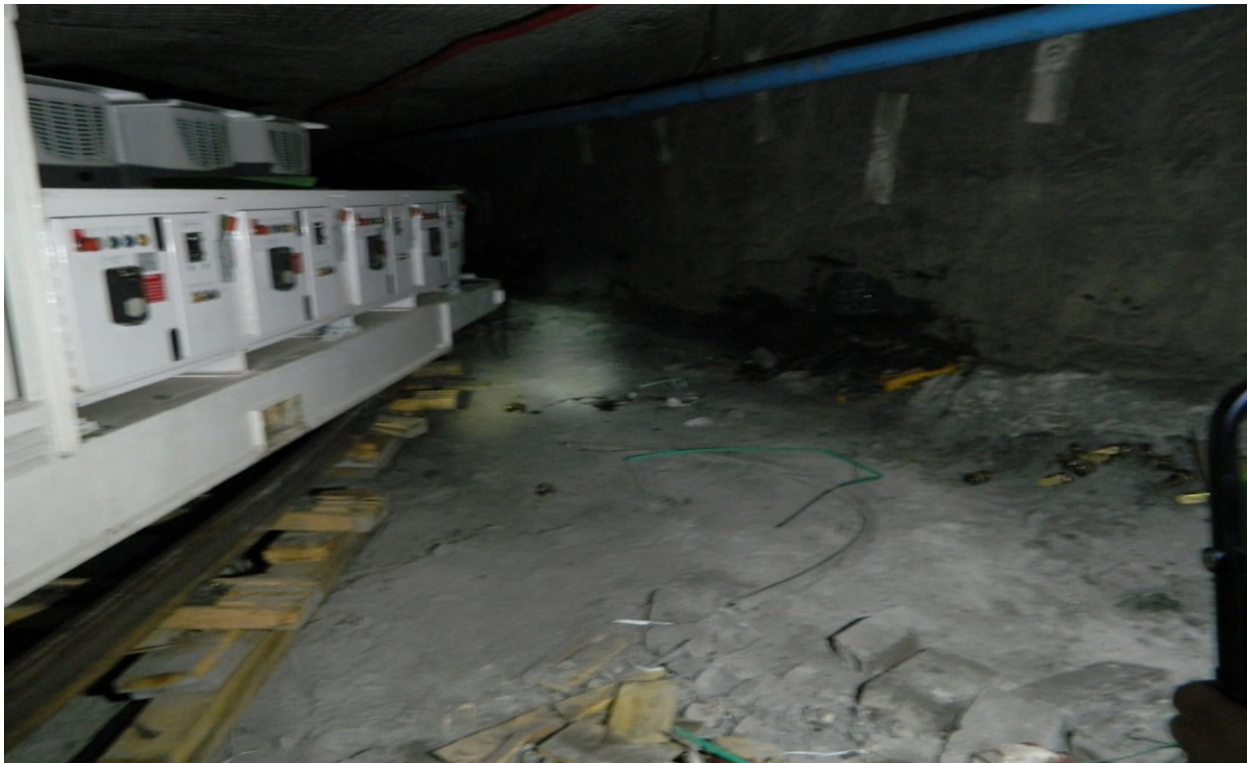
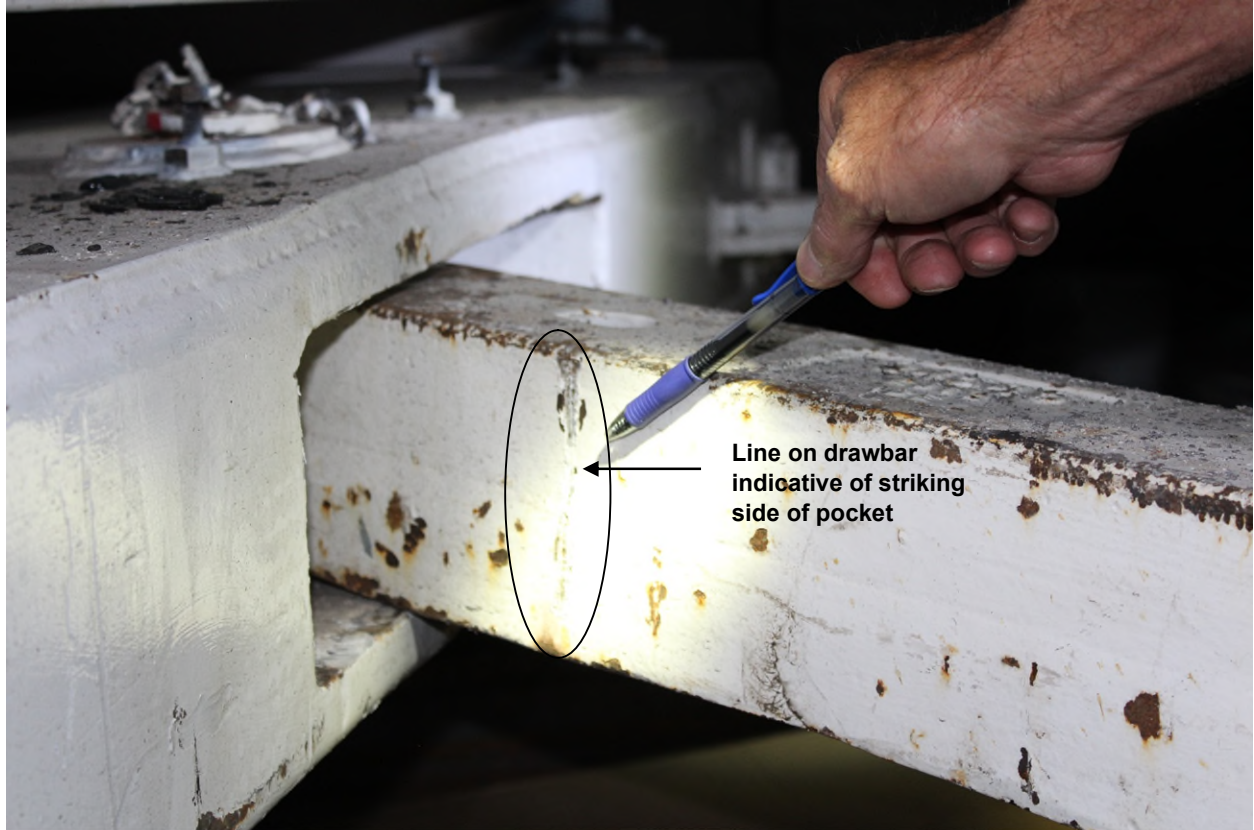
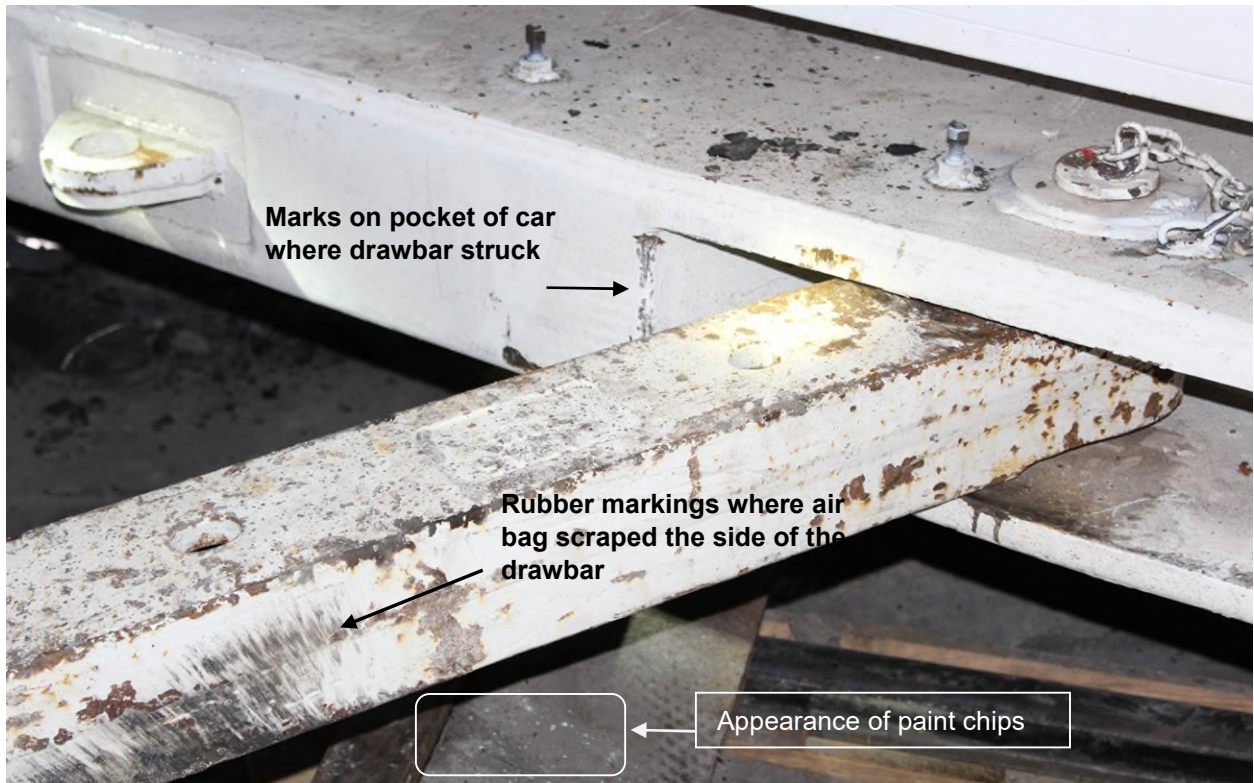
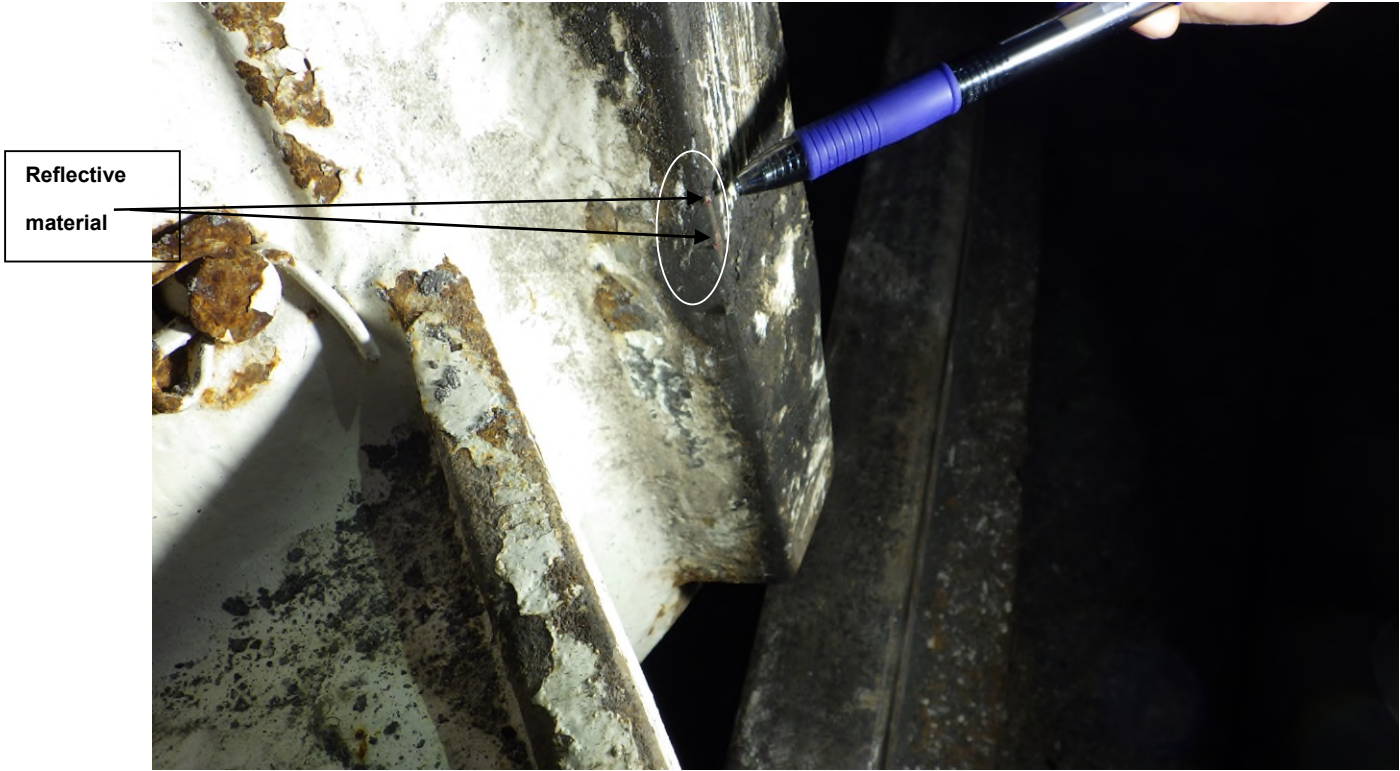
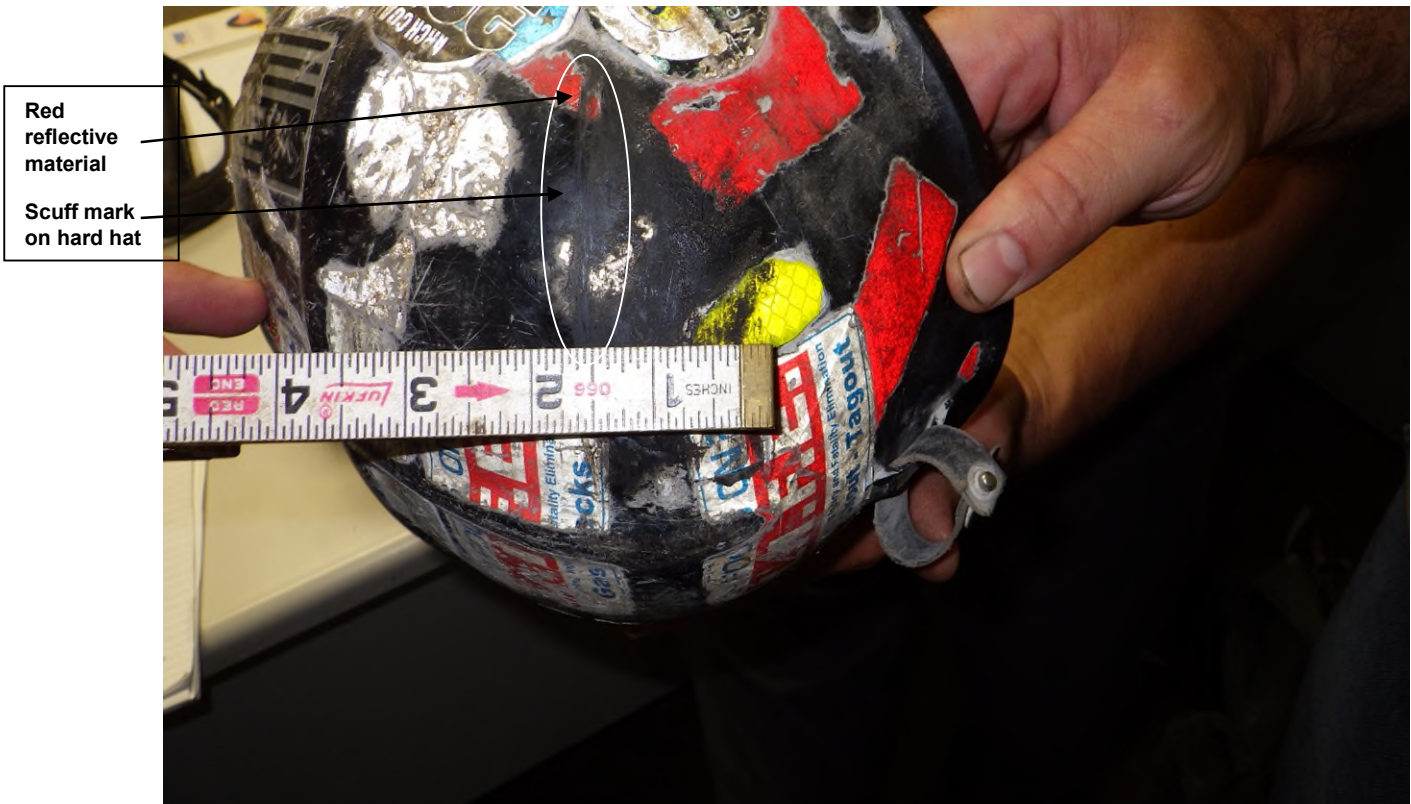
**Photos of the Longwall 3MVA Power Car and the accident scene located at
10 Left 16 Block Mule Train Spur**

Mr. Crandall was last observed by Mr. Bevins kneeling on the mine floor, looking under the inby walk side corner of the 3 MVA longwall power center car. While attempting to rerail the equipment using an air bag system, the air bag or air bags became dislodged, resulting in the 3 MVA longwall power center car striking Mr. Crandall. Mr. Crandall was severely injured after being struck by the 3 MVA longwall power center car at the 16-block track spur on the 10-Left section. On August 7, 2024, Mr. Crandal succumbed to his injuries at 1:45 p.m.

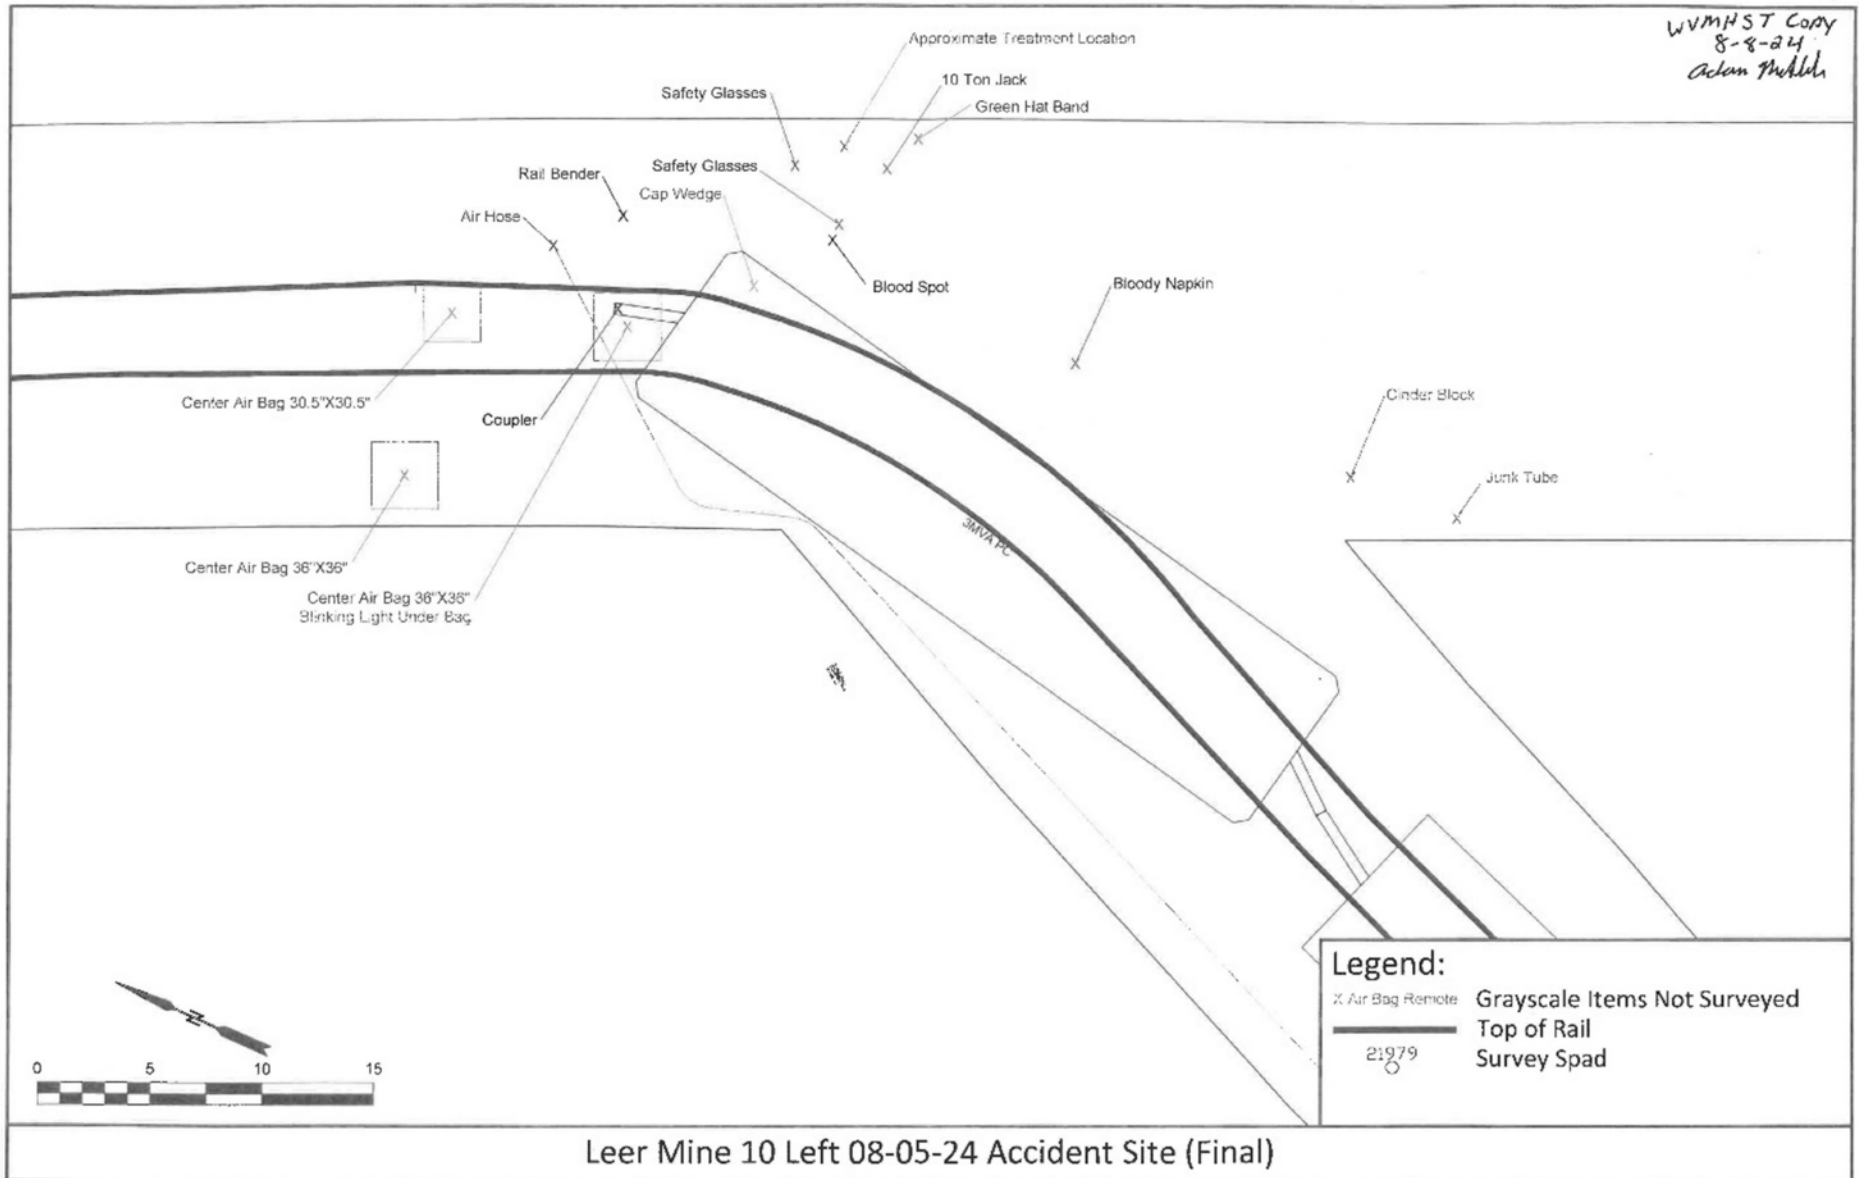
Mr. Crandall's hard hat

20. The 3 MVA longwall power center car weighs approximately forty-eight thousand pounds.
21. Samples of red reflective material taken from the drawbar/coupler by the Mine Safety Health Administration were submitted to the Technical Support Group located in Triadelphia, West Virginia. Based on several factors, it is believed that the drawbar/coupler struck the right rear of Mr. Crandall's hard hat.
