Report of Fatality
Longwall Face Equipment
September 28, 2024

ACI Tygart Valley
Leer Mine
Permit No. U00200406A
Near Grafton in Taylor County, WV

Region I Office
14 Commerce Drive Ste 1
Westover, WV 26501
Edward Peddicord, Inspector-At-Large

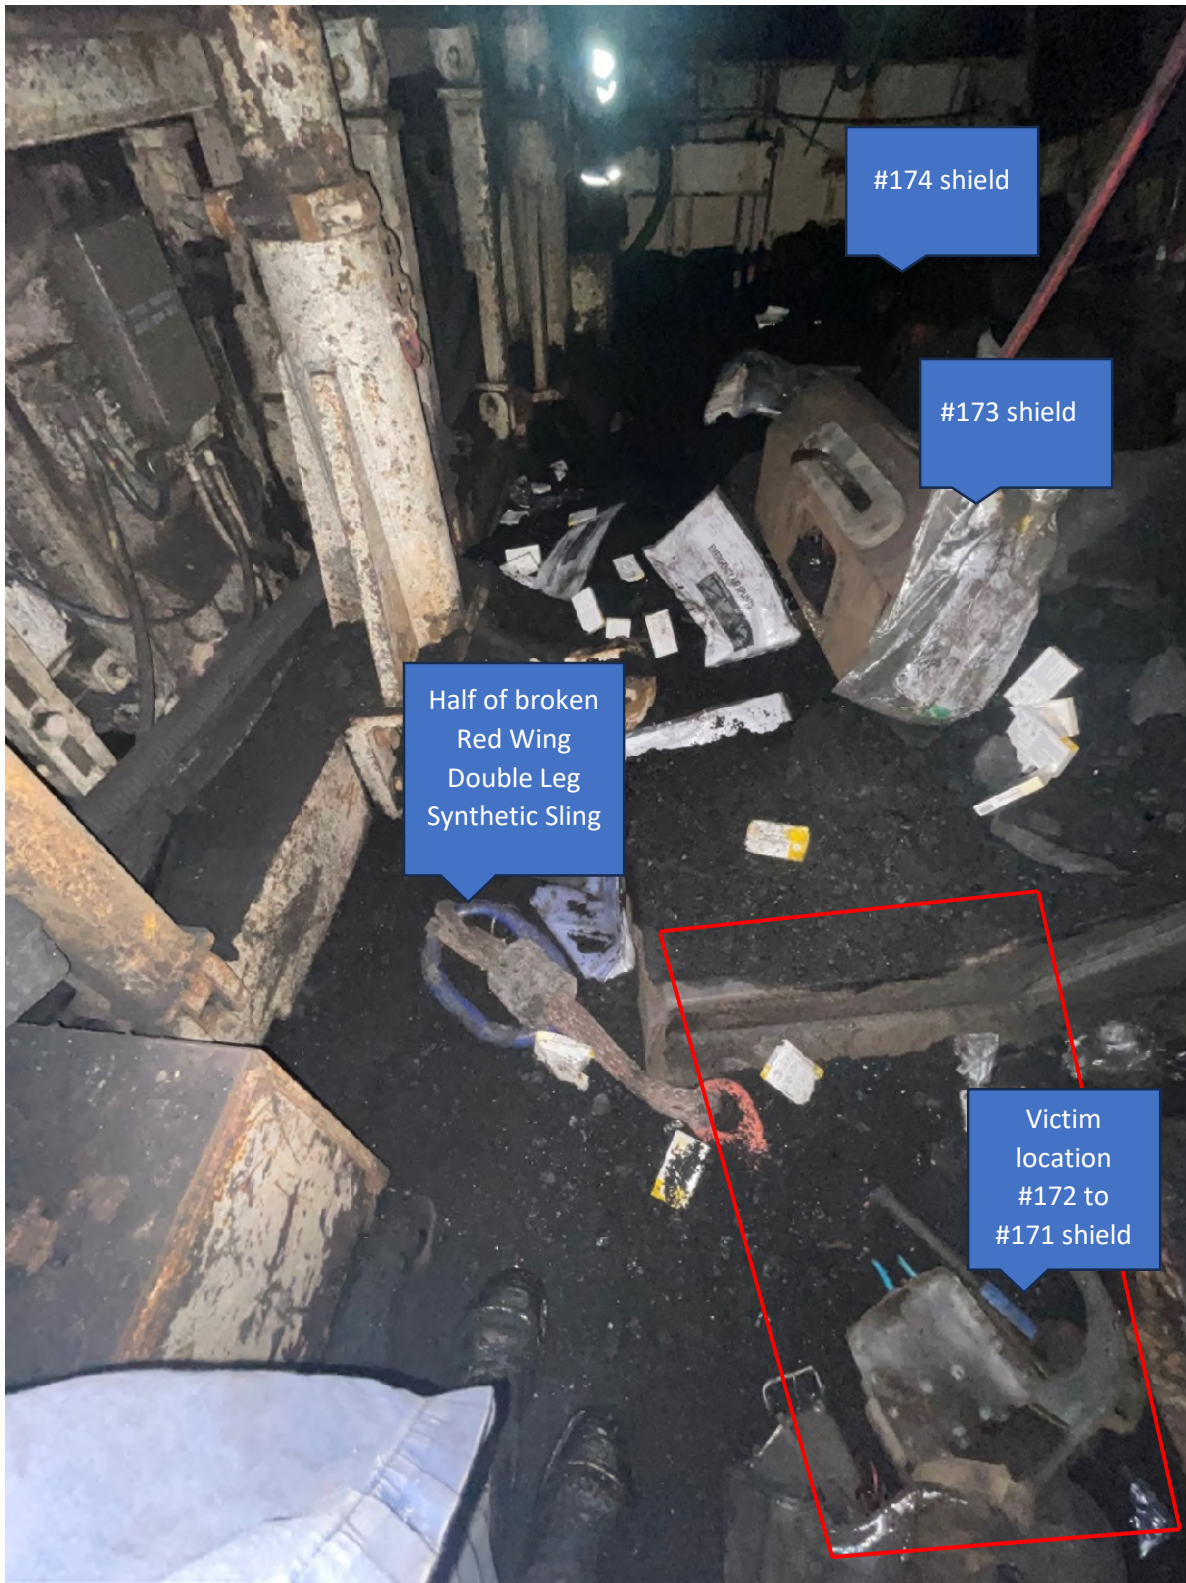
Photo of the accident scene at 10 Left Longwall Face.

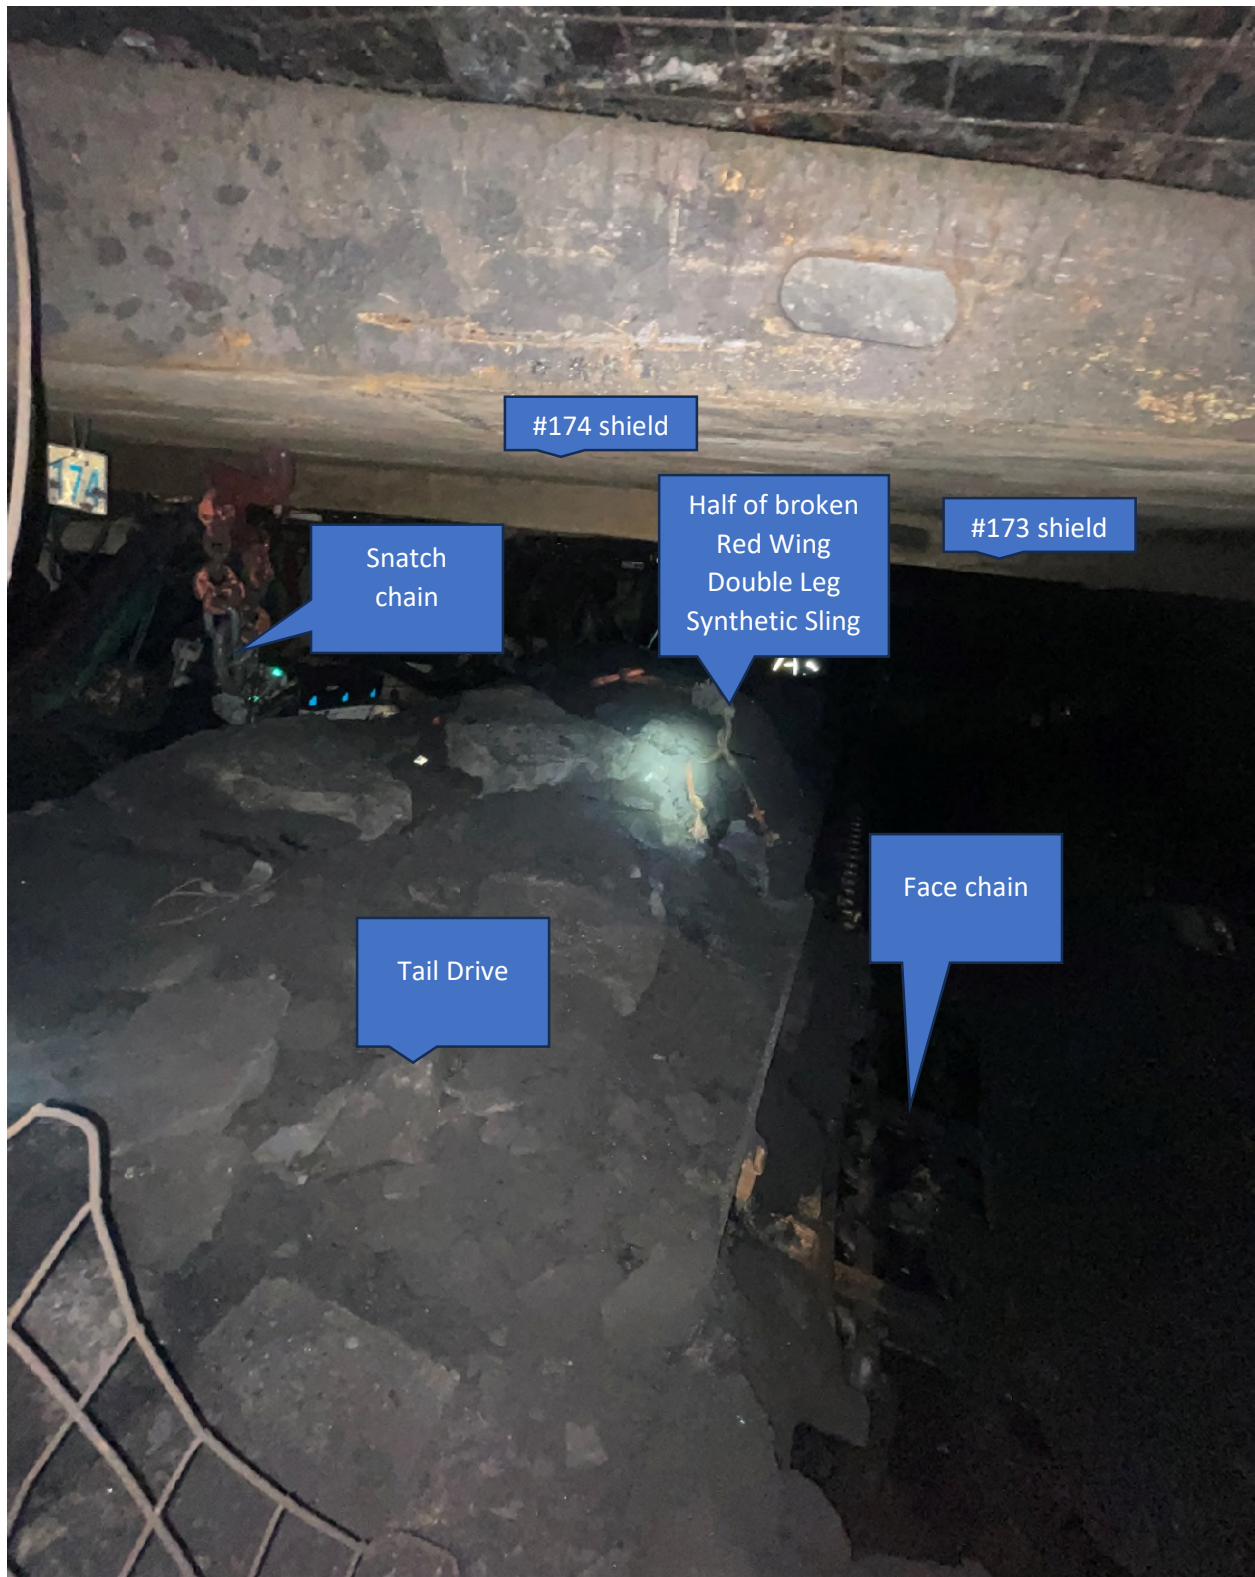
Photo of the accident scene at 10 Left Longwall Face.

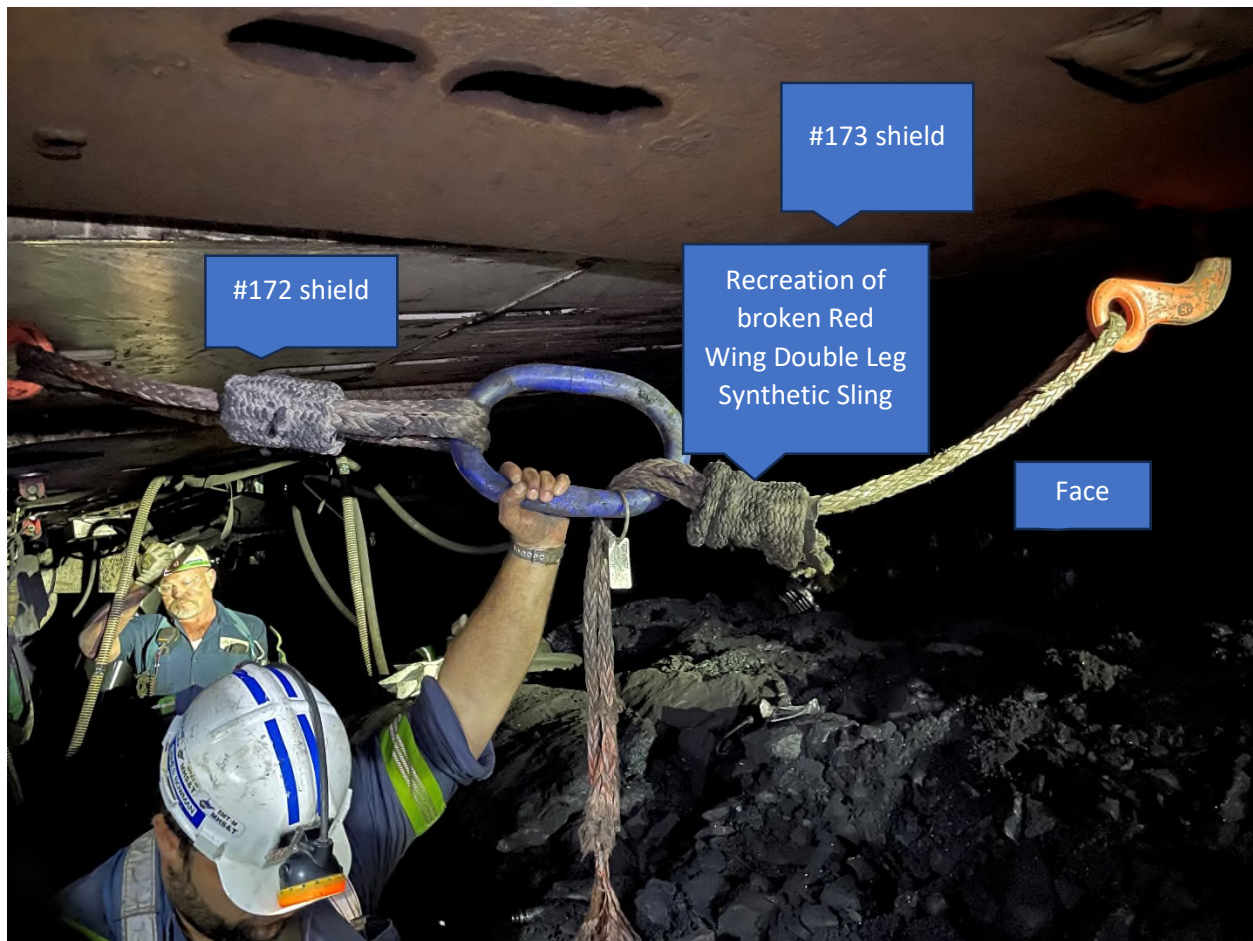
Photo of the accident scene at 10 Left Longwall Face.
