Report of Fatality

Machinery

Marfork Coal Company, LLC

Black Eagle Mine

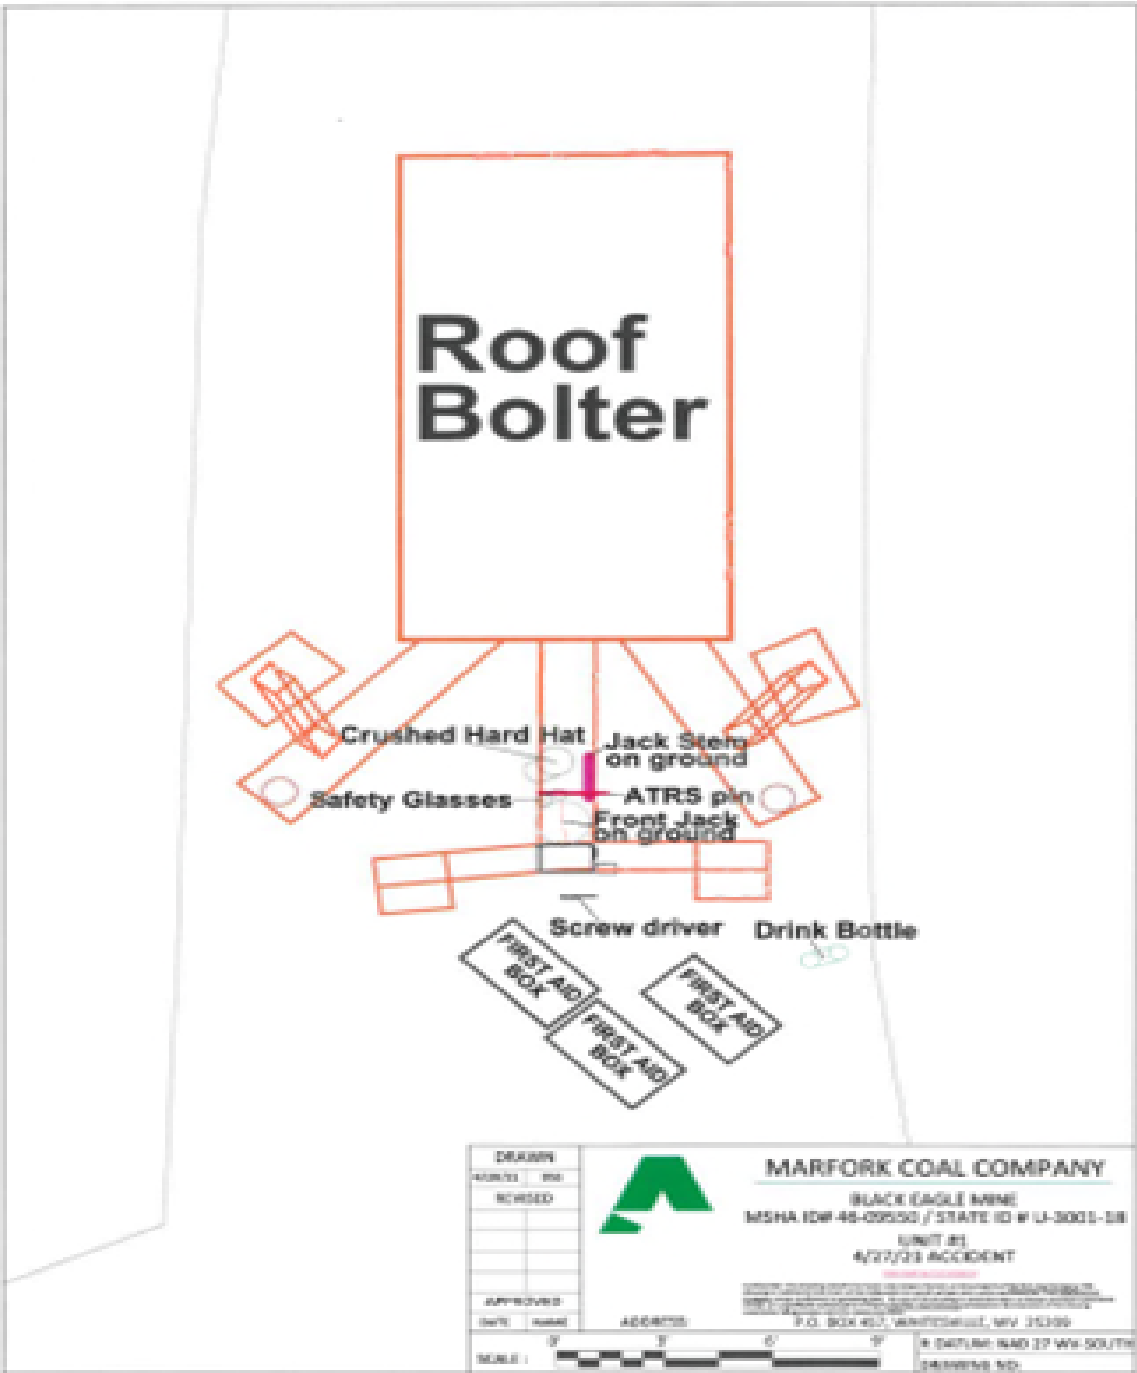
Survey Drawing

The Map of the Accident Area

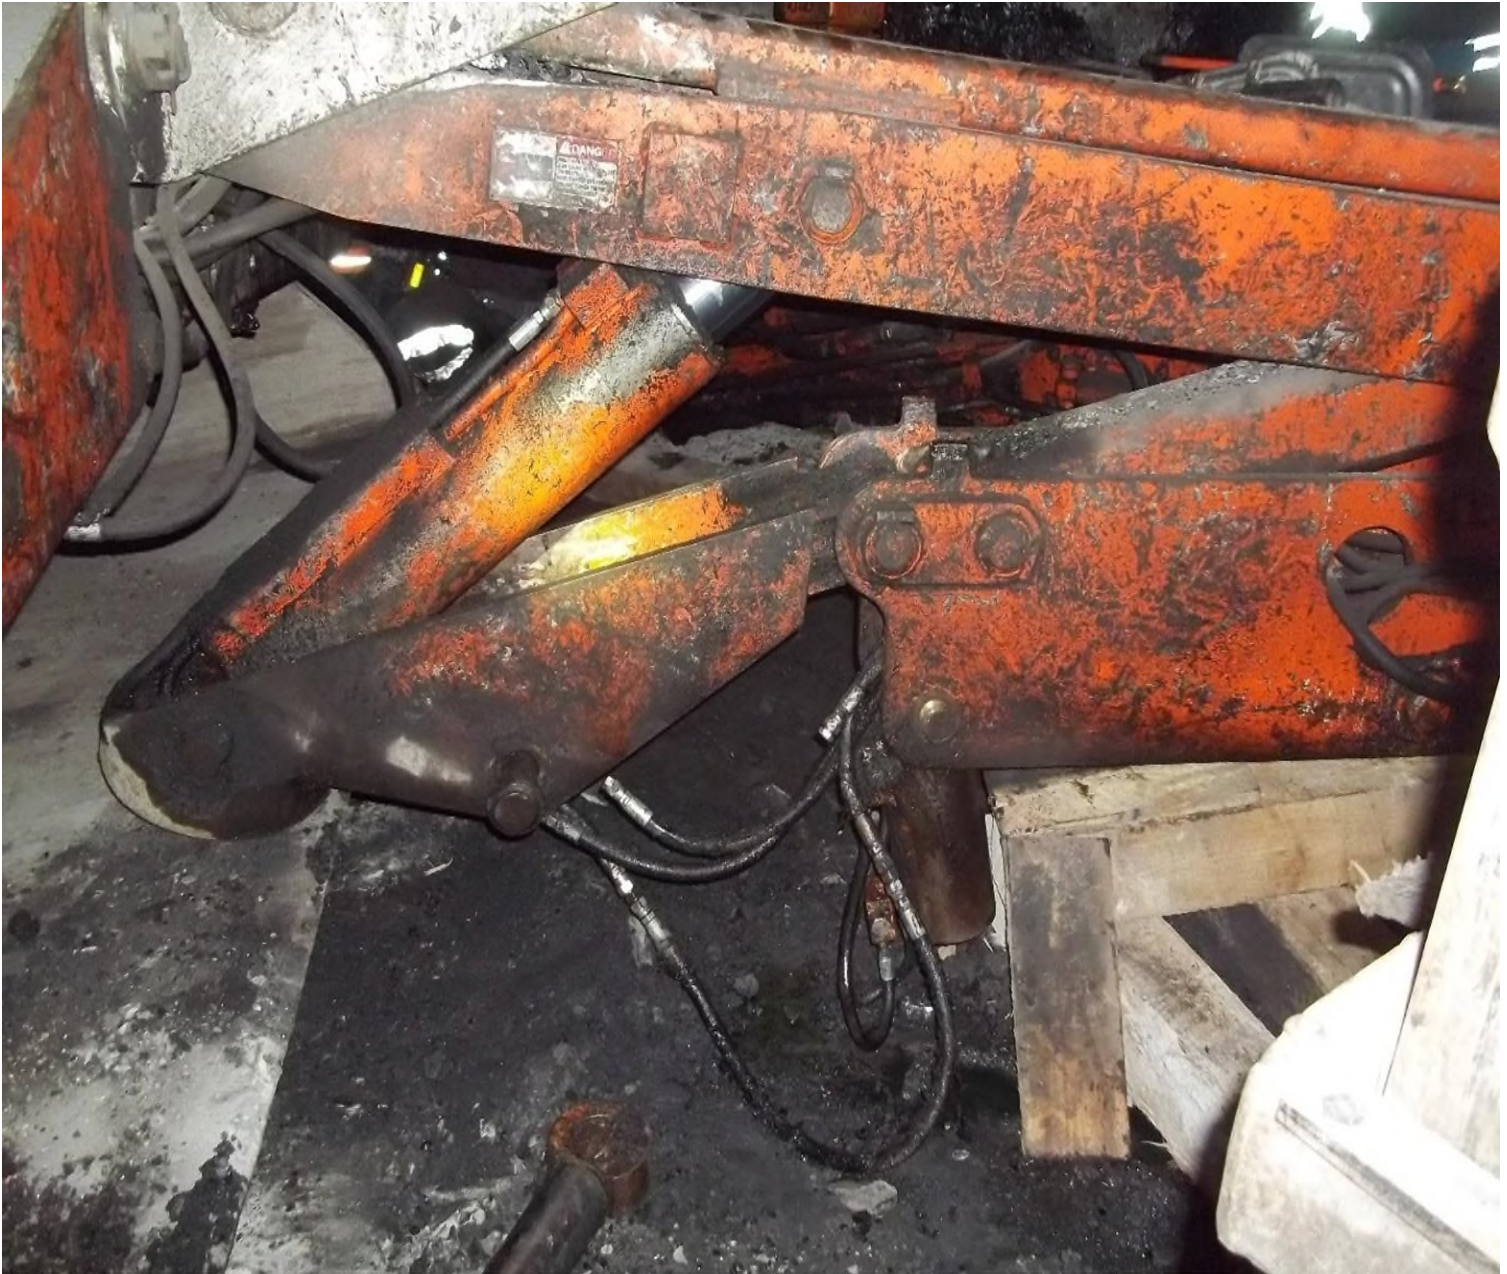
Photo 1

The #2 Roof Bolter Involved in the Accident

The Black Eagle Mine evening shift started at 3:30 p.m., on Tuesday April 27, 2021. When the evening shift arrived, the #2 Roof Bolter on the #1 Section was broken down, due to a failed foot cylinder on the ATRS. The foot cylinder failure occurred during the day shift. The cylinder had to be ordered and was delivered to the mine after the evening shift had started. A safety meeting was held with all employees prior to going underground. Mark Hatfield and Brian Wall, who are outby electricians on the evening shift, waited on the surface for the roof bolter parts to arrive. After the parts arrived, Mr. Hatfield and Mr. Wall loaded the parts on a four-wheel rubber tire mantrip and transported them to the #1 Section. They arrived at approximately 5:45 p.m.

4. Mr. Hatfield cut the front foot cylinder pin with a torch, which allowed the arm assembly to close toward the frame assembly on the ATRS.
5. Mr. Hatfield had his head positioned between the arm assembly and the frame assembly when the pin was cut.

6. When the gap between the arm assembly and frame assembly closed, Mr. Hatfield's head was caught in between them.
7. No type of blocking was in place when the accident occurred.

1. Prior to returning to work, all personnel at the mine will be trained immediately on proper procedures for blocking equipment against potential energy or unexpected movement. The Chief Electrician is the person responsible for conducting this training. The training will be recorded on a 5000-23 form.

- a) A safety meeting will be held prior to changing the ATRS foot cylinder.
 - b) Blocking under ATRS frame assembly.
 - c) Blocking between the ATRS frame assembly and the ATRS arm assembly.

- d) Blocking under the ATRS footpad.
 - e) All training will be recorded on a 5000-23 form.

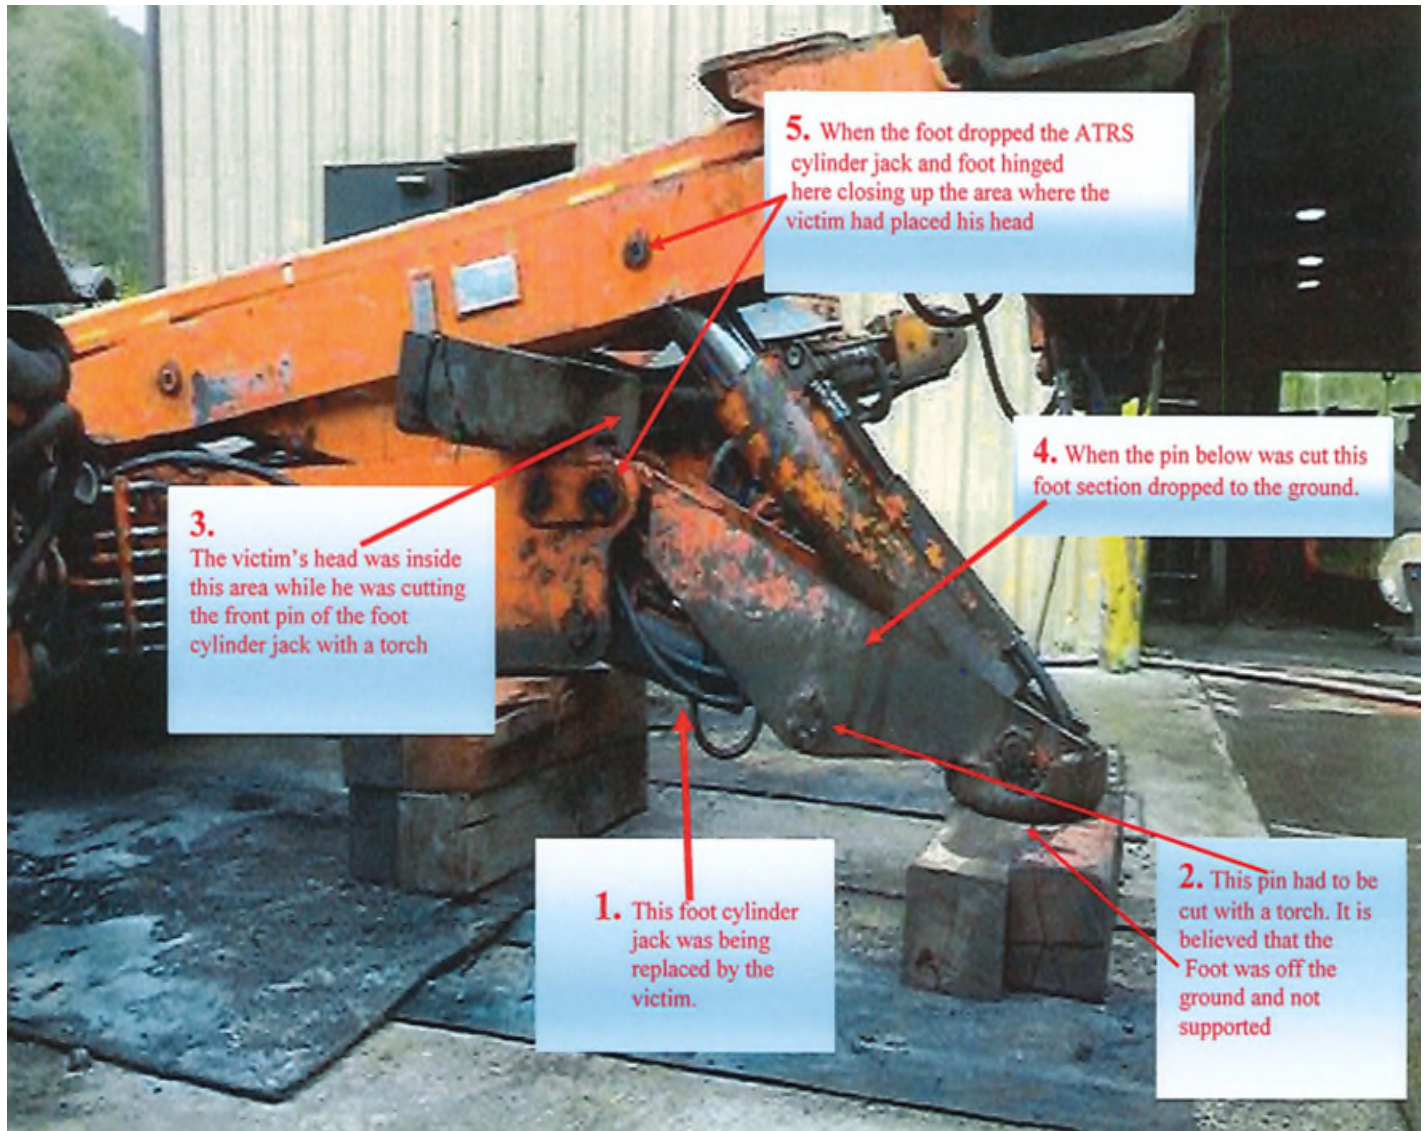
Photo 2

A Re-Creation of the Placement of the #2 Roof Bolter

The victim was working to replace a foot cylinder on the automated temporary roof support system on the #2 Roof Bolter on the #1 Section when the accident occurred. No blocking was installed to prevent movement of the arm and frame assemblies on the ATRS.
