**WEST VIRGINIA OFFICE OF MINERS' HEALTH, SAFETY AND  
TRAINING**

**REPORT OF FATALITY**

**Fall-Elevated Work Place**

**Ohio County Mine Preparation Plant**

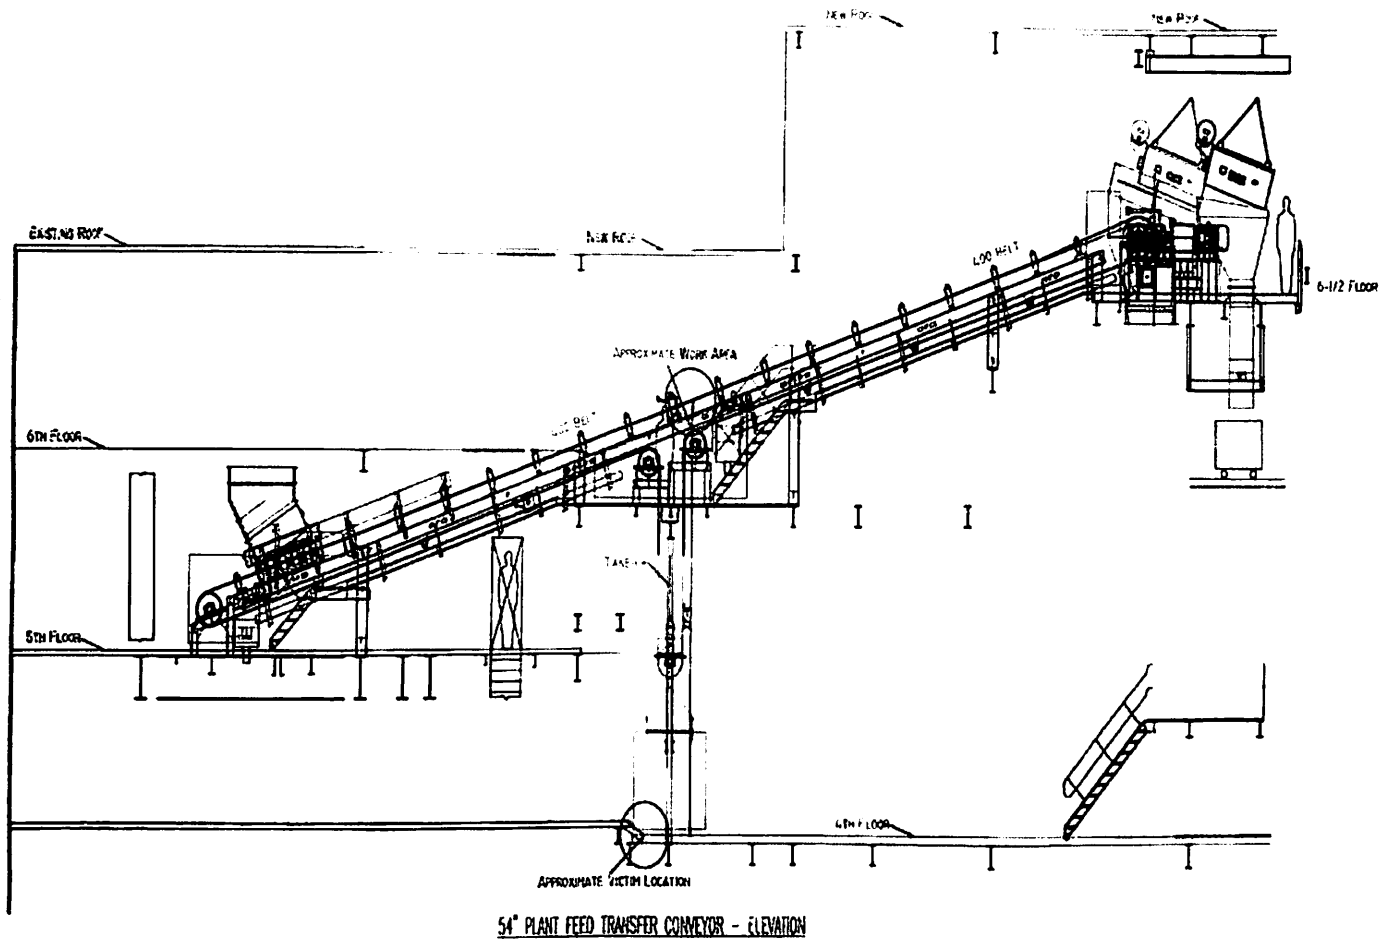
Photo of the working location on 400 belt
