**Report of Fatality  
Coal Processing Facility  
Hoisting Accident**

**August 26, 2025**

**Marfork Coal Company, LLC  
Marfork Processing  
L00000646**

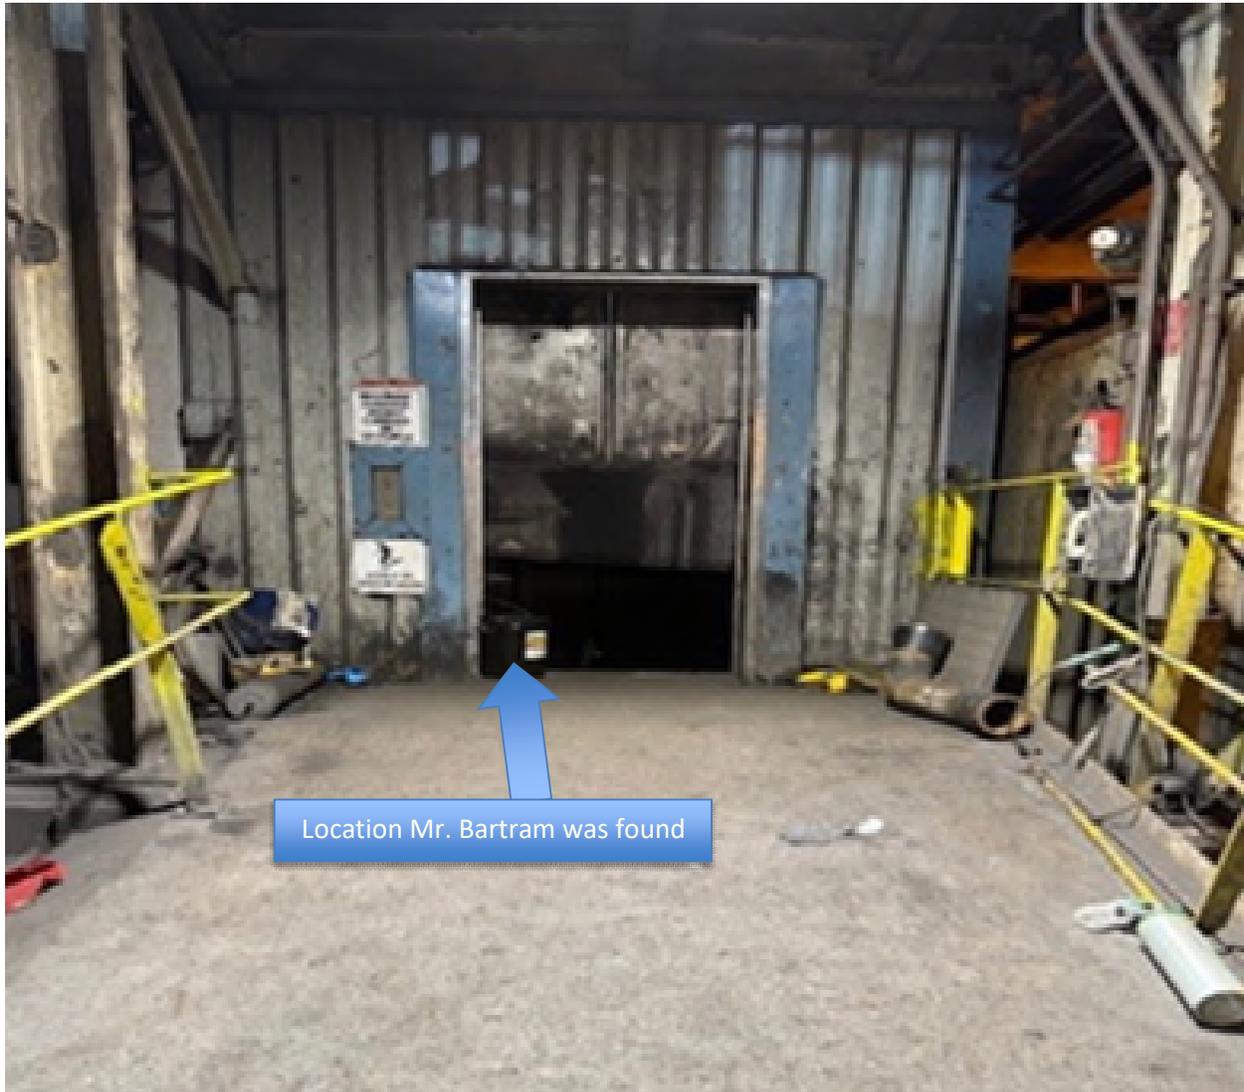
**Photo 1**  
**Accident Location**

On August 26, 2025, Eric Bartram, Electrician, was fatally injured at the preparation plant after being caught between the bottom of the elevator car and the first-floor basement elevator landing. See Photo 1 on page 1.

3. The elevator was not locked and tagged out of service prior to the victim being positioned in the hoist well where he was caught between by the descending elevator car and the first-floor landing.

1. Train all employees in the importance of de-energizing, locking, and tagging equipment out of service before entering pinch point areas.
2. Train all employees to remove all jumpers that are used during troubleshooting before returning equipment back into service.
3. Train all employees on the importance of properly terminating conductors to prevent inadvertent contact with other conductors.

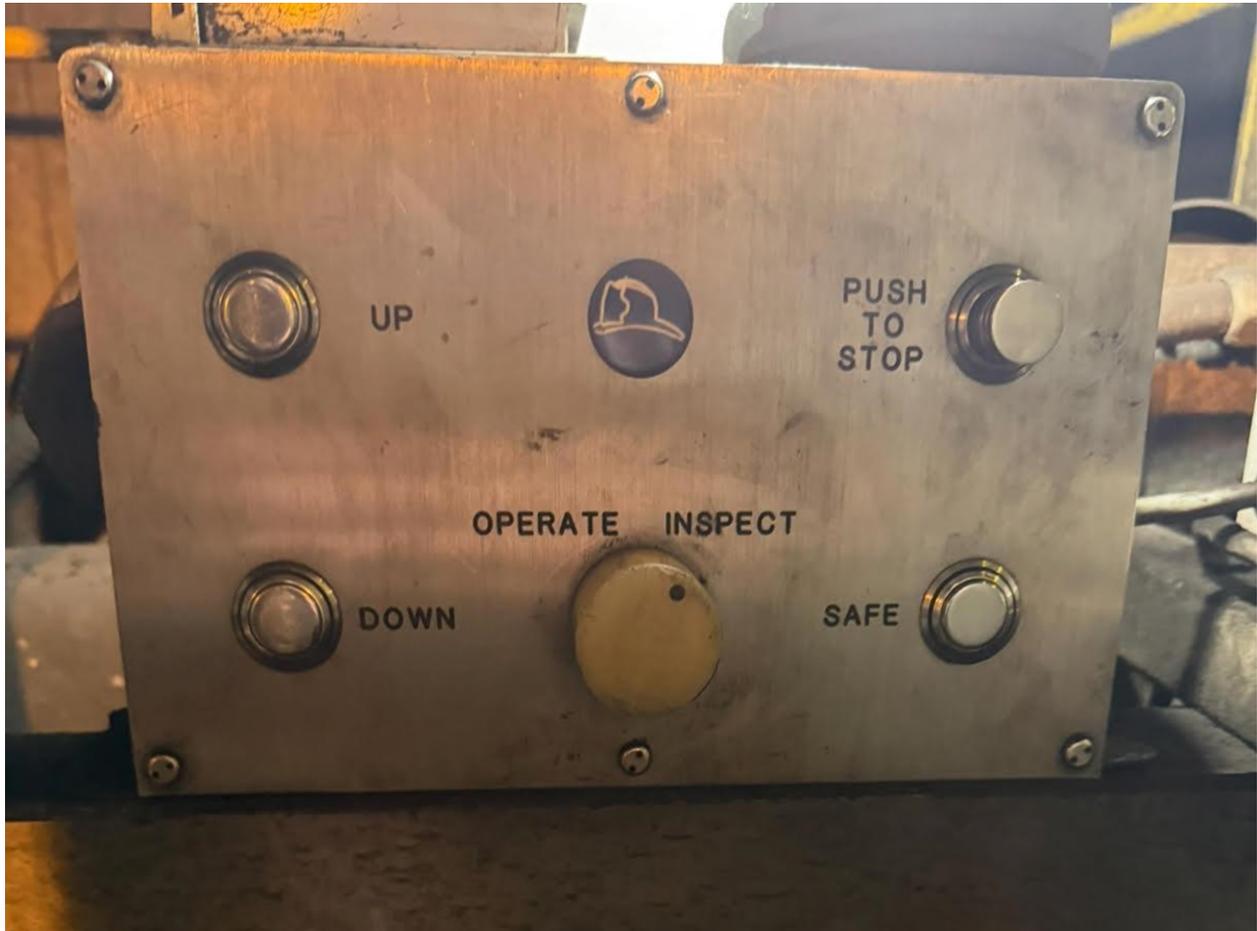
**Photo 2**

**Operator controls located on top of the elevator car**

At approximately 10:15 a.m., the elevator car was sent to the fifth floor to allow Mr. Bartram and Mr. McNeely to access the top of the elevator car from the sixth floor. Once the elevator car stopped, the doors on the sixth floor were opened by Mr. Bartram and the controls were switched from "Operate" mode to "Inspect" mode on the control box located on top of the elevator car. (See Photo 2, Page 2).

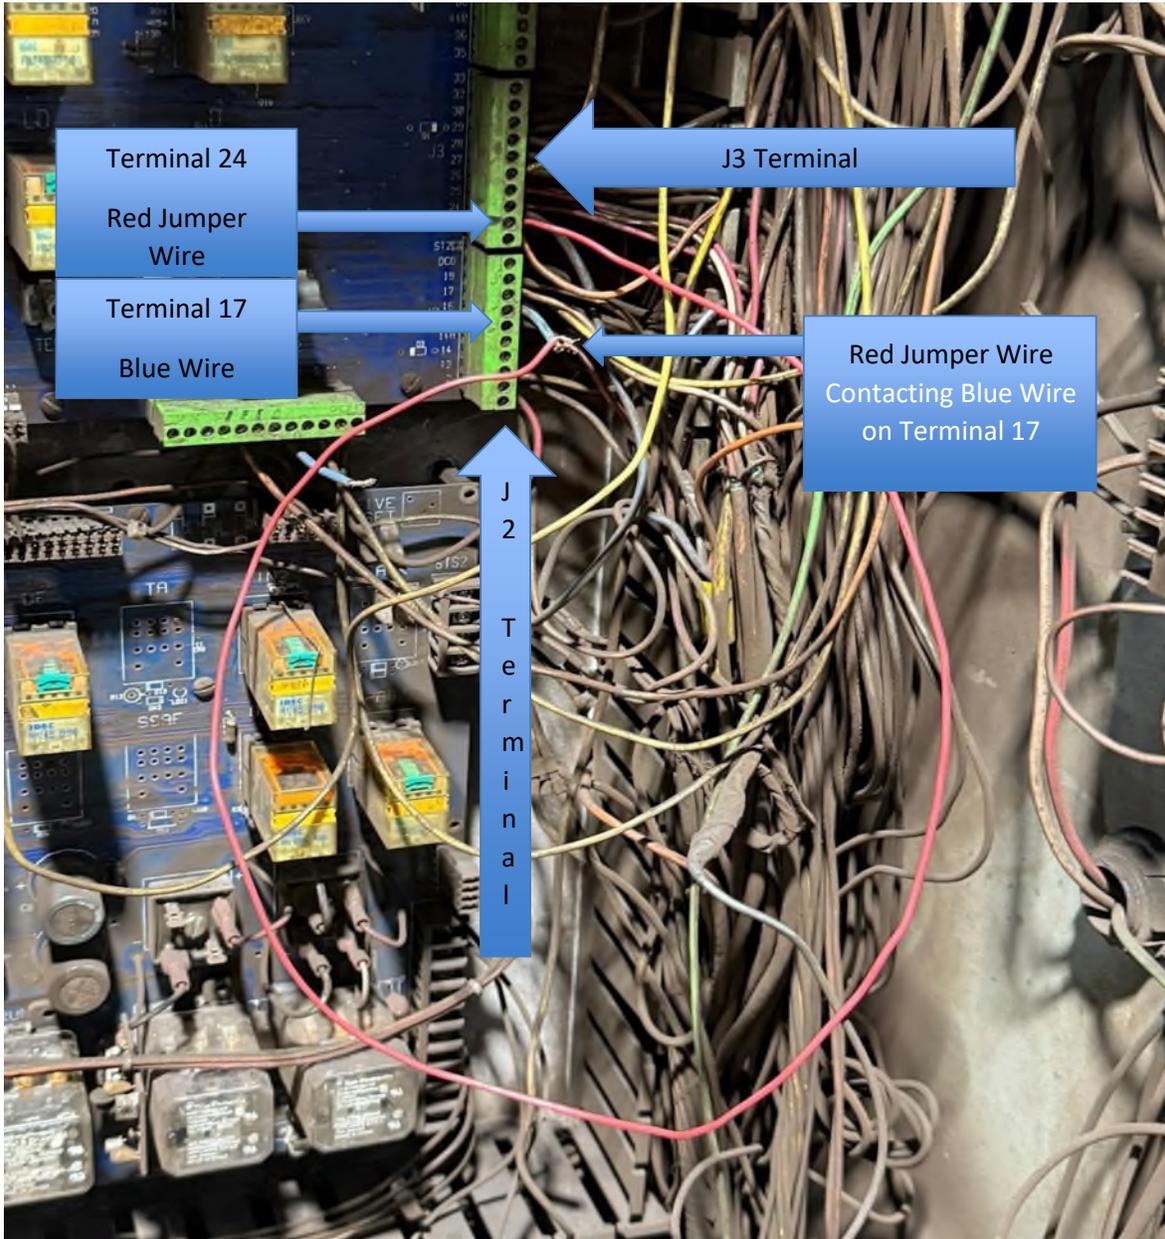
**Photo 3**

**Red wire installed in terminal 24 and contacting blue wire installed in terminal 17 creating a jumper**

1. Investigators examined the electrical system and determined that a red jumper wire was connected in the circuit control board (J3) under terminal 24 and was connected to a blue pigtail wire that was connected to the circuit control board (J2) under terminal 17. (See Photo 3, Page 3). This condition of wiring created a bypass of the following safety features: emergency stop buttons, limit switches, buffer switches, and governor switches. Installing jumpers is only allowed by trained and qualified individuals and only for testing or troubleshooting purposes.

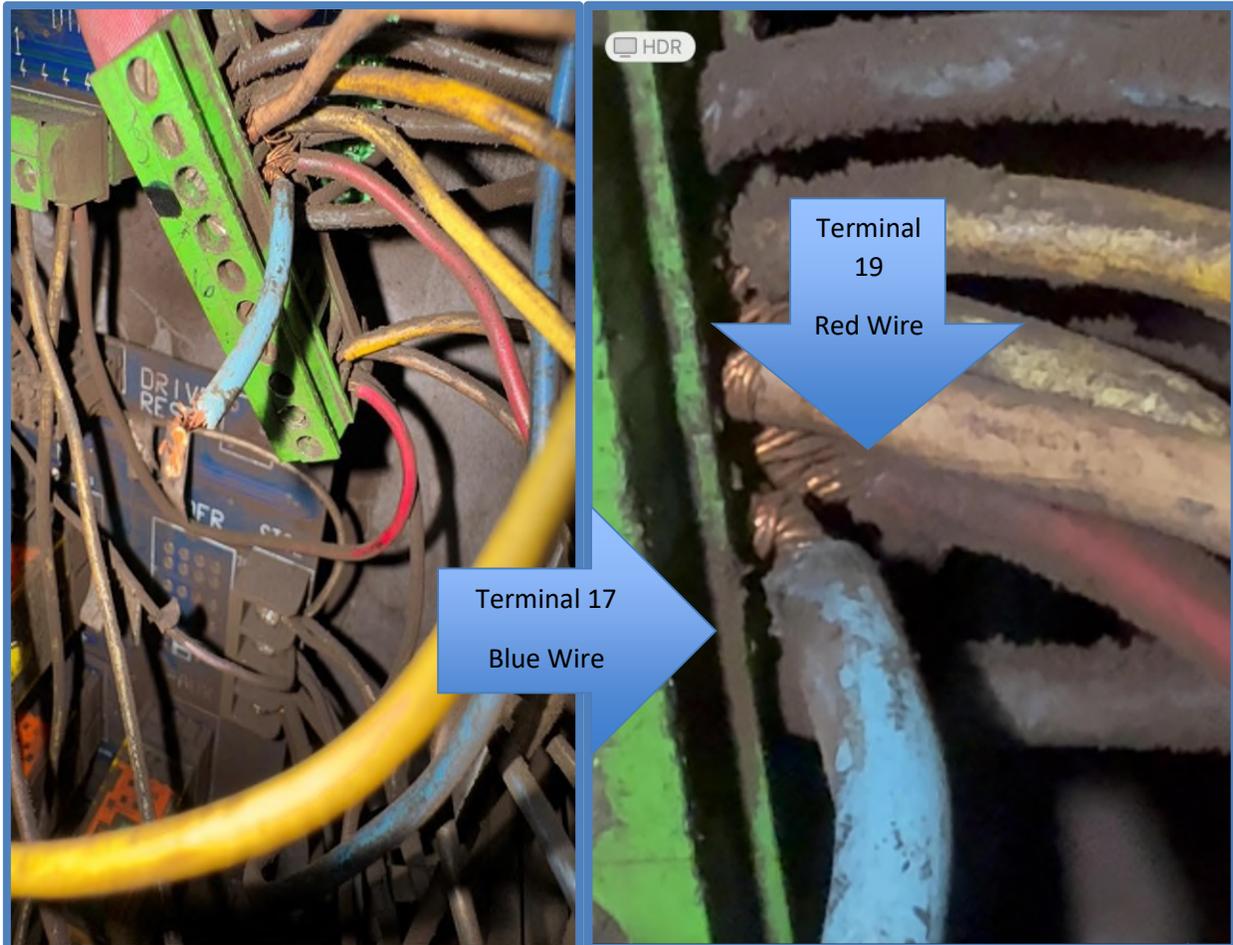
**Photo 4**

**Frayed wires in terminals 17 and 19 allowed unintended contact.**

**\*The red wire that created the jumper was removed prior to this photo.**

2. There was also an unintended connection that existed in that there were wires installed on the circuit control board (J2) were intermittently touching. The wires were in terminals 17 and 19 on the (J2) terminal block. (See Photo 4, Page 4) This was observed by investigators and confirmed with an electrical measurement between the two terminals that indicated continuity between 4 ohms and 15k ohms. This created a bypass of all the door interlock switches at each landing. Investigators determined that connection between wires in these terminals would have bridged out the door circuit and would allow the elevator car to move with the doors open. The mine operator did not properly maintain the electrical components of the elevator system in safe operating condition.
