Report of Fatality  
Track/Rubber Tire Haulage Equipment  
Underground Mine

November 6, 2025

Mettiki Coal WV, LLC.  
Mettiki E-Mine  
Permit Number U00200104  
Near Davis, in Tucker County

Region I Office  
14 Commerce Drive, Ste 1  
Westover, WV 26501  
Ed Peddicord, Inspector-at-Large

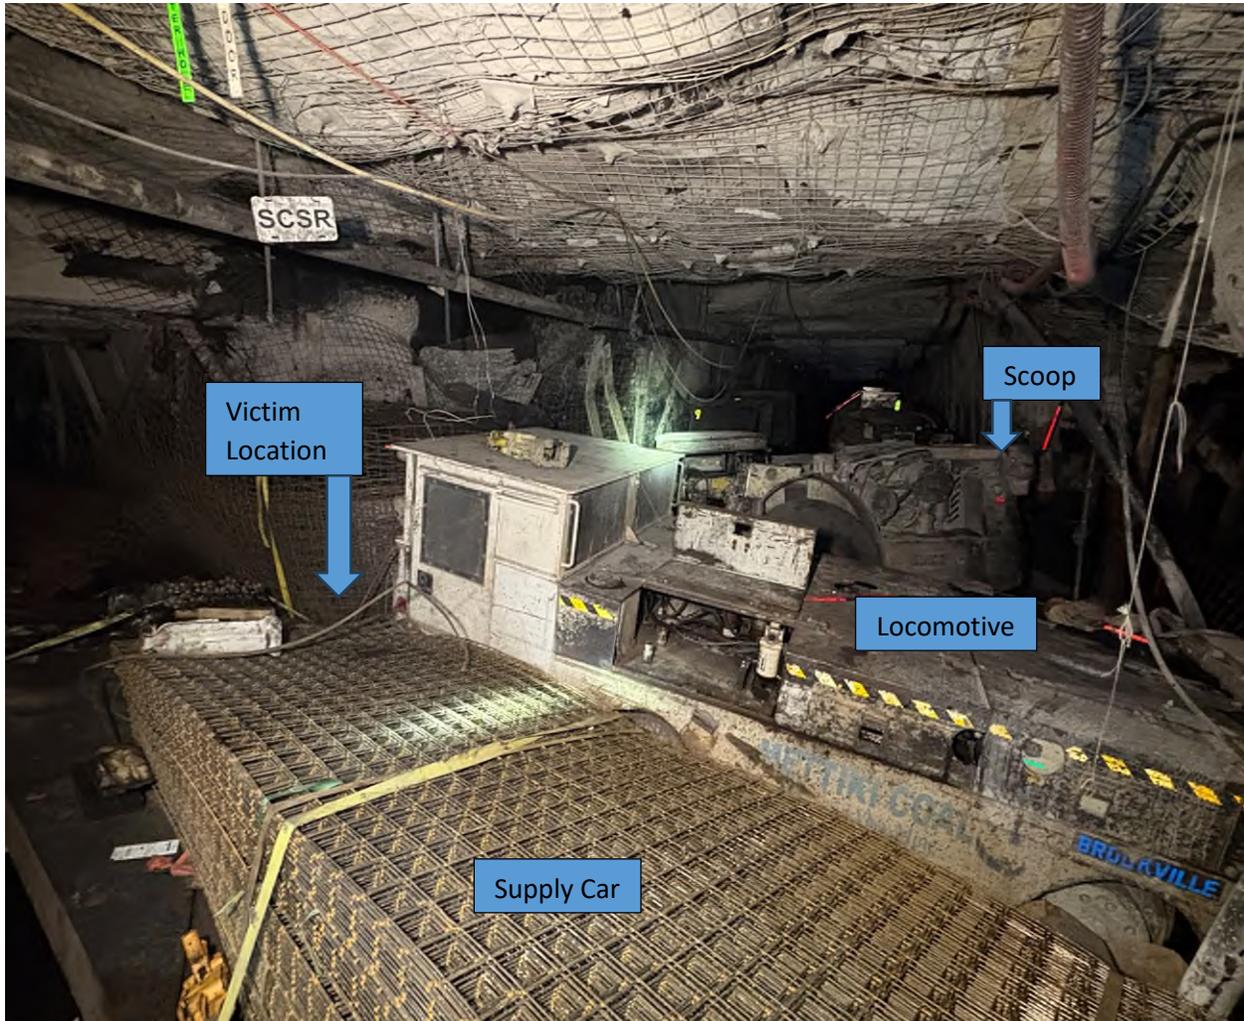
**Photo of the accident scene located at 58-block 41-Butt Section**

The impact of this collision caused Mr. Mitchell to be ejected from the operator's compartment and caused the #2 locomotive and the six (6) Irwin flat cars to push the #1 Eimco scoop inby. The scoop bucket struck the left rib corner and was pushed horizontally across the track entry. The inby car, loaded with roof bolts, uncoupled from the #2 locomotive and struck Mr. Mitchell. Mr. Ahern went to check on Mr. Duckworth. Mr. Duckworth was trapped in the #2 locomotive's operator compartment. Mr. Duckworth had to break the window to get out of the cab due to the door being blocked by part of the wreckage of supplies. On exiting, Mr. Duckworth and Mr. Ahern started looking for Mr. Mitchell. Mr. Duckworth located Mr. Mitchell. His legs were positioned toward the #2 locomotive and his upper body was pinned under the Irwin flatcar. Mr. Ahern called Mr. High for help, requesting Emergency Medical Services personnel. Mr. High called 911. Jason Heckler, Fireboss (EMT) and Sean Devlin, Beltman (EMT), overheard Mr. Ahern call for help on the radio and traveled to 41-Butt, 58-block. When Mr. Heckler arrived, he immediately checked Mr. Mitchell for a pulse but none was detected.

Mr. Joseph D. Mitchell, Jr. was fatally injured after the #2 Brookville 30-ton locomotive collided with the #1 Eimco scoop. During this collision, Mr. Mitchell was ejected from the scoop operator's compartment. The Irwin flatcar that uncoupled from the #2 Locomotive during the collision contacted Mr. Mitchell. Mr. Mitchell was last observed sitting in the operator's deck of the #1 Eimco scoop.

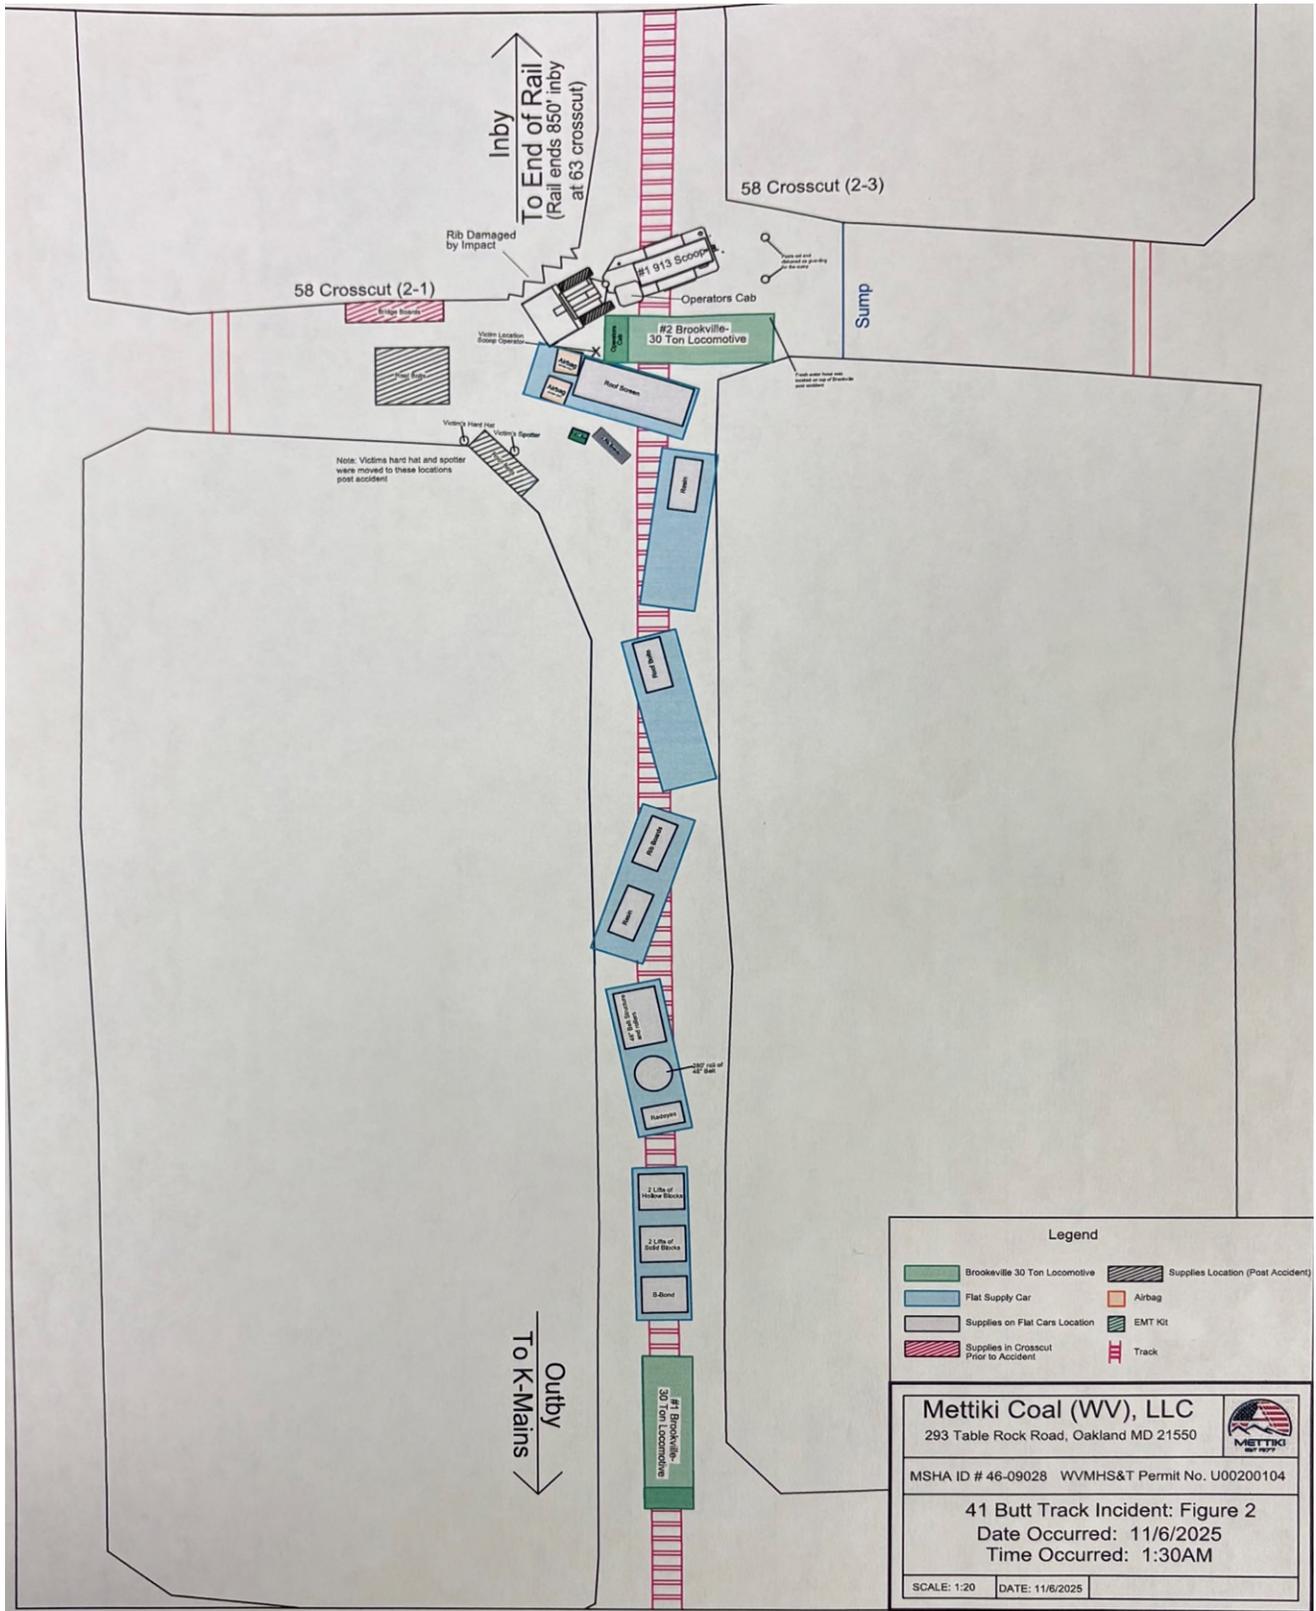
CAD drawing of accident scene obtained from Mettiki Coal WV, LLC.
