Report of Fatality
Underground Mine
November 8, 2025

Nicholas Contura, LLC
Rolling Thunder Mine
Permit Number U00300804
Near Vaughn, Nicholas County

Region IV Office
337 Industrial Drive
Oak Hill, WV 25901
Christopher Dawson, Inspector-at-Large

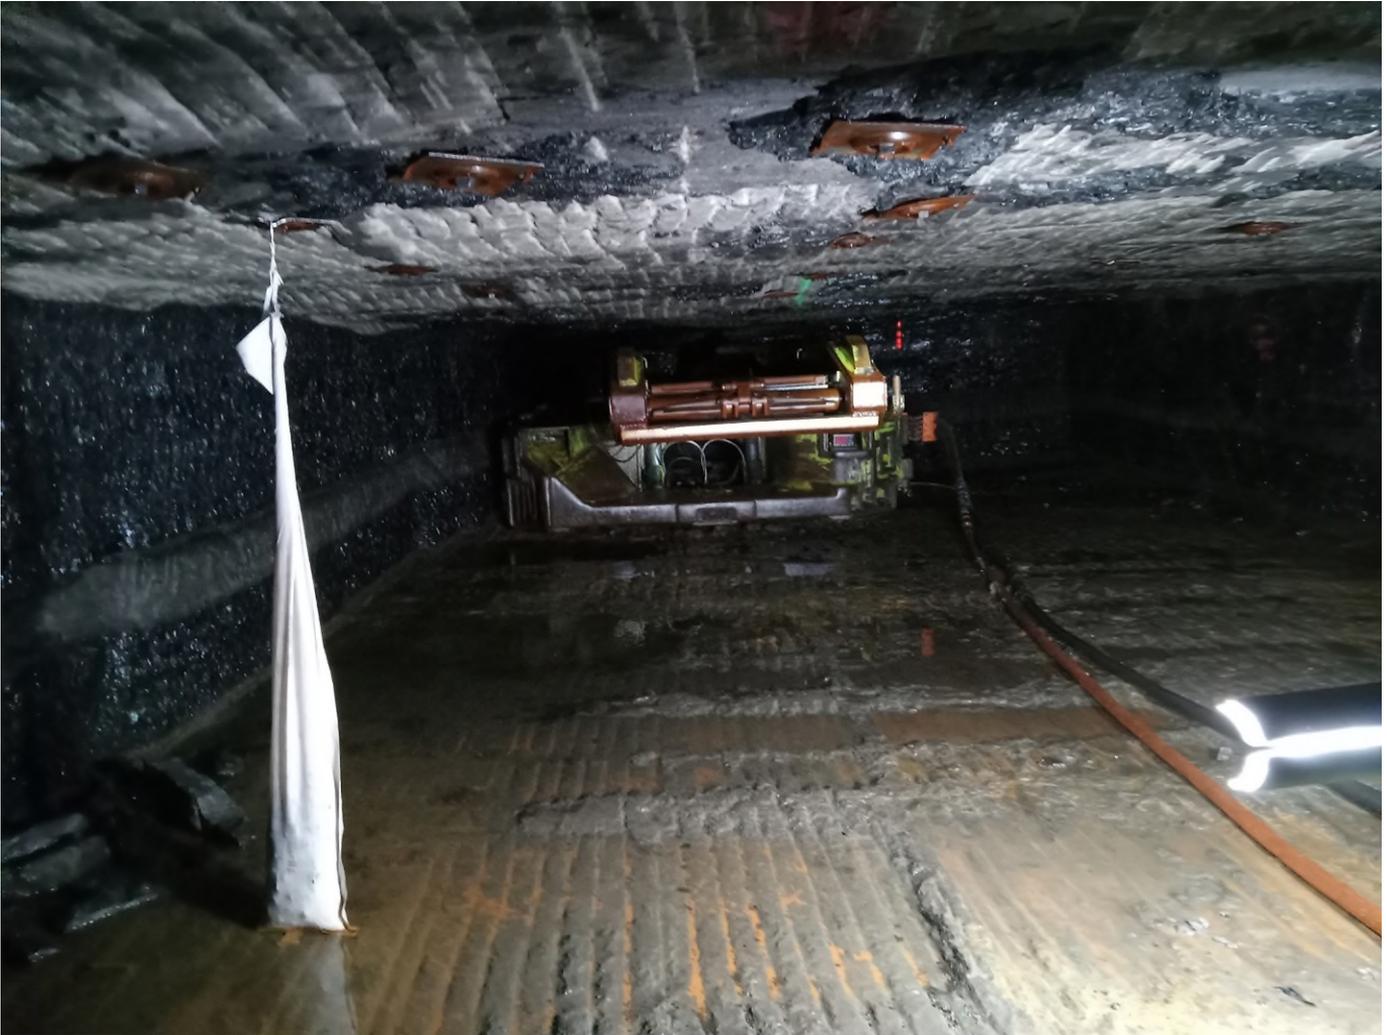
Photo 1

This is a picture of the left-side continuous mining machine and the cut-through into the water-impounded in the Mountain State Mine.

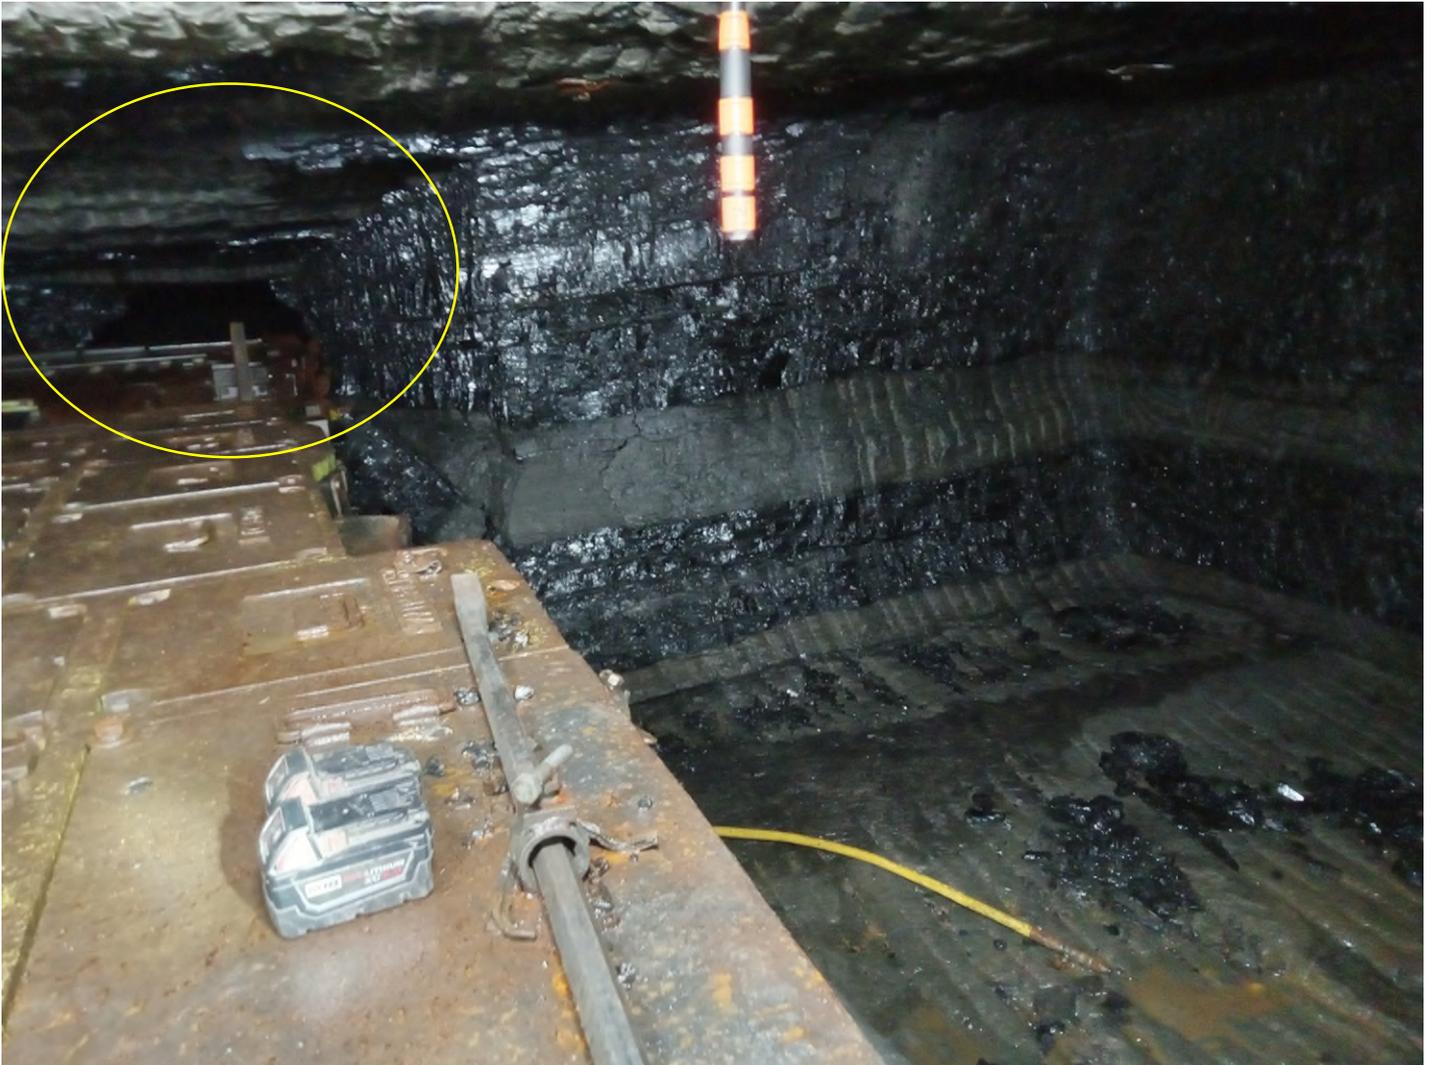
Photo 2

This picture is of the cut-through into the Mountain State Mine (circled in yellow).

Mine. It was later found that the Aracoma Coal Co., Inc. team's drill encountered a dip in the mine floor that resulted in the drill being in the lower split of the Powellton Seam and as the coal seam turned uphill, the drill encountered a fireclay bottom with coal streaks and continued until entering the upper split of the Eagle Seam beneath the Powellton Seam. This being beneath the Powellton Seam caused the drill to miss the Mountain State Mine workings.

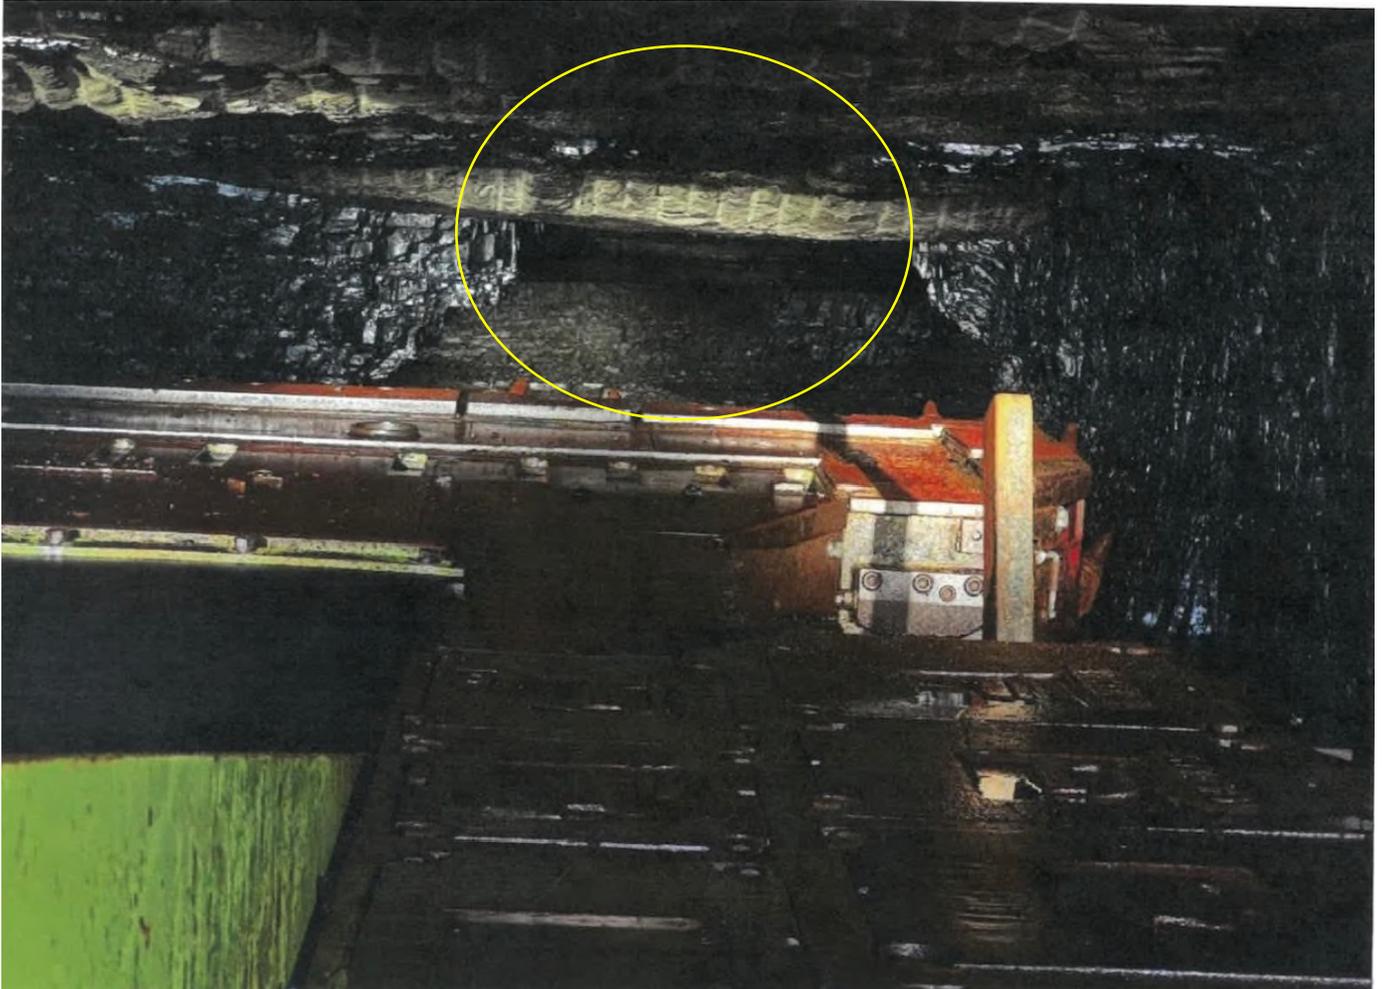
Photo 3

This is a picture of the cut-through into the Mountain State Mine in front of the left-side continuous mining machine. (The hole is circled in yellow.)

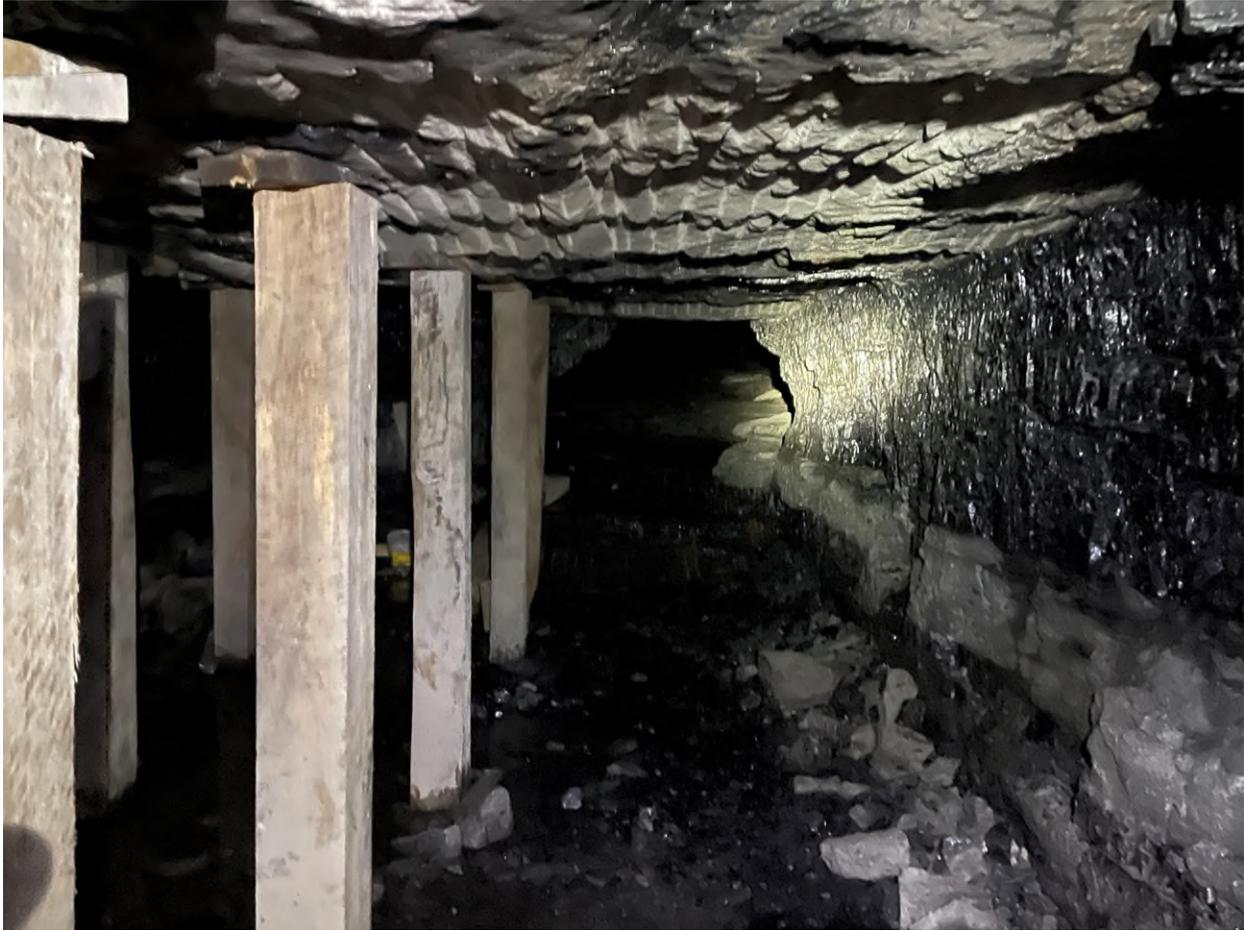
Photo 4

This is a picture of the cut-through point between Rolling Thunder Mine and the Mountain State Mine. The timbers are set where the continuous mining machine was sitting when it cut into the Mountain State Mine.
