Report of Fatality
Powered Haulage
Underground Mine

December 18, 2025

Greenbrier Minerals, LLC
Lower War Eagle Mine
Permit Number U00400299B
Near Cyclone, W.V. in Wyoming County

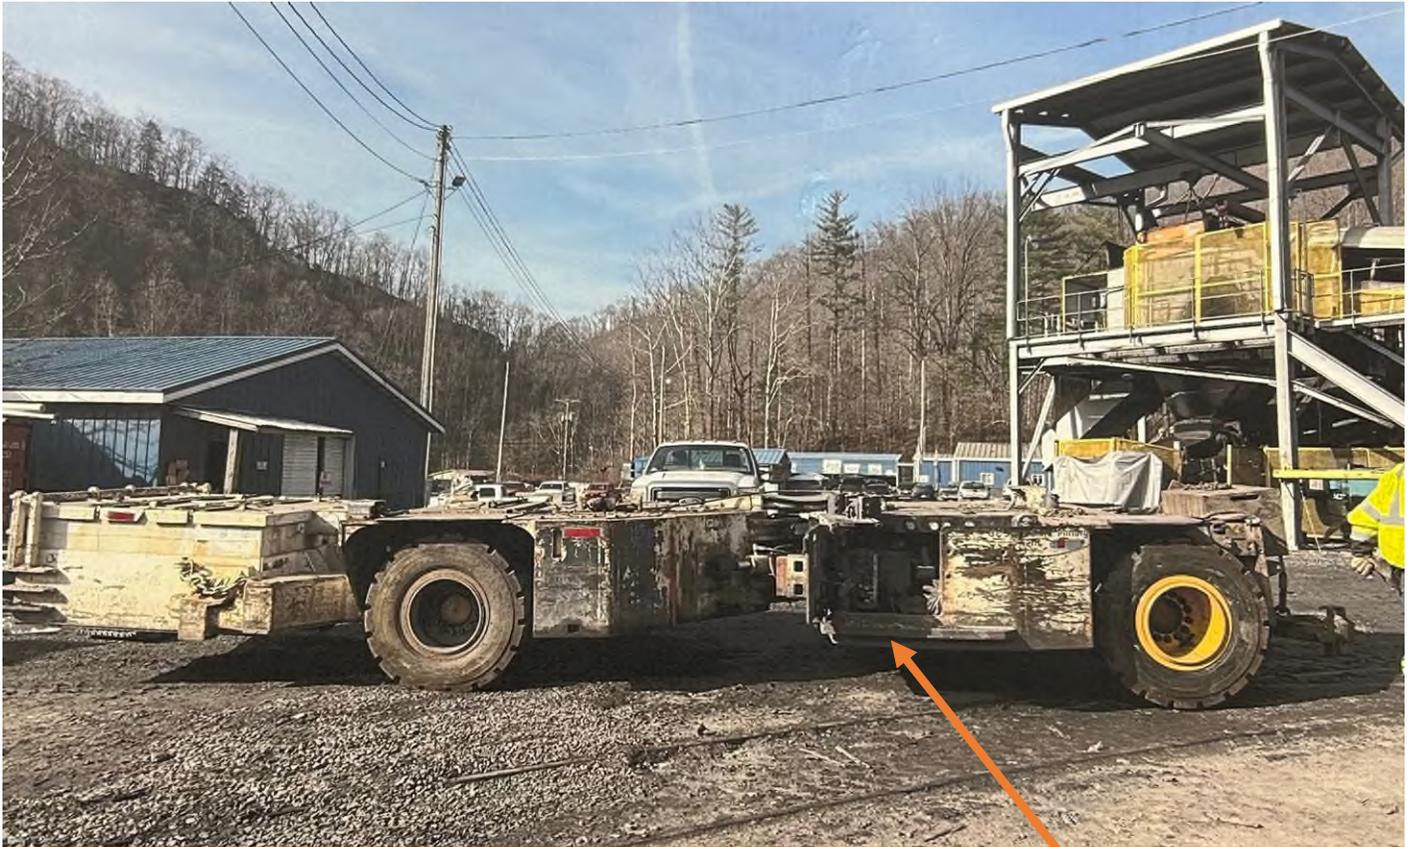
Photo 1

This is the rubber-tired tractor that was involved in the accident.

The equipment involved in the accident was a 35C-WH2-30-AC Fairchild Workhorse Rubber-Tired Tractor, coupled to a flat car.

11. Robert White Jr. was struck by the Fairchild Rubber-Tired Tractor, Serial Number T400-168 at 7:27 a.m.
12. The tractor weight is 68,000 lbs.
13. The slope was an 8% grade.

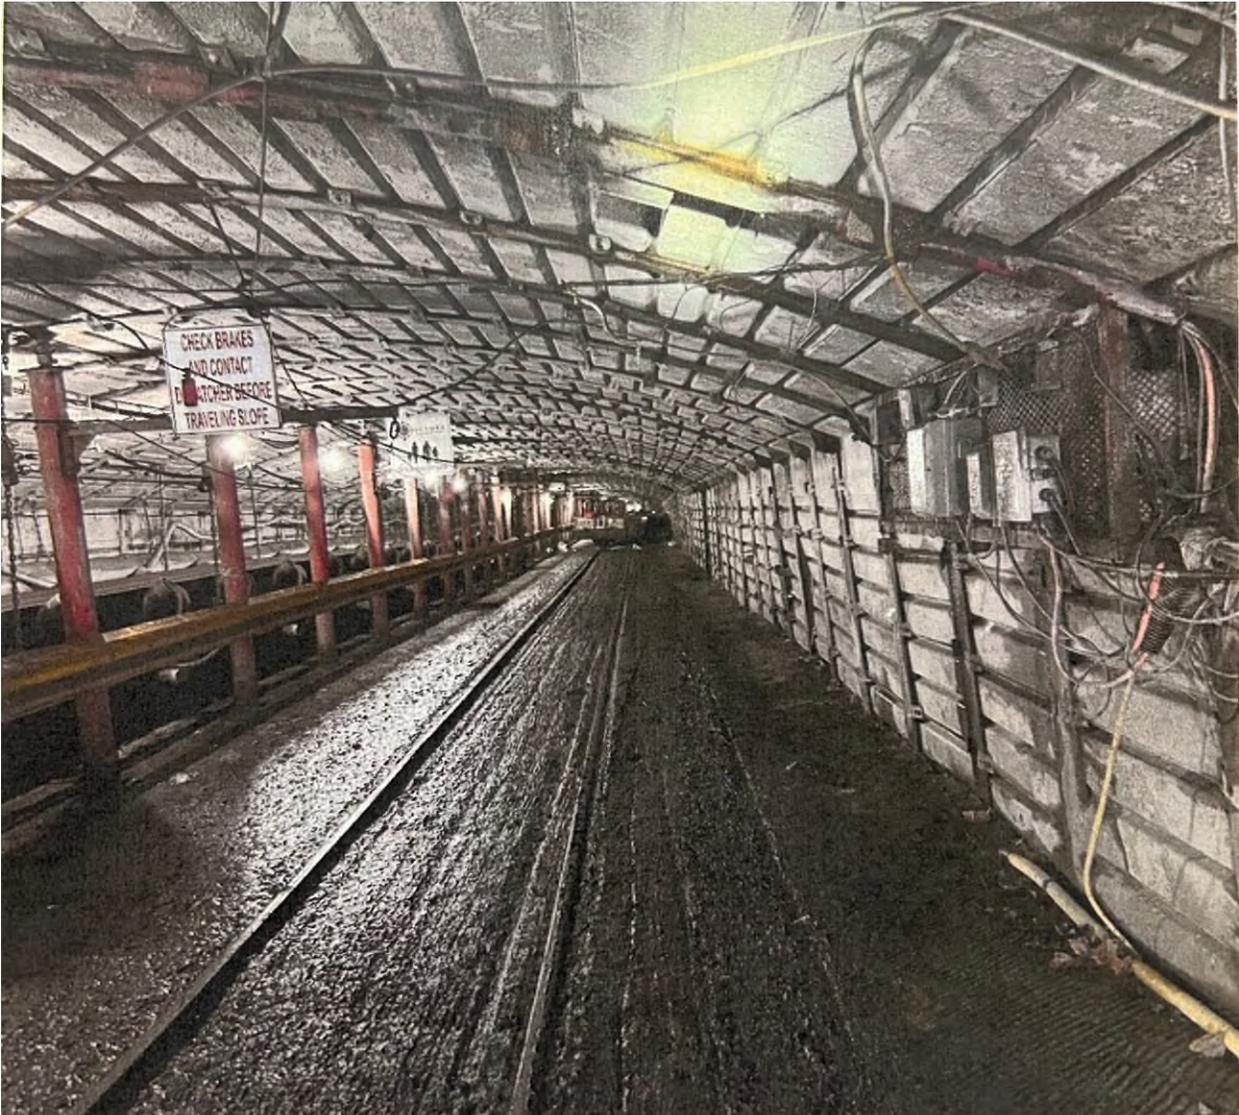
Photo 2

This is the slope where the accident occurred.

14. The flat car was twenty-three feet, six inches long and seven feet, two inches wide.
15. The rubber-tired tractor was coupled to a flat car that weighed 26,784 pounds, with the car itself as well as the supplies loaded on it. According to Komatsu engineers, the towing weight capacity is 40,000 pounds on a 10% grade or less.

- Indicator lights have been installed at the top and bottom of the Lower War Eagle slope.
 - The lights are activated by a motion sensor mounted overhead.

- At no time will rubber-tired equipment and foot traffic be allowed on the slope at the same time.
 - If a piece of mobile equipment becomes inoperable on the slope, the equipment will be blocked against motion and only foot traffic will be permitted on the slope, while it is being repaired.

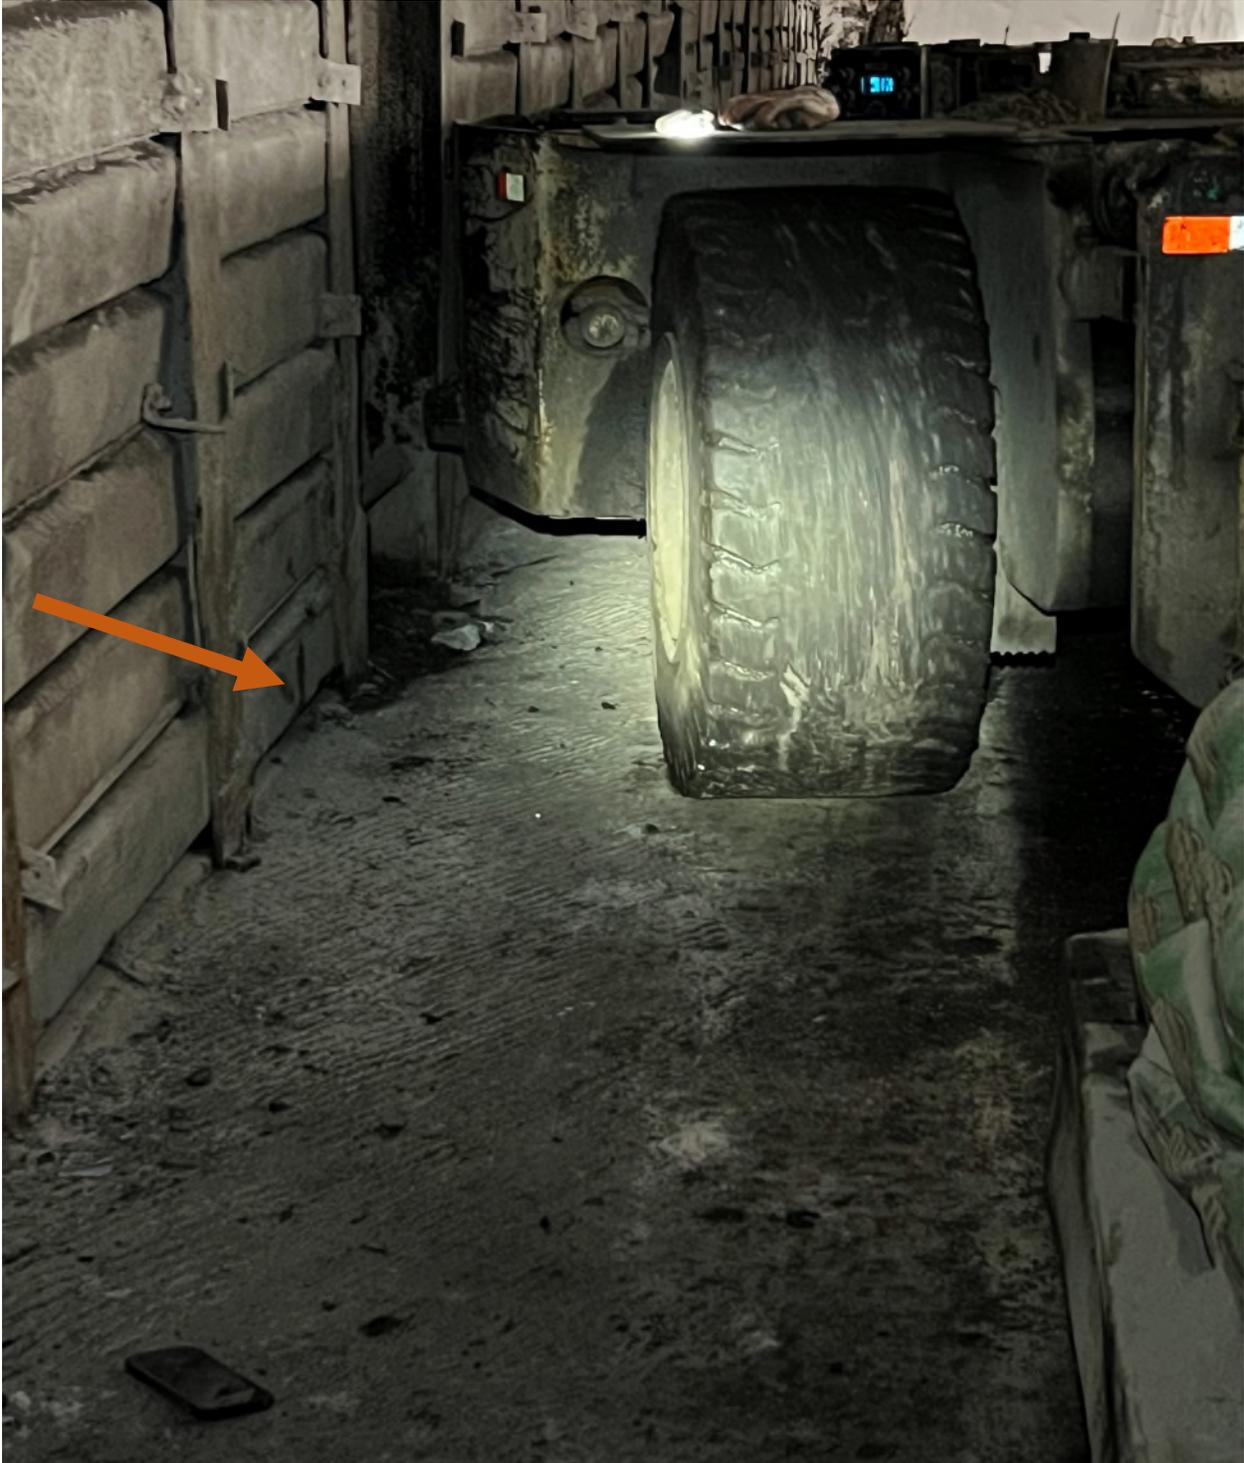
Photo 3

This is where Mr. White was located. (The rubber-tired tractor was trammed back to free Mr. White before this photo was taken.)

Robert White Jr. was fatally injured when he was crushed between the wall of the slope canopy and a battery-powered, rubber-tired tractor.

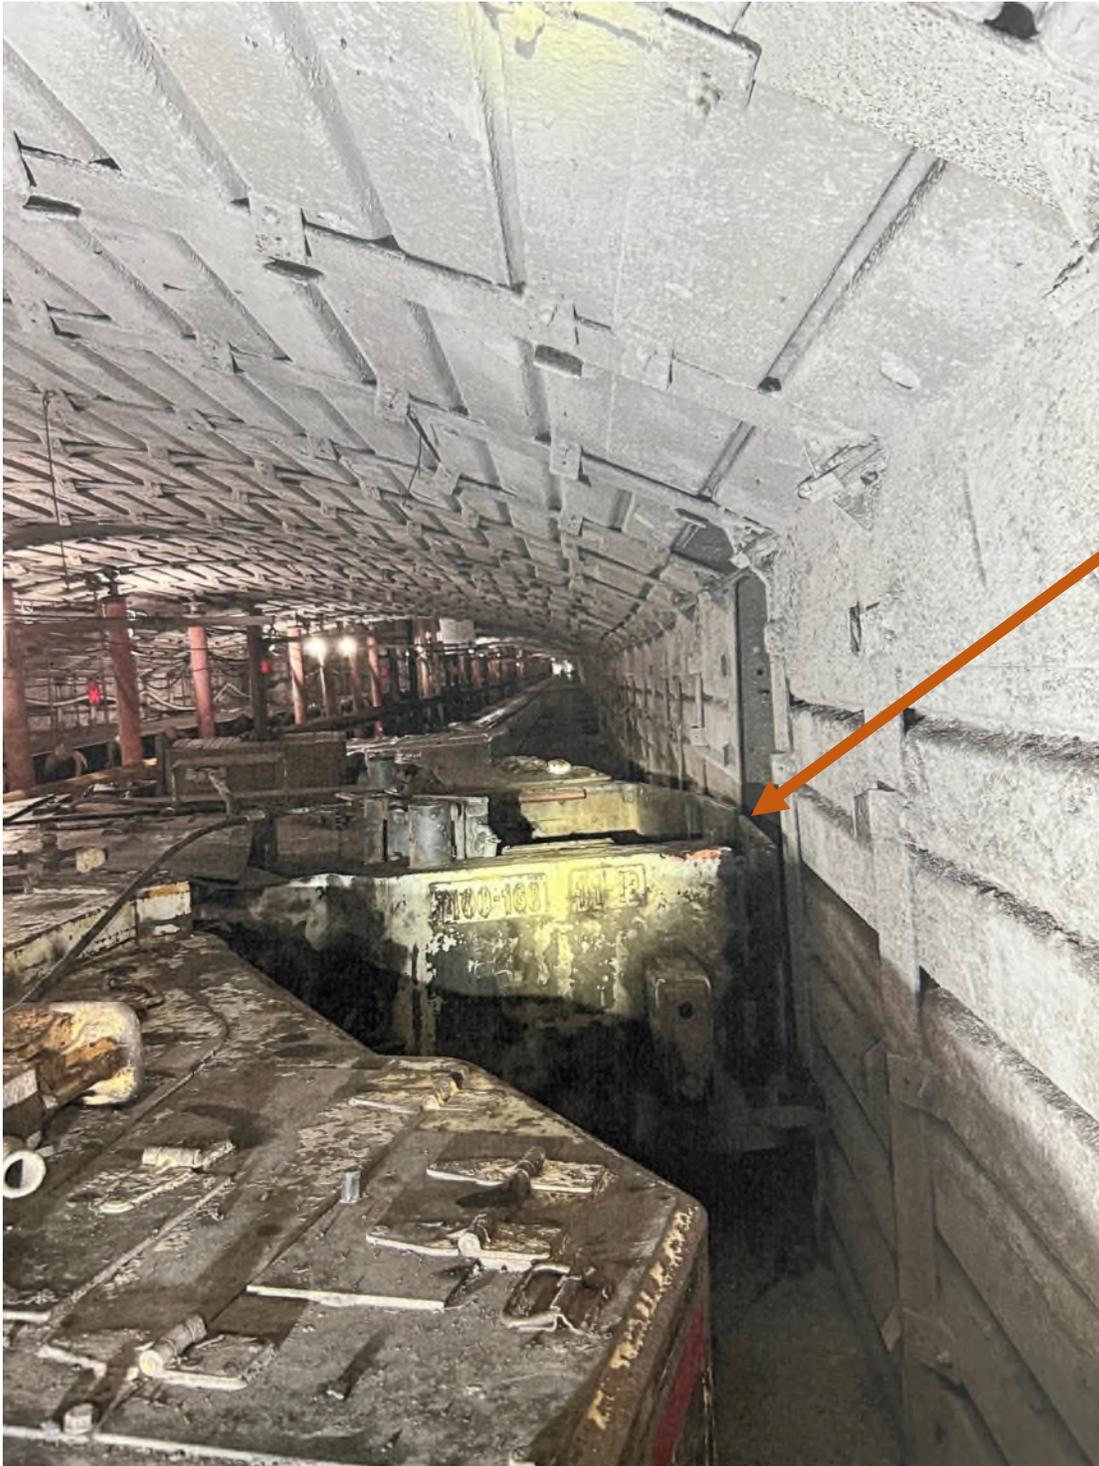
Photo 4

This is looking down the slope at the rubber-tired tractor accident scene.

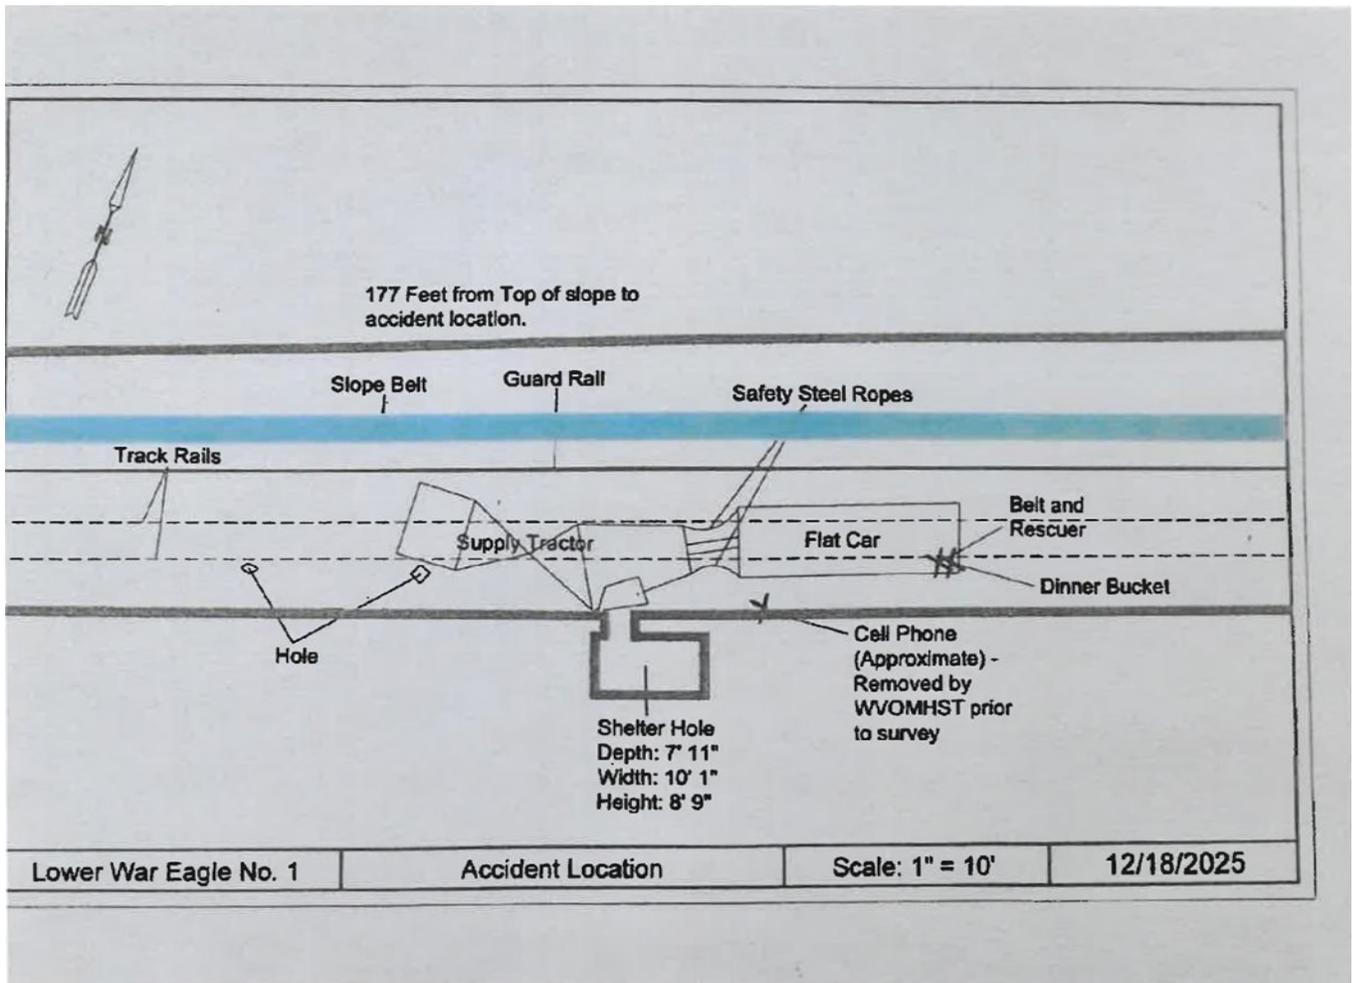
Photo 5

This map shows the equipment locations at the time of the accident.

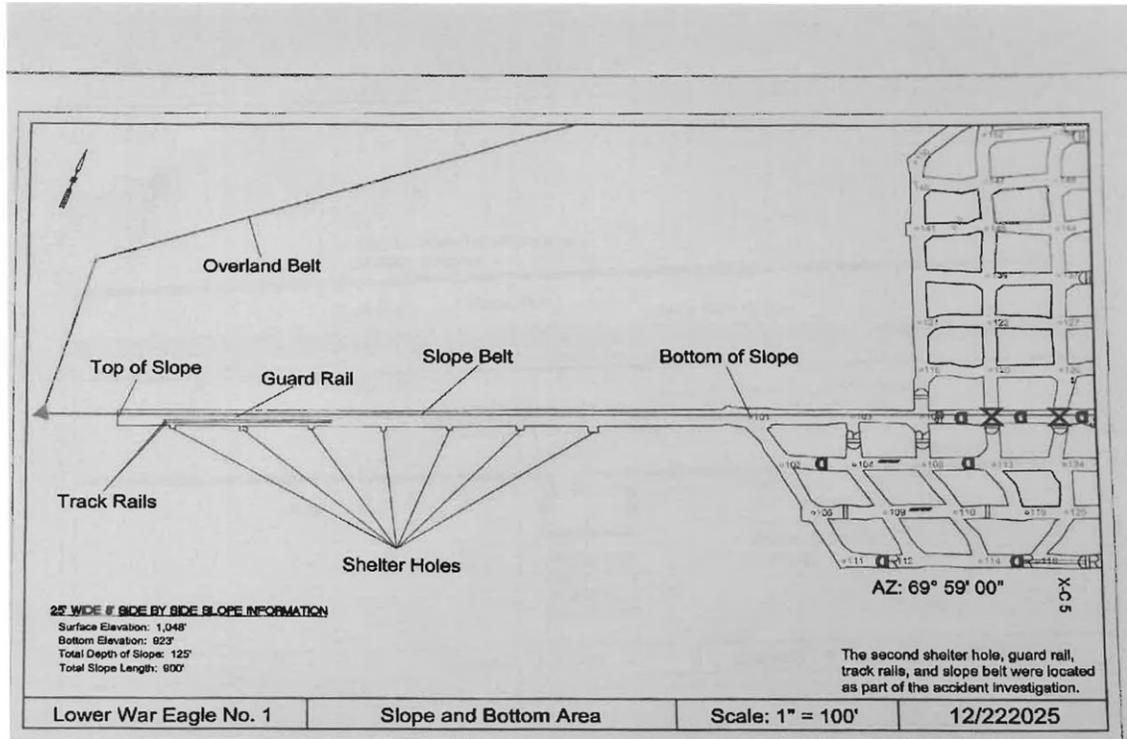
Photo 6

This is a detailed map of the area where the accident occurred.
