Report of Fatality

Fall of Mine Roof
Underground Mine

April 2, 2026

Marfork Coal Company, LLC
Panther Eagle Mine
Permit Number U00300398
Near Naomi, WV in Raleigh County

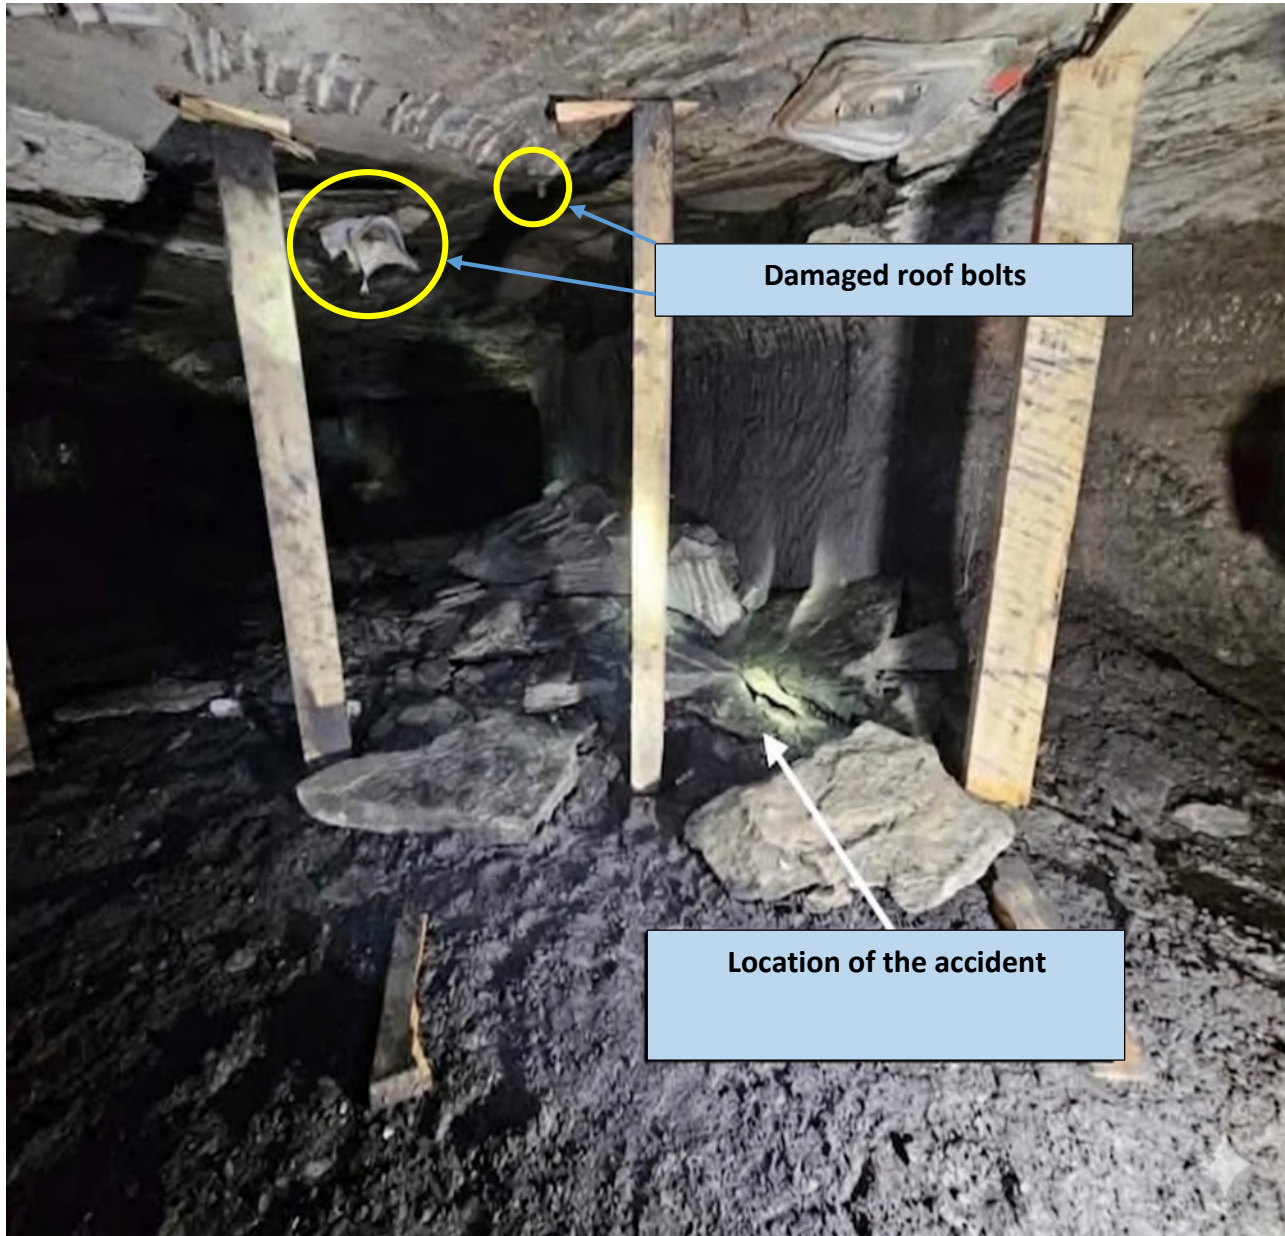
#12 Entry, #2 Right-Hand Pillar Lift

*The rocks in this photo have been moved from where they fell to free Mr. Warrix from underneath them.

10. Mr. Warrix was a Shuttle Car Operator/Timberman at the time of the accident.
11. Mr. Warrix received injuries from the roof which had fallen from the area where one roof bolt was sheared off and the other roof bolt had become dislodged.

Mr. Warrix received fatal injuries from falling rock in the area of the #12 Entry, #2 Lift, where one roof bolt was sheared off and another roof bolt had become dislodged. Mr. Warrix was transported to the surface to an awaiting ambulance. While the ambulance was enroute to the Marfork landing zone, Mr. Warrix went into cardiac arrest. Mr. Warrix later succumbed to his injuries at approximately 8:19 p.m. on April 2, 2026, at Charleston Area Medical Center General Hospital.

Retrain all underground personnel on the Approved Roof Control Plan, more specifically, maximum cut depths and widths while Retreat Mining. Also, retrain all personnel on what mine roof conditions are considered to be supported and unsupported and how one should position themselves when setting standing roof support.

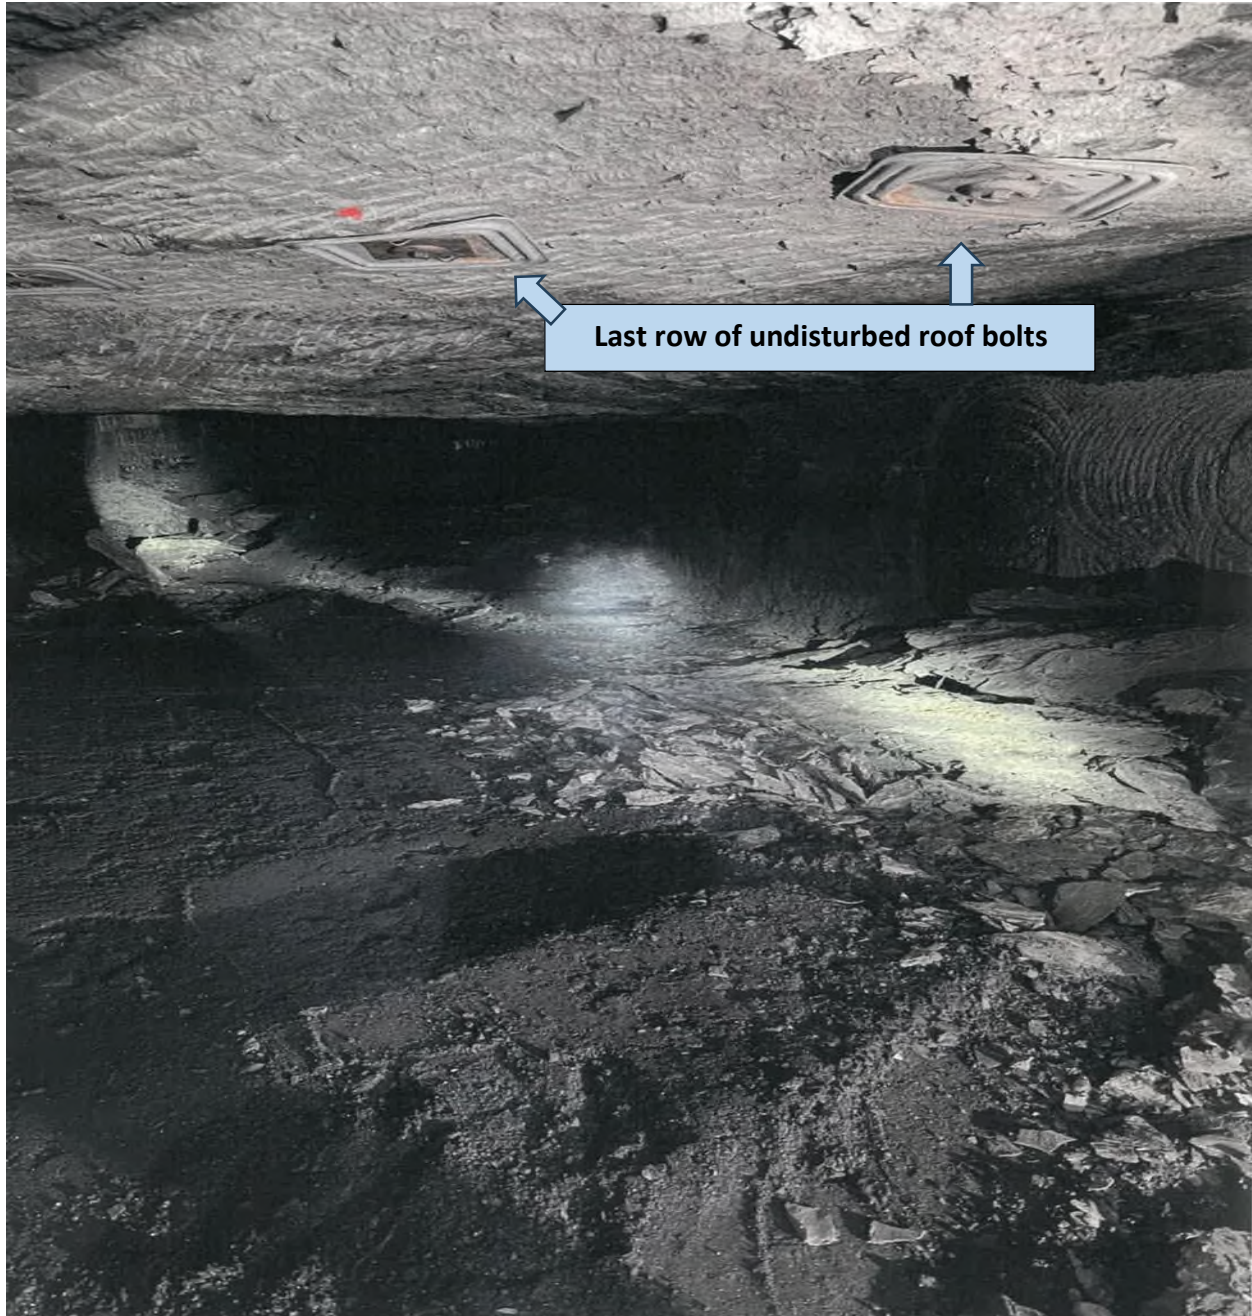
(This is the area that had been mined prior to this accident.)

4. The entire width of the coal block being mined was 34.2 feet wide.
5. The #2 Right-Hand Pillar Lift was measured at a depth of 49 feet, 11 inches with a Hilti Laser Measurer and was more than 22 feet wide on a 12 feet approved plan.
