**WEST VIRGINIA OFFICE OF MINERS' HEALTH, SAFETY AND
TRAINING**

**REPORT OF FATALITY
Track Haulage Equipment
August 17, 2022**

**Tunnel Ridge, LLC. Tunnel Ridge Mine
PERMIT NO. U00018183**

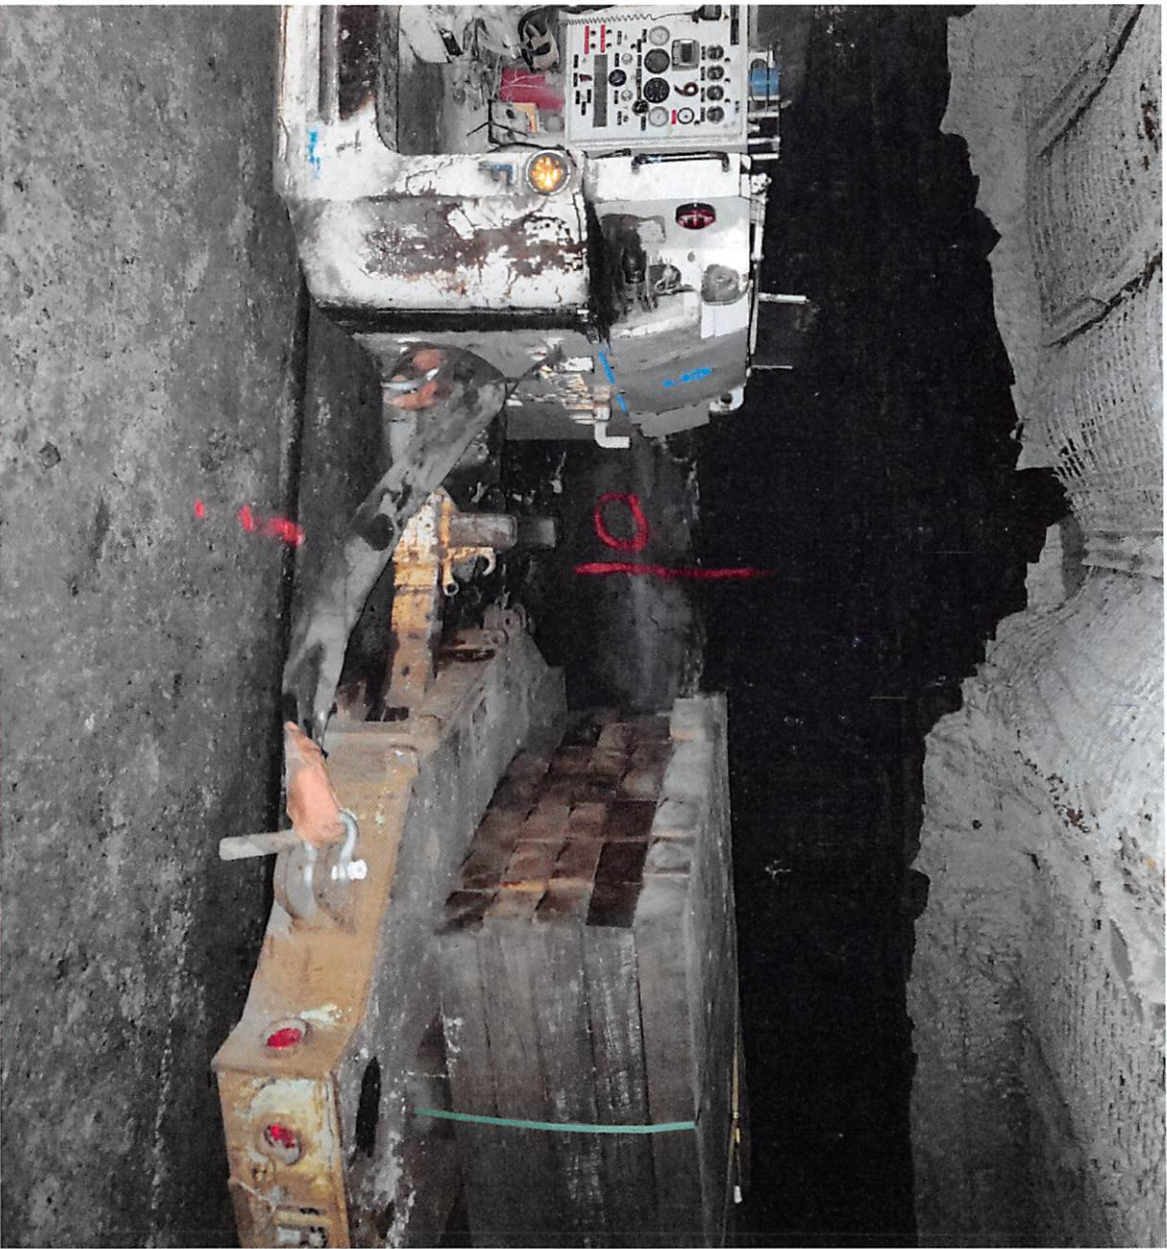
Photo of the accident scene located at East Main's #1, 55-wall track spur.

Mr. Richards was fatally injured after the #6 Brookville 30-ton locomotive entered the 55-wall track spur, striking the #9 Brookville 30-ton locomotive. Mr. Richards was last observed sitting on the front, tight side, corner, between the Irwin RB7227 flatcar and the #9 Brookville 30-ton locomotive.

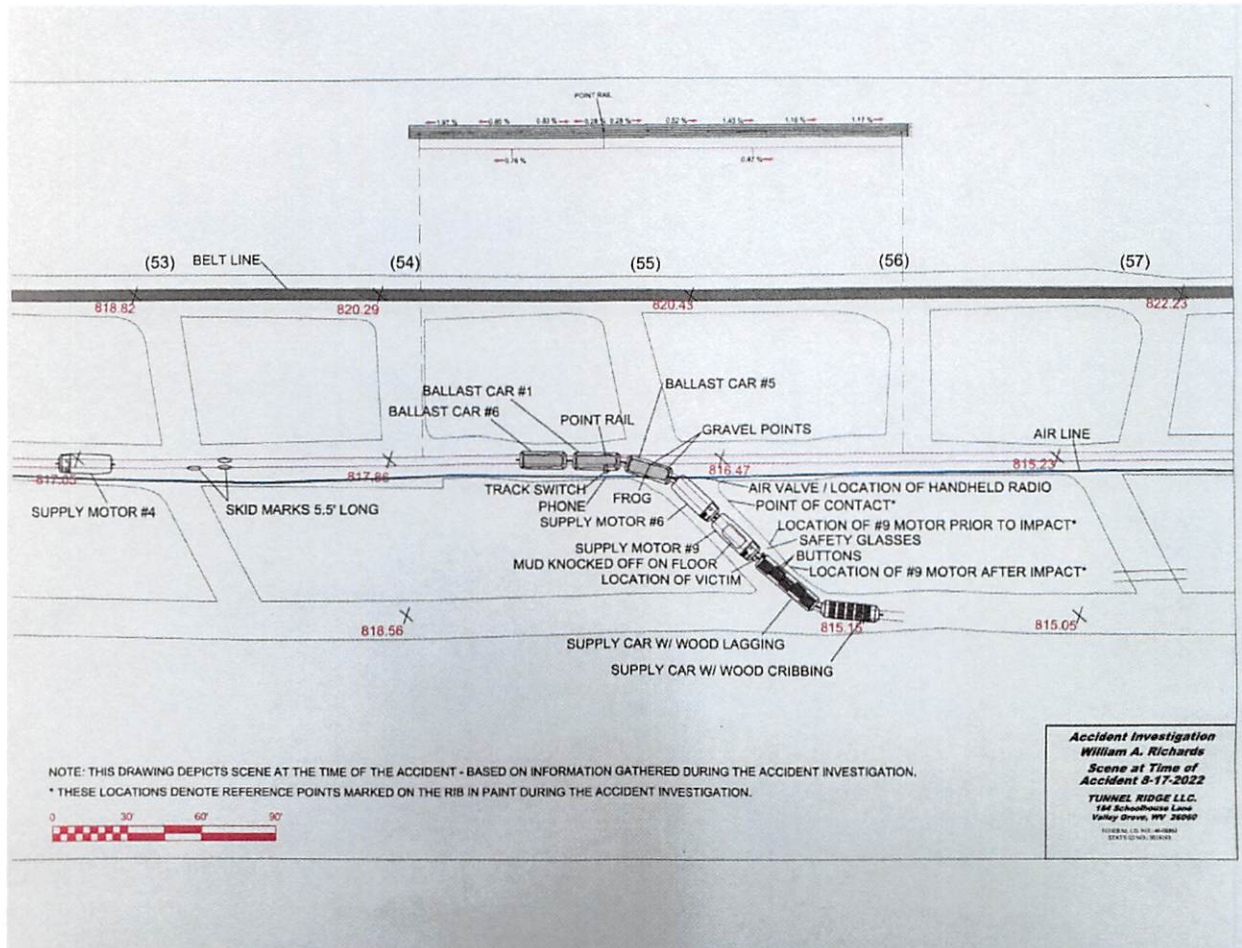
CAD drawing obtained from Tunnel Ridge, LLC.
