**Report of Fatality
Electrocution Accident
Underground Coal Mine
September 1, 2022**

**Kanawha Eagle Mining, LLC
Coalburg #1 Tunnel Mine
Permit Number U00500302B**

**Region IV Office
337 Industrial Drive
Oak Hill, West Virginia 25901
McKennis P. Browning, Inspector-at-Large**

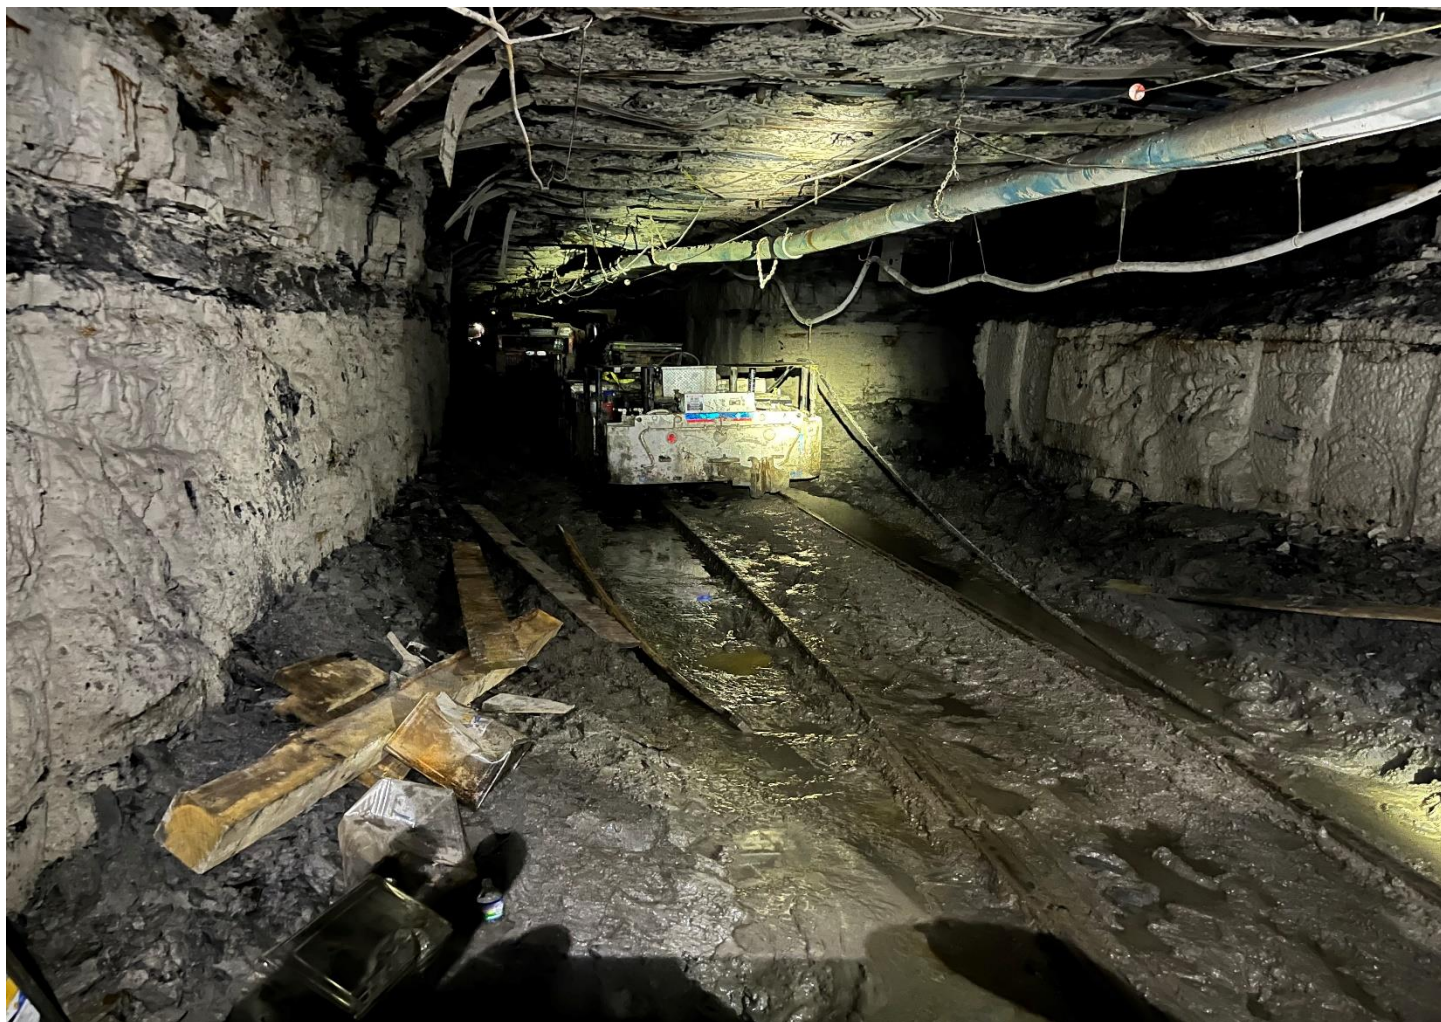
Scene Picture

6. The mine floor was wet and muddy in the area where the accident occurred.
7. Upon arrival the WVOMHS&T investigators found that Mr. Ball had been fatally injured when he contacted the metal hook of a rope hanger that had been placed on the 2/3 G-GC cable that is used to supply power to the #930010 Roof Bolter.

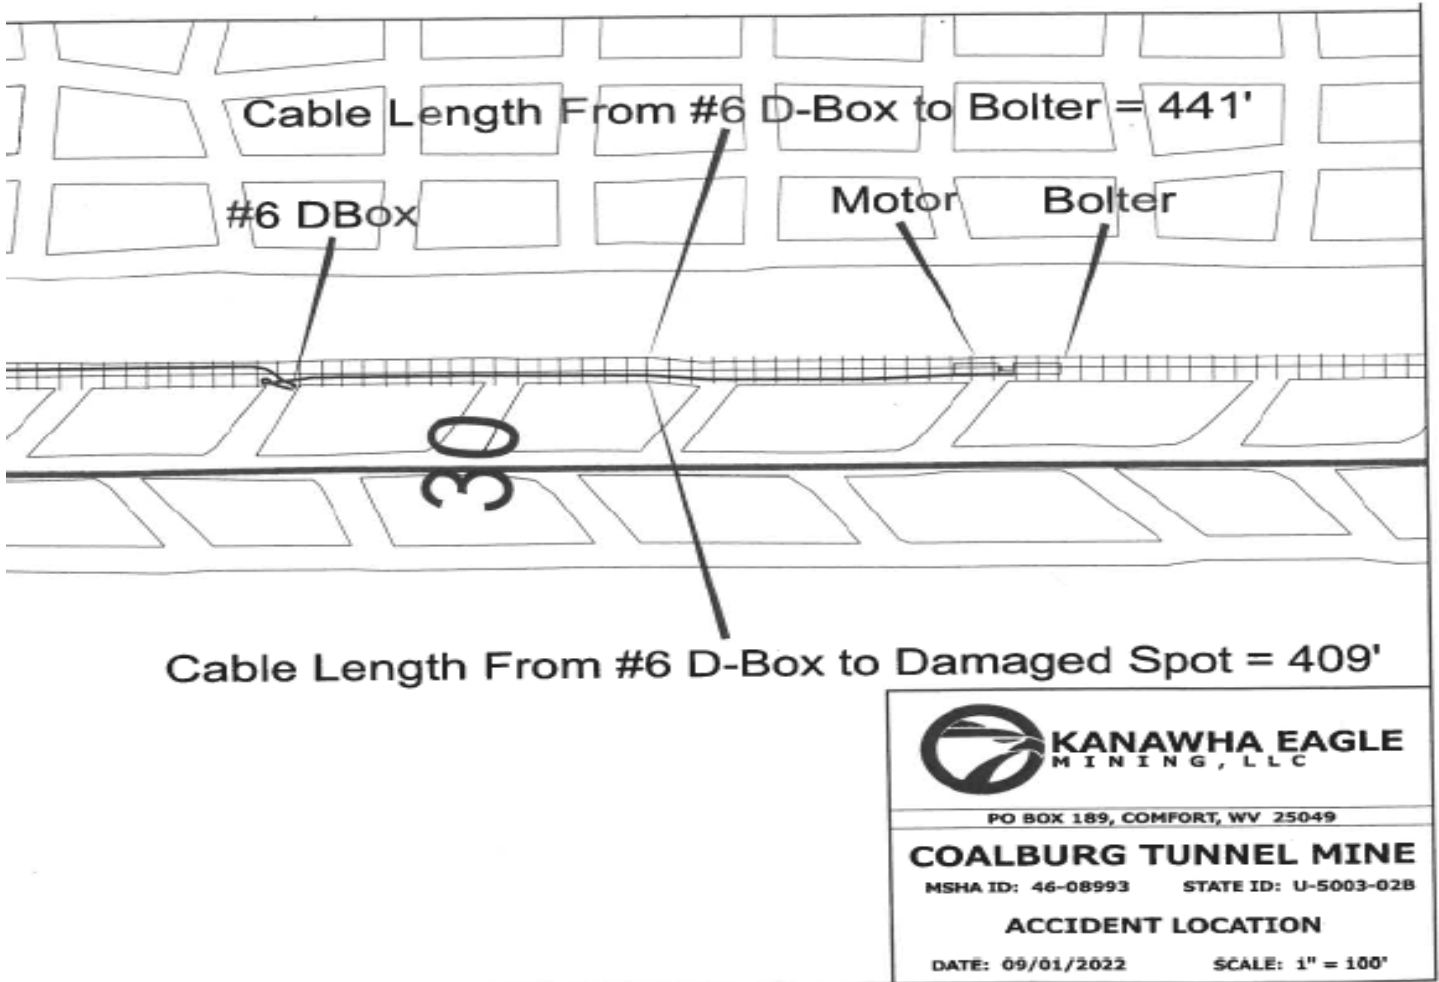
Map of Accident Scene and Surrounding Area

3. Mr. Ball was a class 07, certified surface coal miner; certification number 14104.
4. Mr. Ball was a class 33, EMT-M; certification number EMTM3834.
5. The accident occurred at the #709 Brookville Locomotive located at 32 crosscut, 2 belt in the track entry. The #709 Brookville Locomotive was coupled to a rail car that was hauling the #930010 Roof Bolter. The roof bolter is powered by three phase 480 Volts A.C.

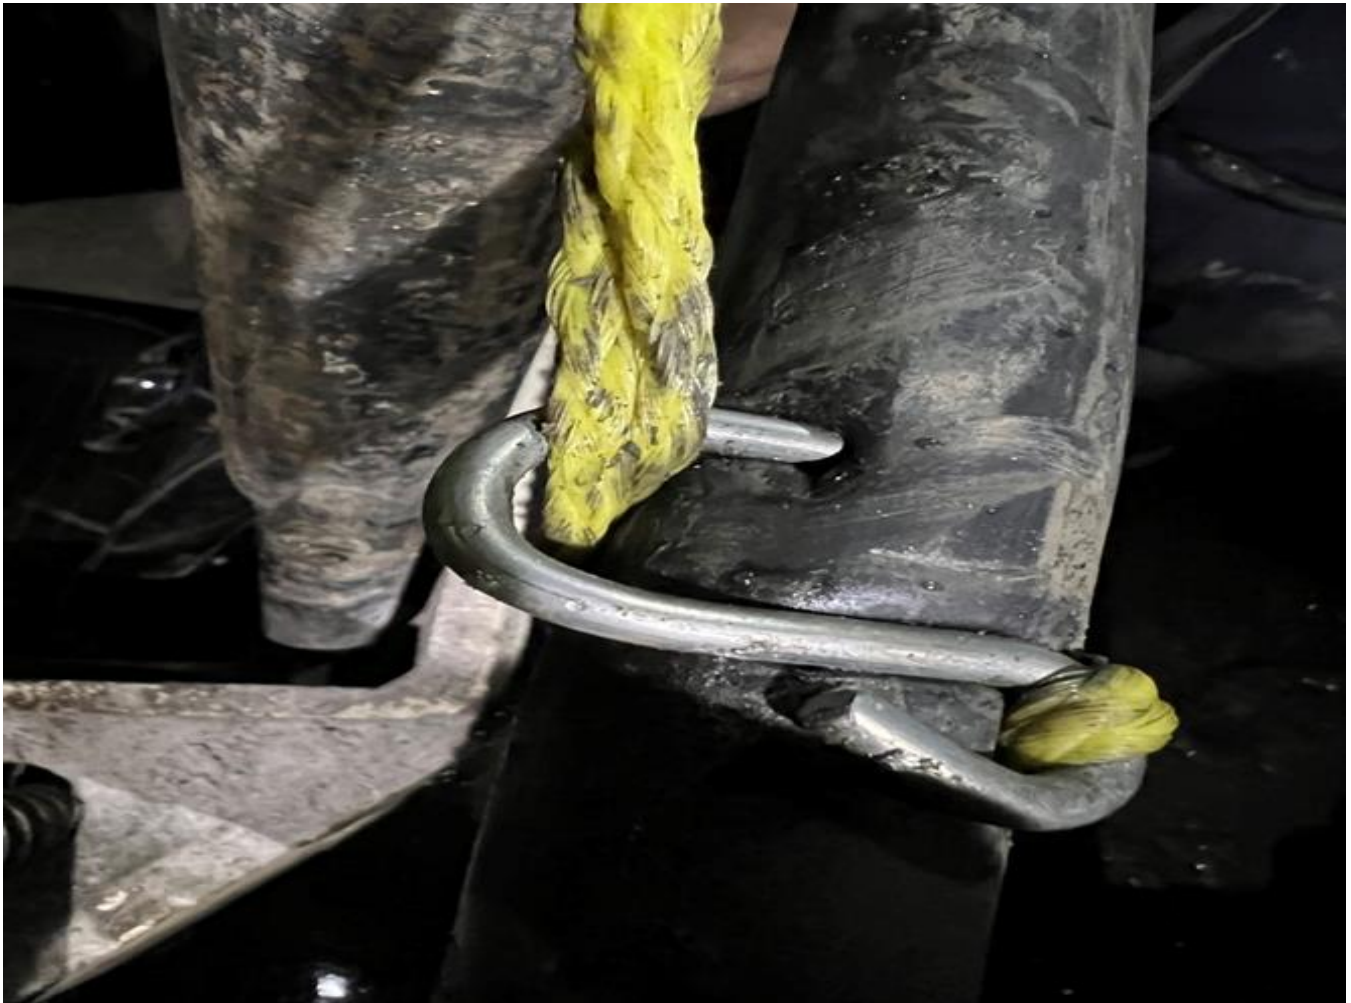
Rope Hanger Metal Hook Imbedded in #930010 Roof Bolter Trailing Cable

8. During the investigation it was found that the metal hook penetrated the outer cable jacket and the insulation of the red phase lead.

The victim had just completed the task of pulling up slack for the #930010 Fletcher Roof Bolter with the #709 Brookville Locomotive. The victim had just stopped to take a break while sitting in the operator compartment of the #709 Brookville Locomotive when the victim placed his left hand on an energized metal rope hanger hook that had become imbedded into one phase lead (red phase) of the #930010 Fletcher Roof Bolter trailing cable. This one phase was energized with 290.3 Volts A.C. According to testimony and written statements, the victim had placed the rope hangers on the trailing cable to be used in pulling the cable. These rope hangers, with the metal hooks, are not designed for this task. Although, according to witness testimony, the use of rope hangers for the task of pulling cables is common practice in the industry. Proper pull ropes/cable slings were found during the accident investigation on the #709 Brookville Locomotive.

One contributory violation §22A-2-40(39) states: Trailing cables shall be clamped to machines in a manner to protect the cables from damage and to prevent strain on the electrical connections. No cables will be hung in a manner which will damage the insulation or conductors.

2. Nylon rope hangers will not be used to pull trailing cables. Trailing cables will be pulled with a more suitable type of non-metallic pull rope that prevents damage to cable.
3. All State and Federal laws, rules, and regulations shall be complied with at all times.
