WEST VIRGINIA OFFICE OF MINERS' HEALTH, SAFETY AND TRAINING

REPORT OF FATALITY

MOBILE EQUIPMENT

H.W.M. TRUCK LINES, INC.

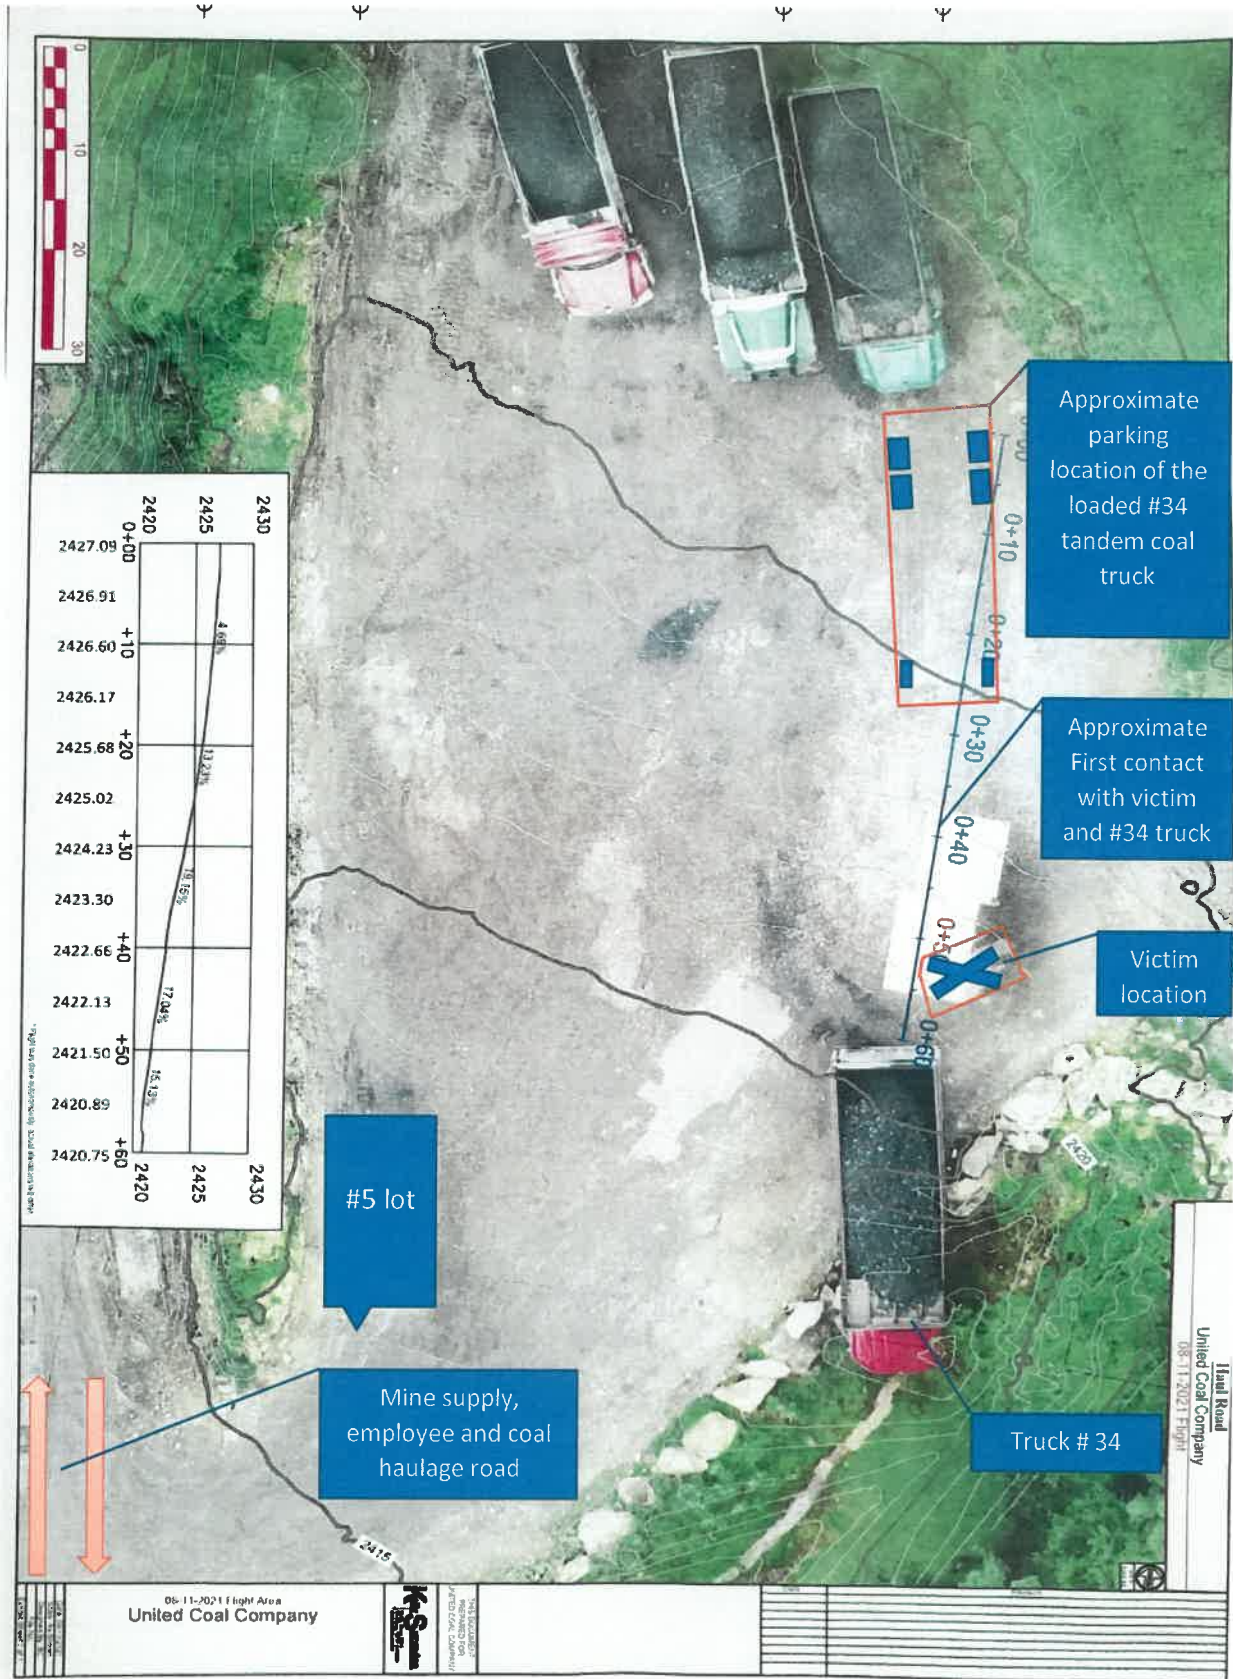
DRONE PHOTO OF ACCIDENT SCENE 1

5. The #5 lot is part of the Carter Roag Coal Co. LLC., Star Bridge Plant haulroad.
6. The #34 truck was parked loaded with approximately forty (40) tons of coal on a downward grade. (See diagram on page one (1)).

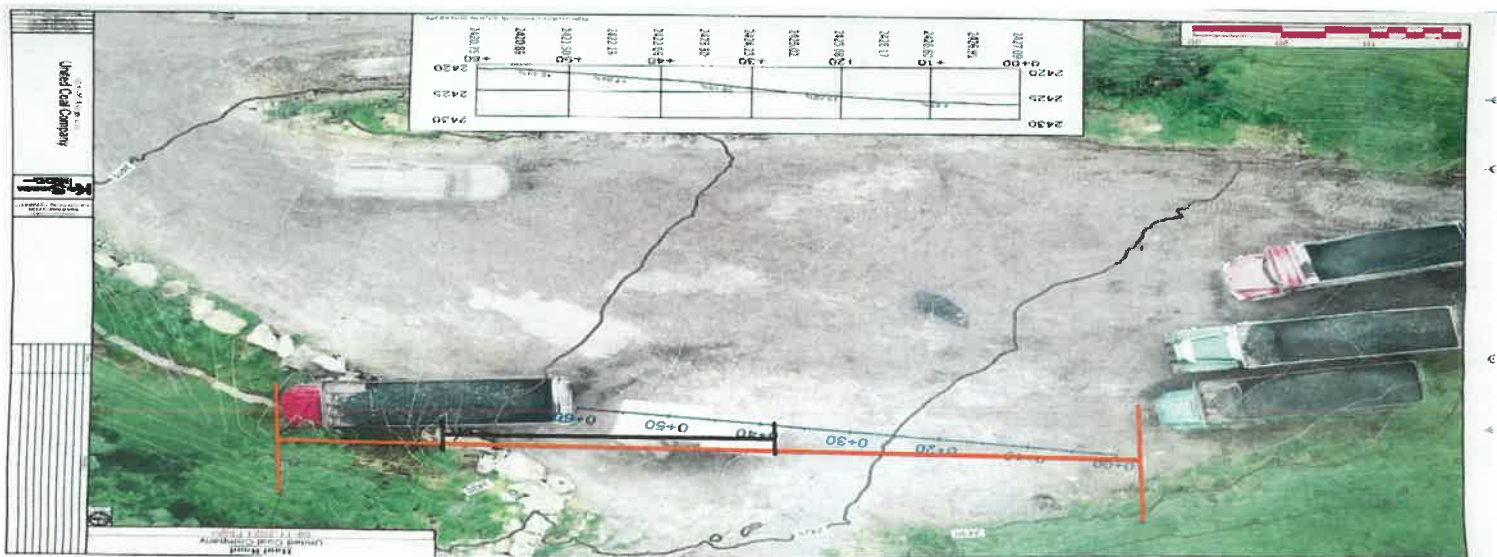
Use picture on 16 & 19

16. The truck traveled forward, unattended, **ninety-eight (98) feet**, striking a rock berm before coming to a stop. (|—|)

19. The measurement from the front rear axle of the truck tires to the victims first contact was fifty-four (54) feet. (|—|)
