West Virginia Office of Miners' Health, Safety and Training

Report of Fatal Personnel Carrier Accident

Mingo Logan Coal, LLC

Mountaineer II Mine

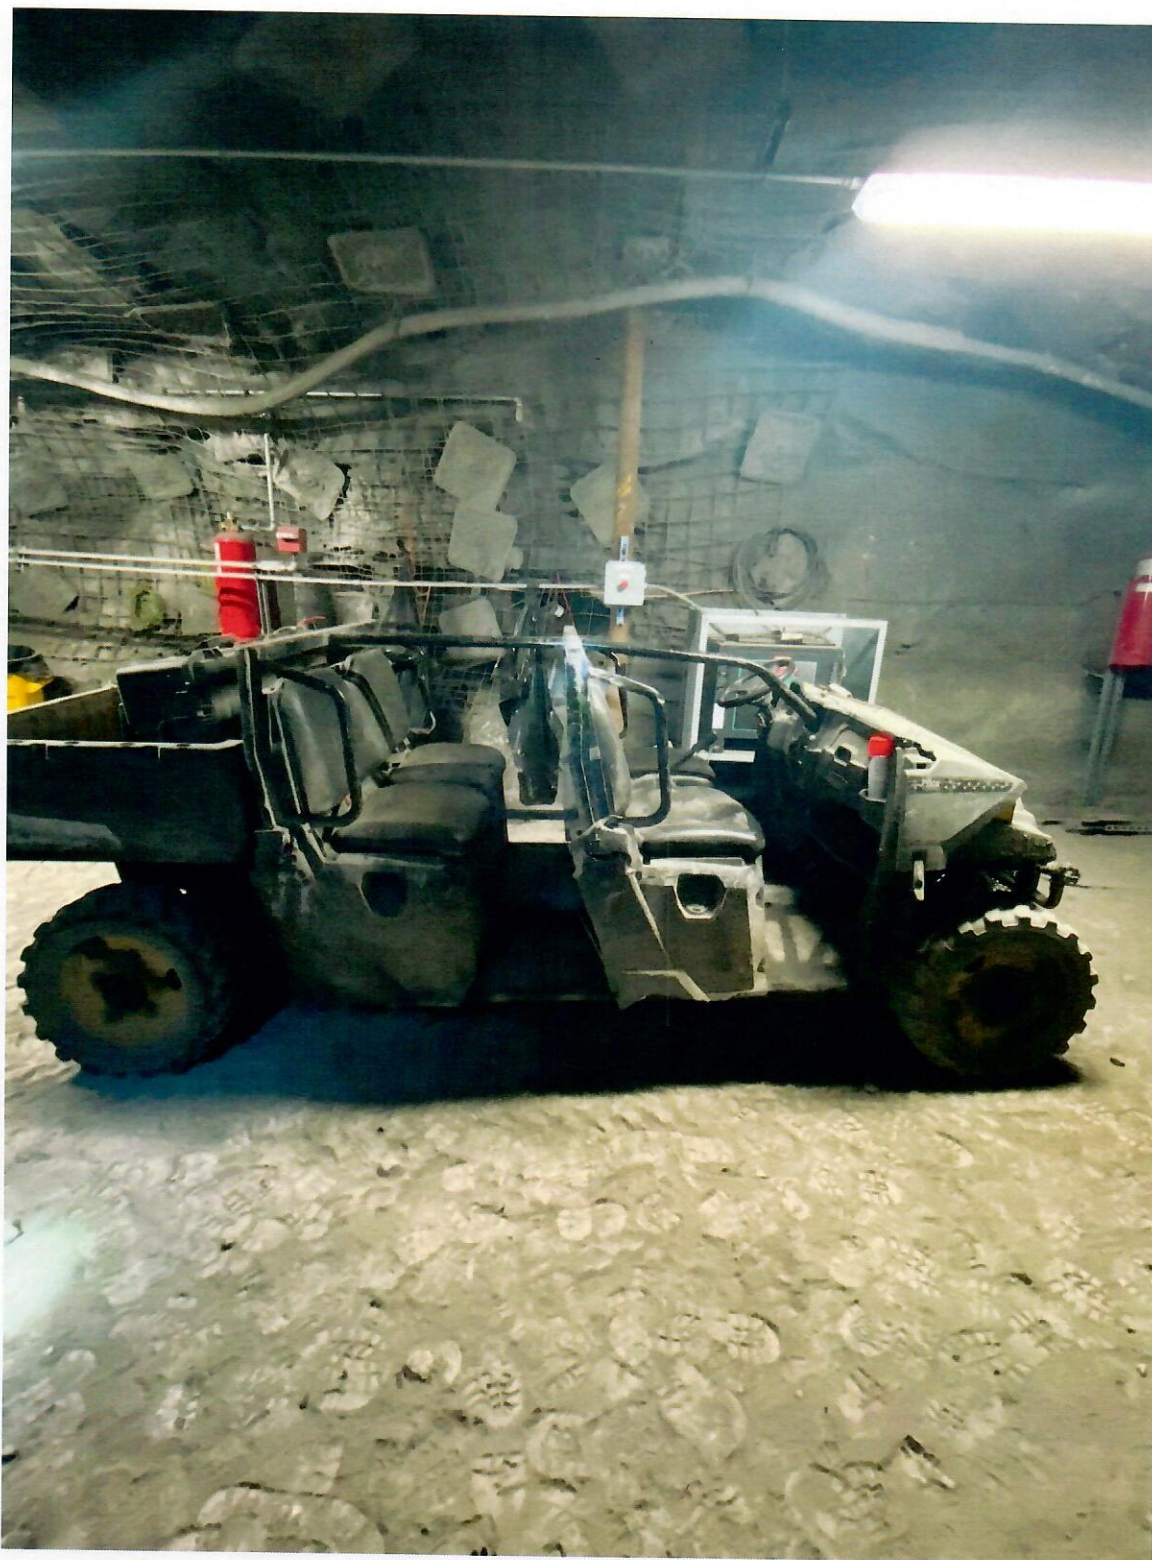
The purpose of this photo is to depict what a typical 4 man Electric Mining Utility Vehicle (“EMU”) would look like. This is identical to the EMU involved in the accident.

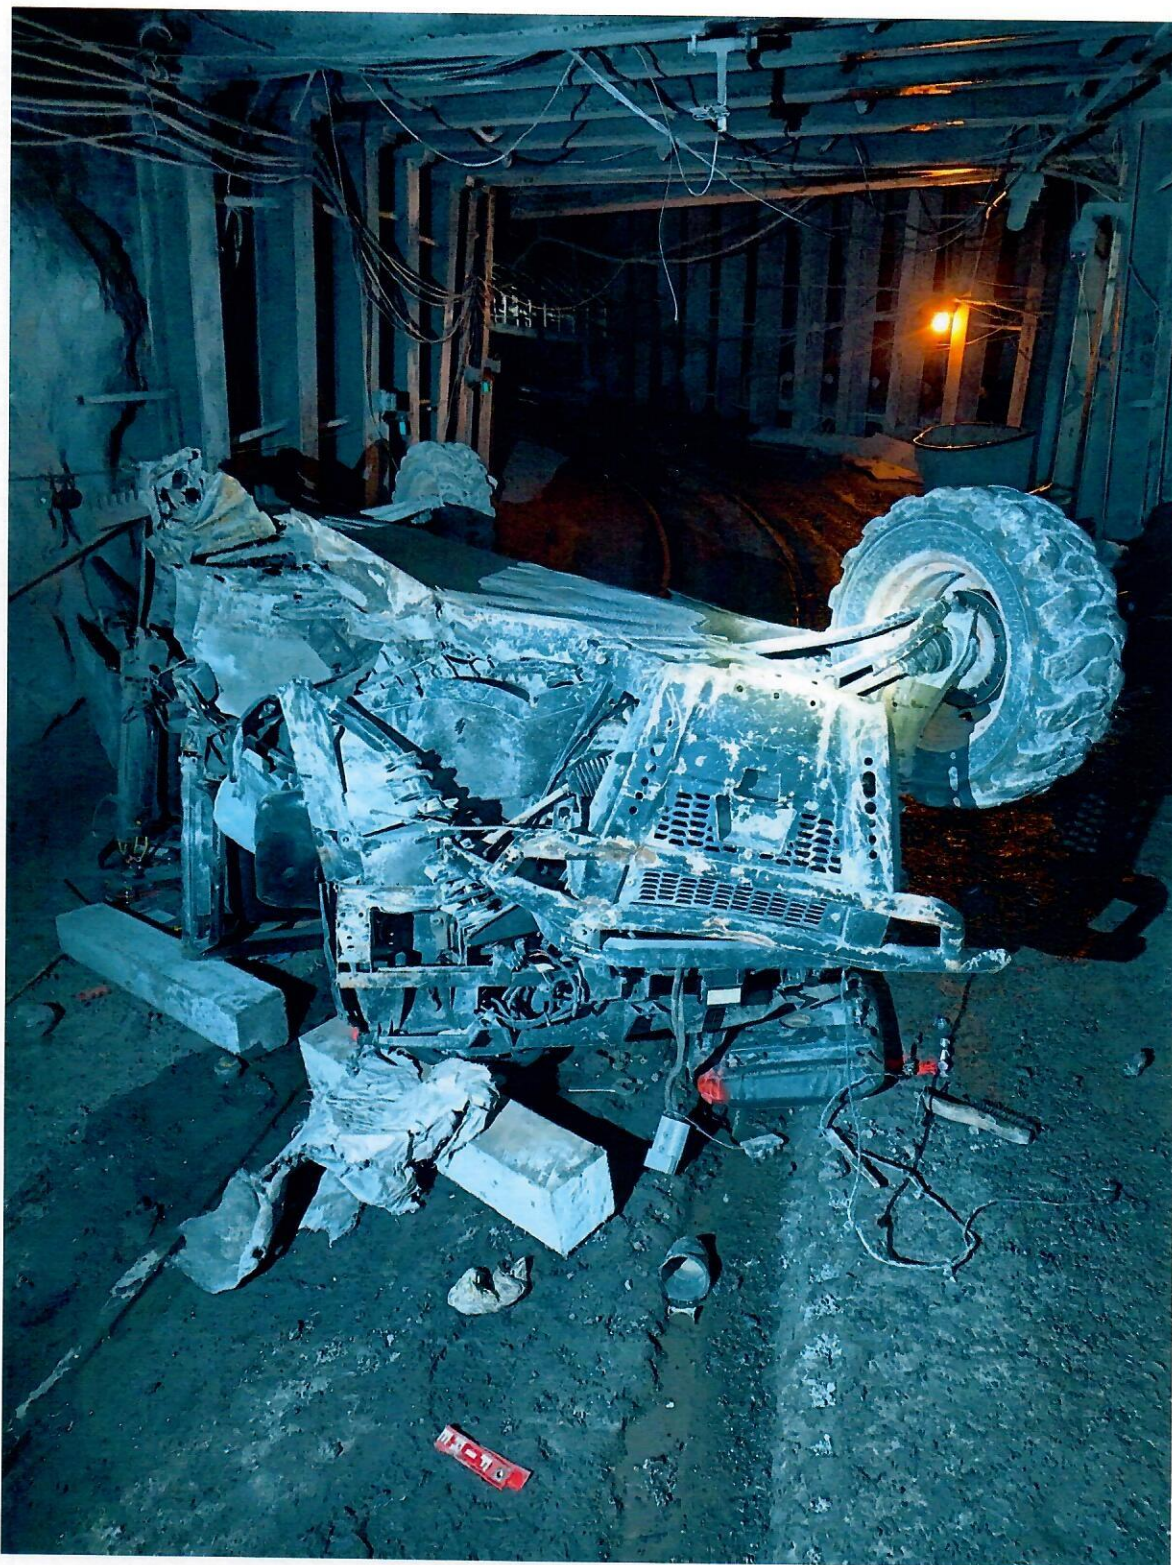
Accident scene, showing the No. 7 EMU on it's top. This photo was taken after Mr. Wallen had been removed from under the No. EMU.

On Monday, November 1st, 2021, Mr. Brian Wallen was fatally injured when he lost control of the No. 7 EMU he was operating, collided with a set of steel roof support I-beams at the bottom of the slope and the No. 7 EMU rolled, landing upside down, entrapping Mr. Wallen.

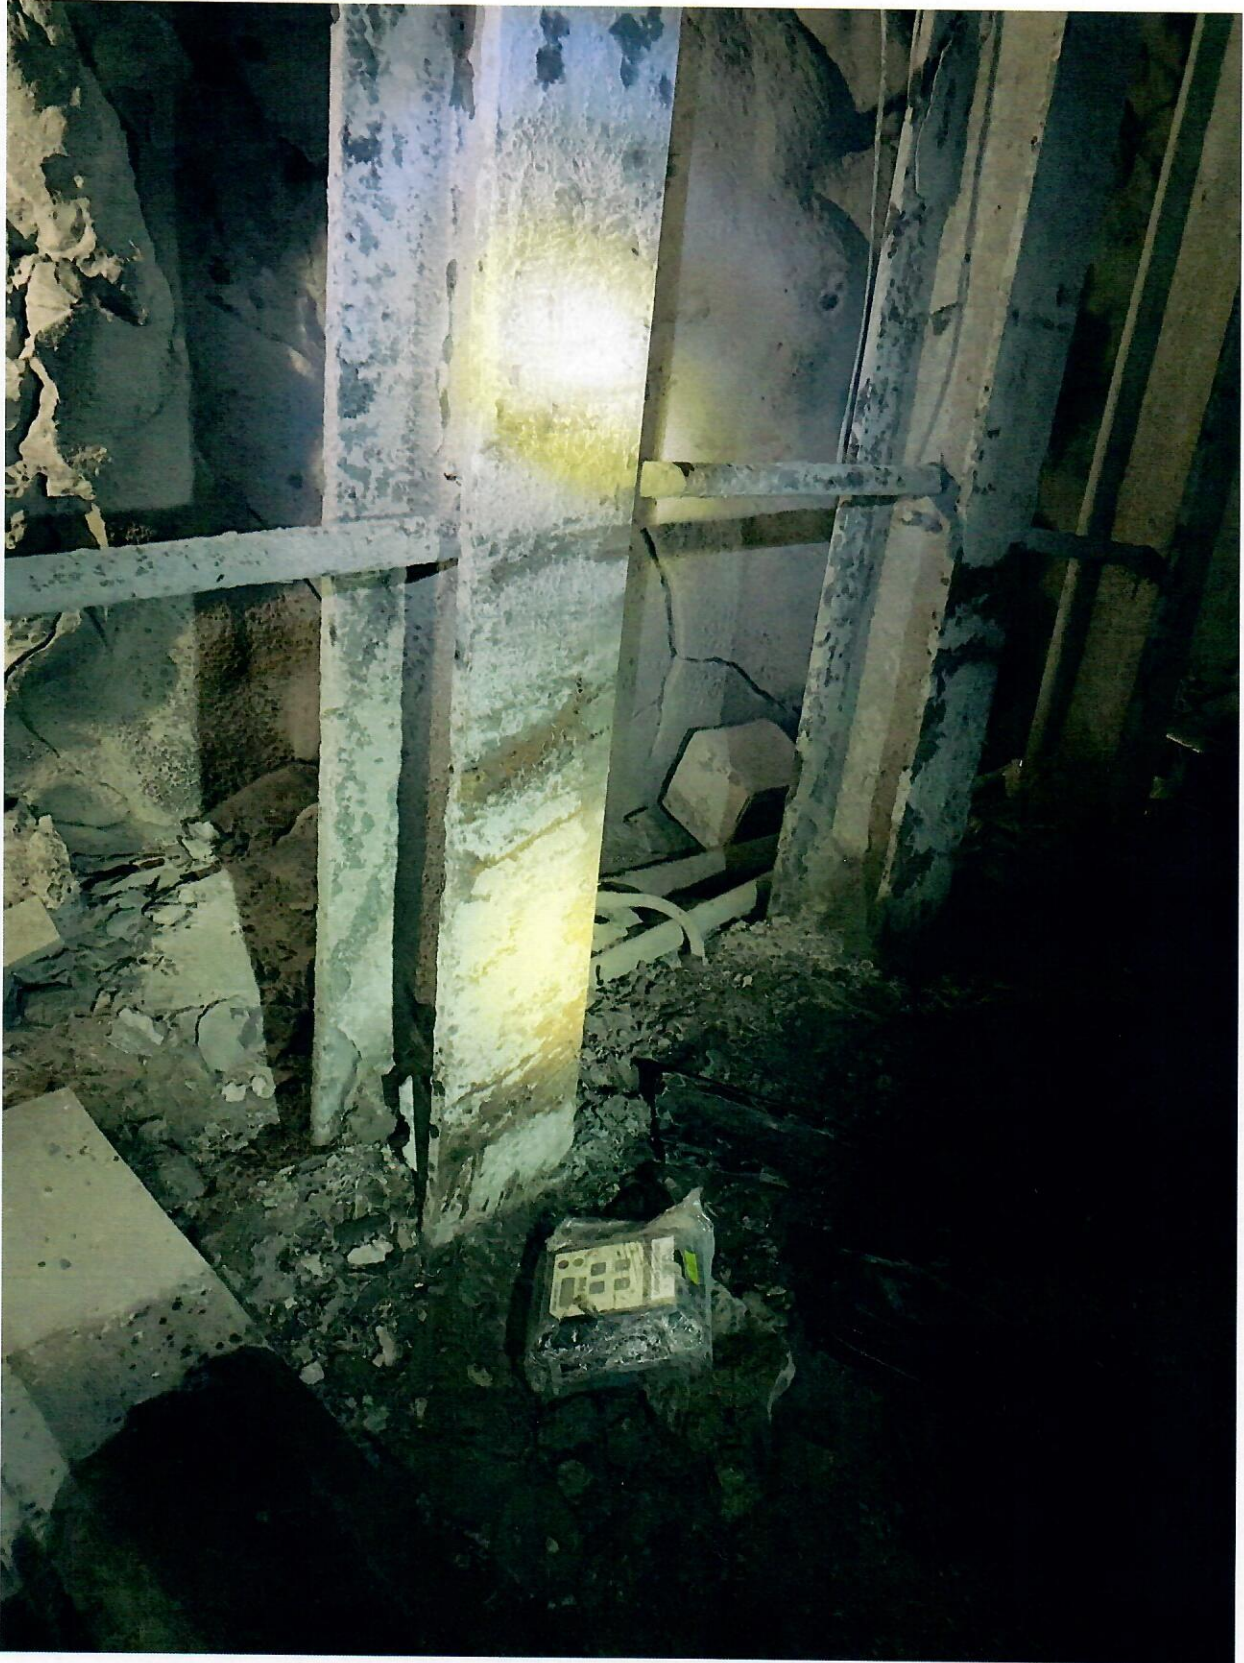
Steel beams at the bottom of slope that the No. 7 EMU collided with during the accident.

7. Mr. Wallen was assistant evening shift Chief electrician acting as Chief electrician on Monday, November 1, 2021.
8. Mr. Wallen traveled approximately 1,356 feet down the slope in approximately 43 seconds before impacting steel support beams, according to the time stamp on the slope camera.

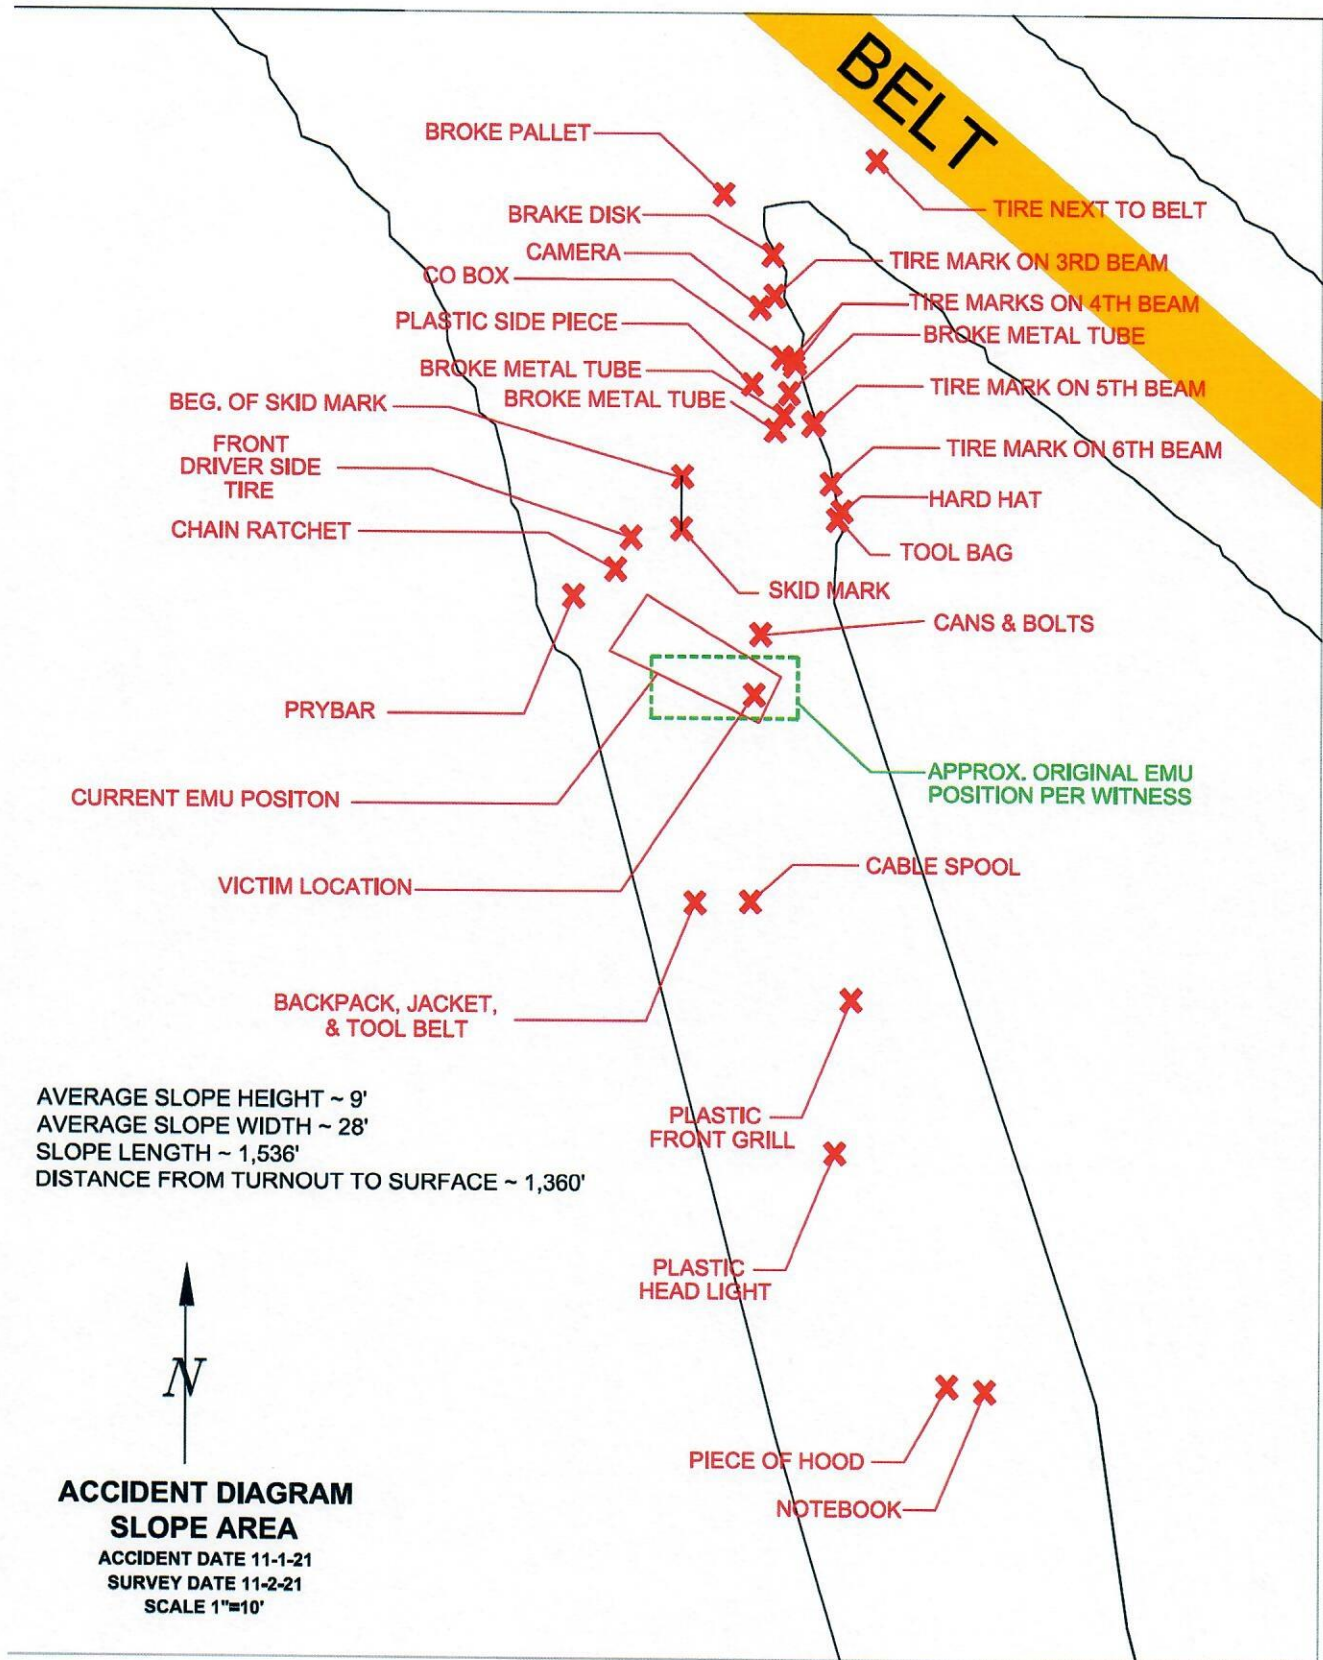
ACCIDENT DIAGRAM
SLOPE AREA
 ACCIDENT DATE 11-1-21
 SURVEY DATE 11-2-21
 SCALE 1"=10'

AVERAGE SLOPE HEIGHT ~ 9'
 AVERAGE SLOPE WIDTH ~ 28'
 SLOPE LENGTH ~ 1,536'
 DISTANCE FROM TURNOUT TO SURFACE ~ 1,360'
