REPORT of INVESTIGATION into the MINE EXPLOSION at the UPPER BIG BRANCH MINE

APRIL 5, 2010

BOONE / RALEIGH CO., WEST VIRGINIA

**WEST VIRGINIA OFFICE of MINERS' HEALTH,
SAFETY & TRAINING**

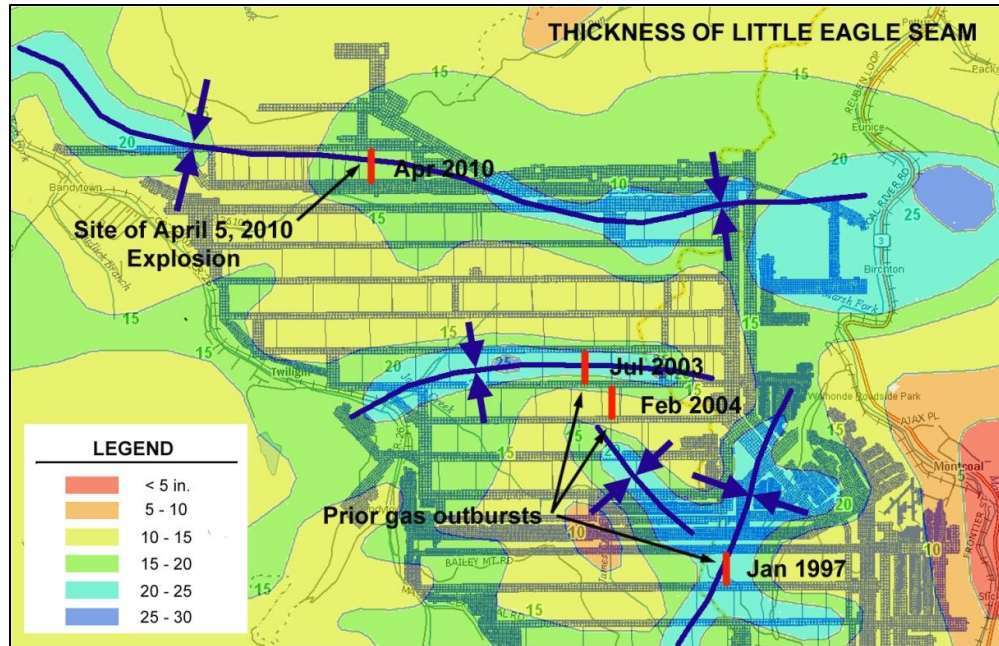
A *Thickness Isopach Map* (**Map 1**) suggests an association between local depositional troughs (where the Little Eagle seam is comparatively thick), and the occurrence of known UBB gas events. The margins of such local subsidence troughs are frequently associated with slips and fractures, along which relatively weak and porous zones can occur, which facilitates local gas accumulations. Weak floor would be more sensitive to abutment stresses under cover depths exceeding 800 feet.

Map 1. *Thickness Isopach Map* of the Little Eagle seam (inches). Known past gas events appear to be associated with local depositional troughs of comparatively thick Little Eagle.

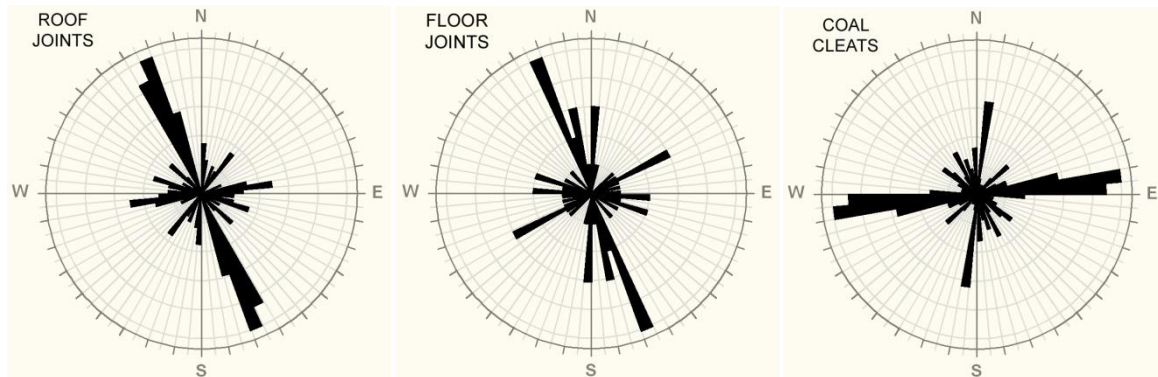
Figure 6. (LEFT) MINE ROOF extension joints trend approximately N25°W. (MIDDLE) MINE FLOOR extension joints trend approximately N20°W. (RIGHT) The COAL face cleat is oriented approximately N80°E.

Structurally, the dominant extension fracture in the UBB mine roof is approximately N25°W. This is similar to the mine floor, which is more difficult to ascertain, but appears to be approximately N20°W. The dominant face cleat directions are approximately N80°E.

Because the dominant fractures in the sandstone roof above the Eagle seam are of similar orientation to the sandstone of the mine floor (the Eagle/Little Eagle interburden) the possibility exists that pre-existing conduits for gas migration might exist which are inadvertently intercepted during mining. These conduits might be pre-established pathways for upward-migrating of gas that ceased when gas pressures and resisting stresses of confinement reached equilibrium. The Eagle/Little Eagle interburden may act as a cap or seal for this confinement, and when ruptured by abutment stresses under areas of deep cover can release pockets of residual gas where the floor is locally weakened and/or fractured.

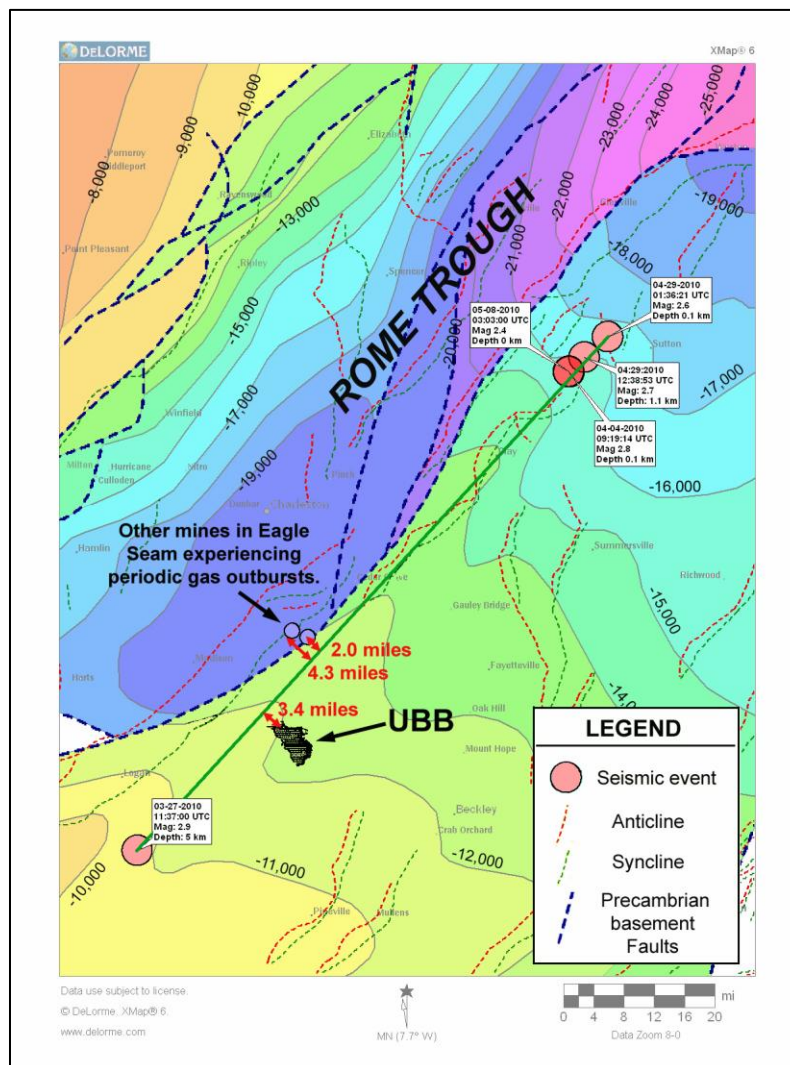
However, upon closer inspection of the seismic reports it appears that natural crustal disturbances may not have been involved. The March 27, 2010 event was apparently not detected by local seismographs. The other four events may be related to industrial activities, and not natural events. Despite their proximity to the edge of the Rome Trough (an ancient major fault system in the Precambrian basement), and their impressive alignment, it appears the correlations are circumstantial, and are probably not related to events causing a gas release or other condition that contributed to the explosion in the UBB mine on April 5, 2010.

Map 4. Location of seismic events reported within 45 days before or after April 5, 2010. The nearby *Rome Trough* is an ancient Cambrian rift system of faults deep in the Precambrian basement rocks, and along such faults subsequent tectonic adjustments (earthquakes) might occur. The structure contour intervals shown are in feet, relative to sea level, and are adapted from information obtained from the West Virginia Geological and Economic Survey. Despite the apparent linear alignment of the seismic events, however, it is not believed that the seismic events reported during the time period were related to events causing a gas release or other condition that contributed to the explosion in the UBB mine on April 5, 2010.

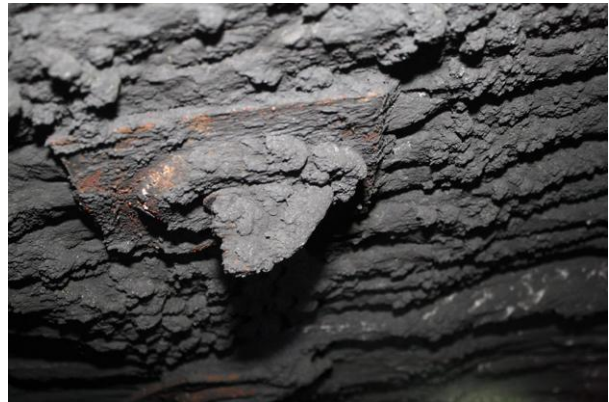
Figure 4B. (RIGHT) Impacted “mud” on north side of roof bolt in entry #2 between BRK 31 and 32, and about 40 feet outby spad 22806 (view looking north).

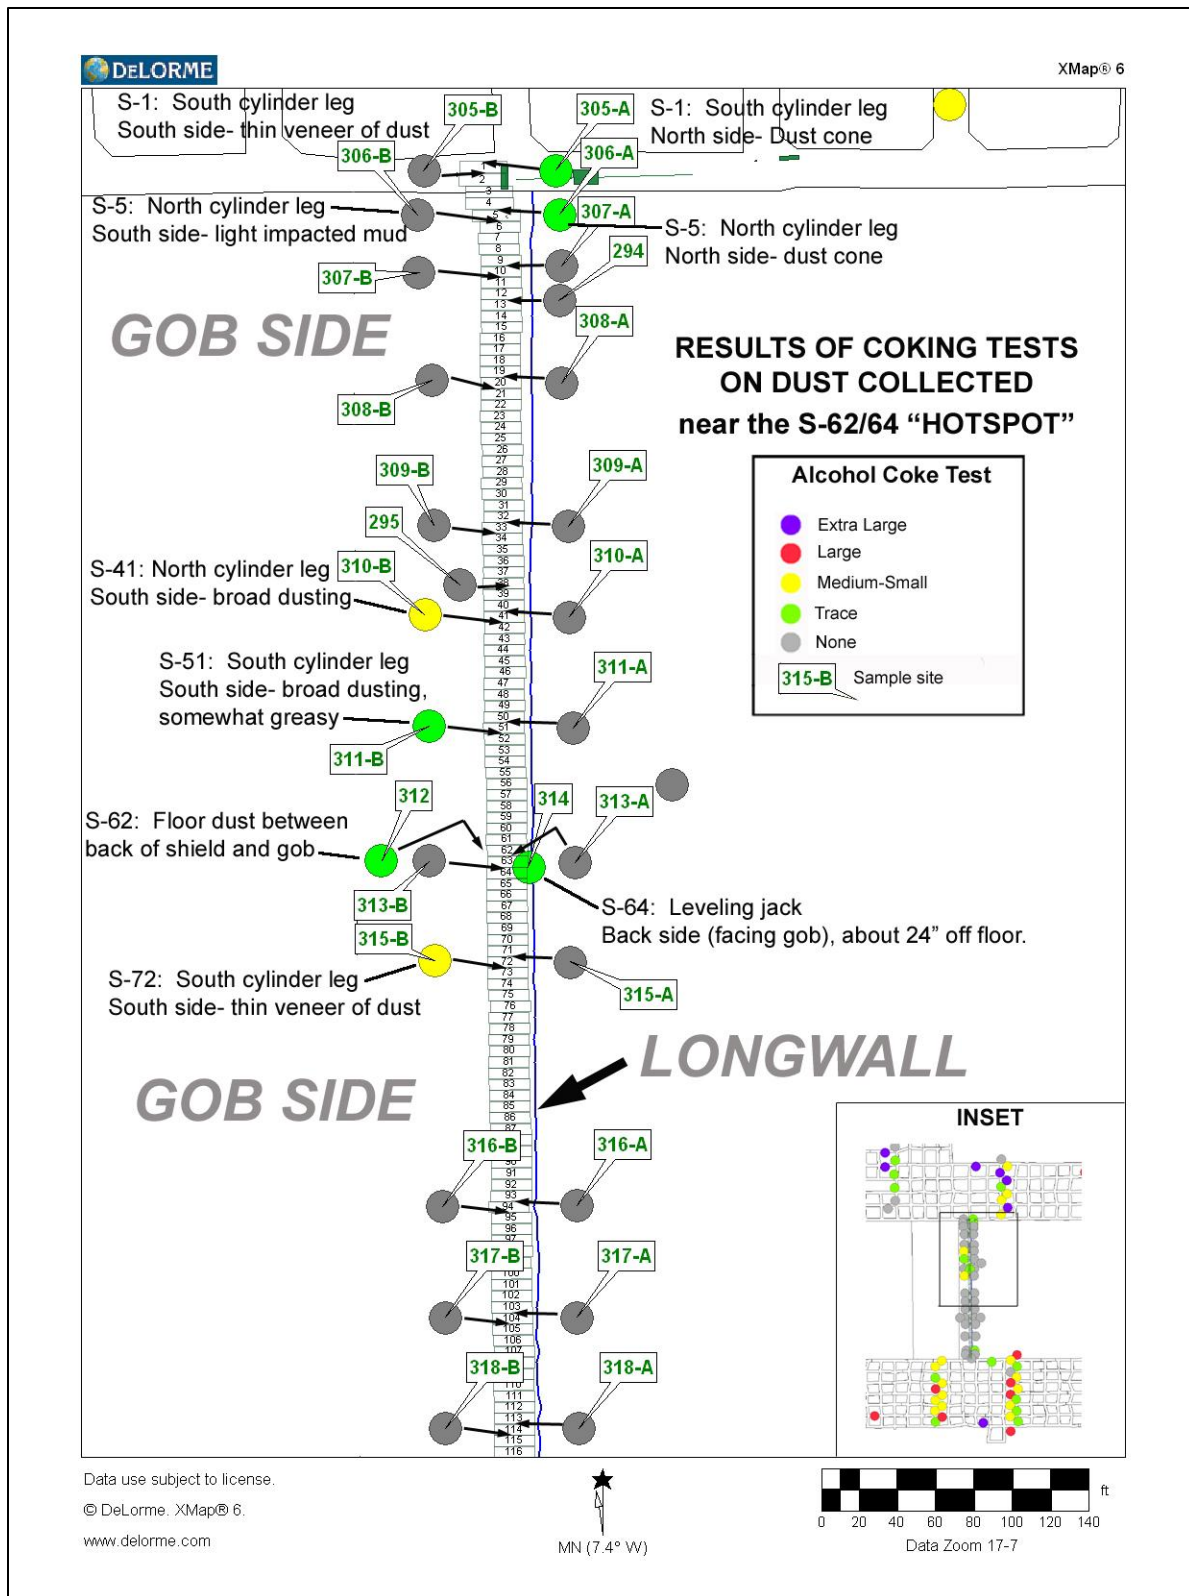
Map 4. Analysis of impacted dust for coke content on the longwall showed the highest amounts between Shield 41 and Shield 72.

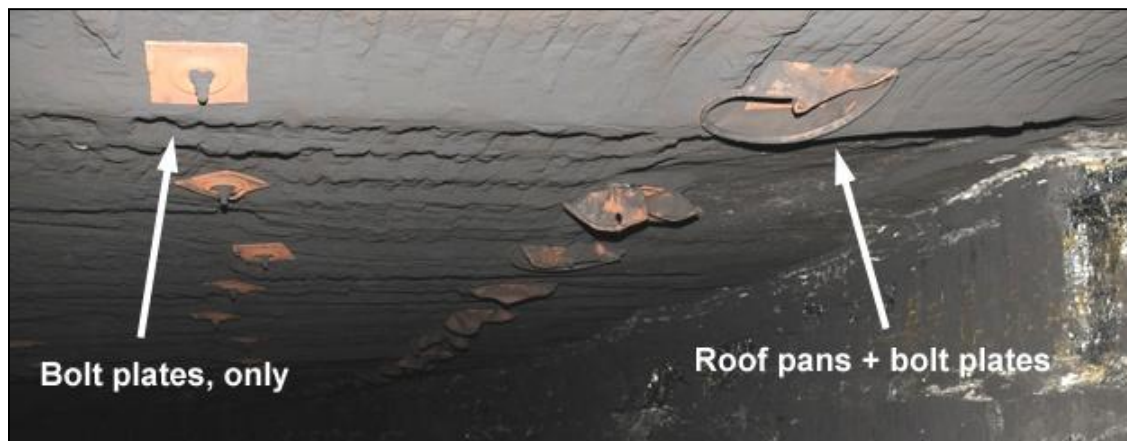
Figure 2. Example of roof pans (right) after explosion. Typically, four lines of bolts are installed on 4-ft. centers, but only one line incorporates roof pans at UBB. Additional roof pans are installed as roof conditions require. Round pans or “pizza pans” are used in this example.

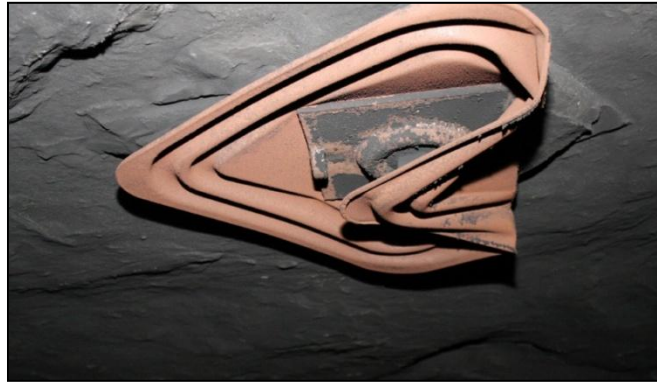
Figure 3. Example of simple roof pan bending in one direction—the most common mode of bending observed during the investigation.

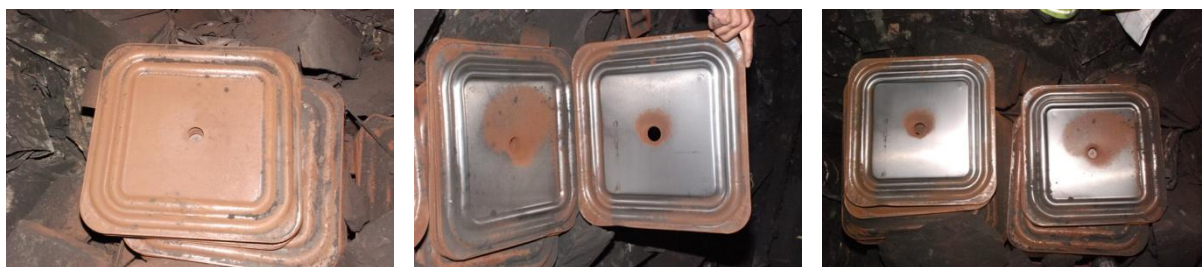
Figure 11. A stack of square pans found near the mouth of #22 Headgate survived the explosion and exhibited general rusting on their outside surfaces. Inside the stack, the only rusting was in the vicinity of the 1" roof bolt hole. It is believed that the "patina rusting" is due mainly to heat vaporizing some or all of the galvanized finish. Abrasion by wind-born particles may also play a role.

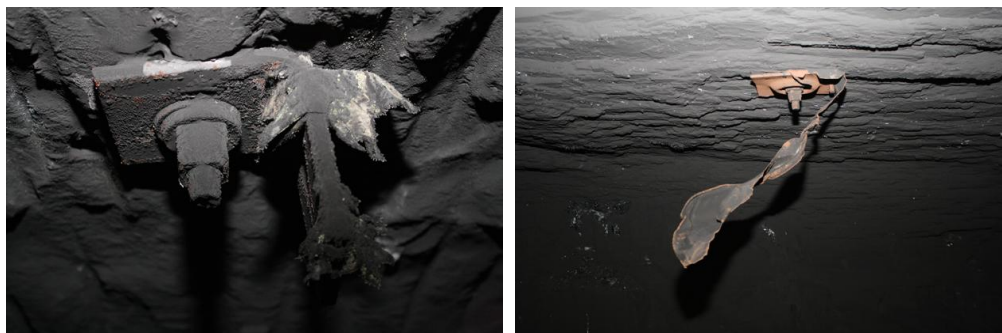
Figure 1. (LEFT) Paper shard, loosely caught on belt hanger; Outby end of #21 Tailgate, near spad 19641. View looking East.. Final Forces are to the EAST.

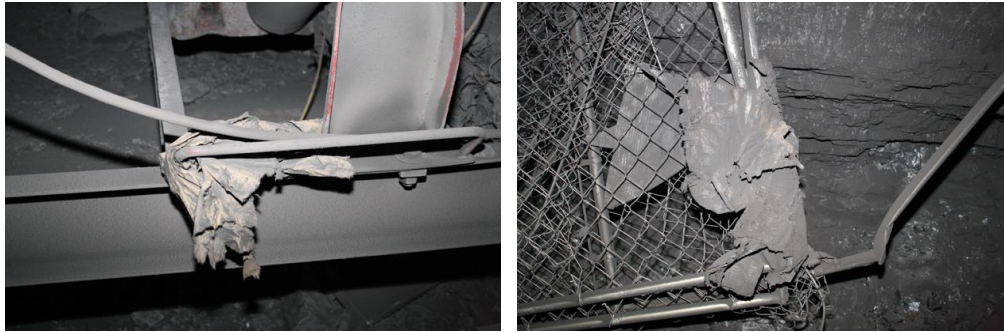
Figure 3. (LEFT) Paper shard on belt structure; North Glory Mains, at spad 19832. View looking NE. Final Forces are to the SE.

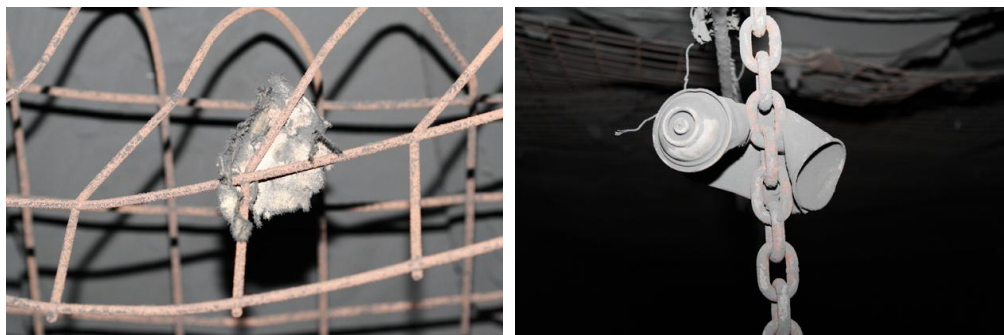
Figure 5. (LEFT) Paper shard caught in wire roof mesh: 8-North (North Jarrel’s Mains), near spad 20473. View looking W-NW. Final Forces are to the SOUTH.

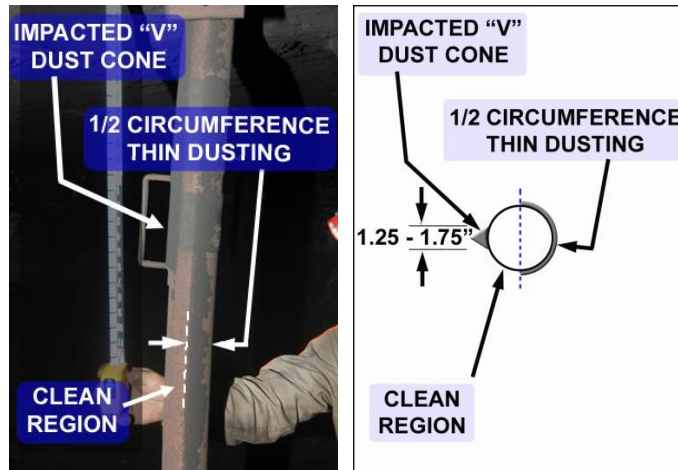
Figure 7. (LEFT) Standing sand jack on #21 Tailgate showing example of an *Impacted "V" Dust Cone* formed on the leading edge that pointed in the windward direction of the Final Forces. *Original photo courtesy of Performance Coal Co,*

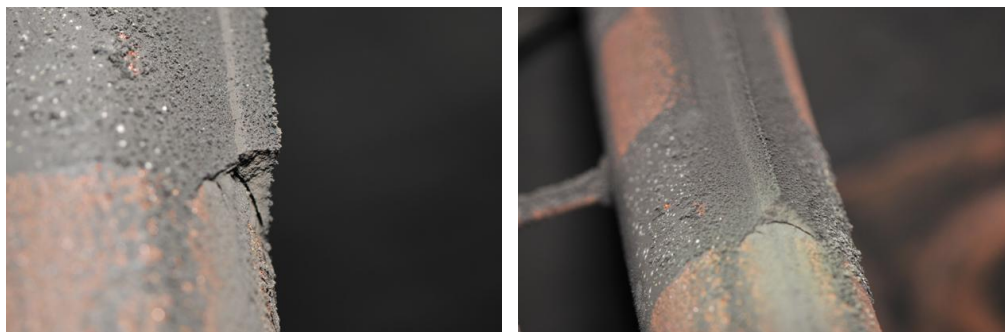
Figure 9A. (LEFT) Dust cone on sand jack; #21 Tailgate; track entry, approx. 2 breaks EAST of the Longwall

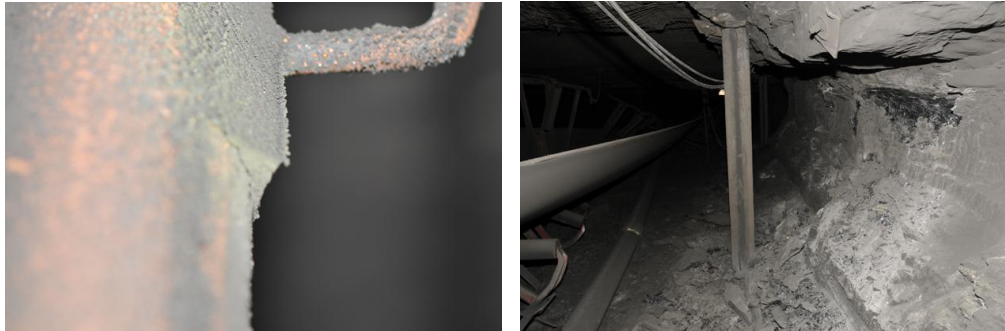
Figure 12. (LEFT) Sand jack with dust cone (lower part has fallen away); #21 Tailgate, approximately 2 breaks east of the Longwall, looking North. Final Forces were from the EAST

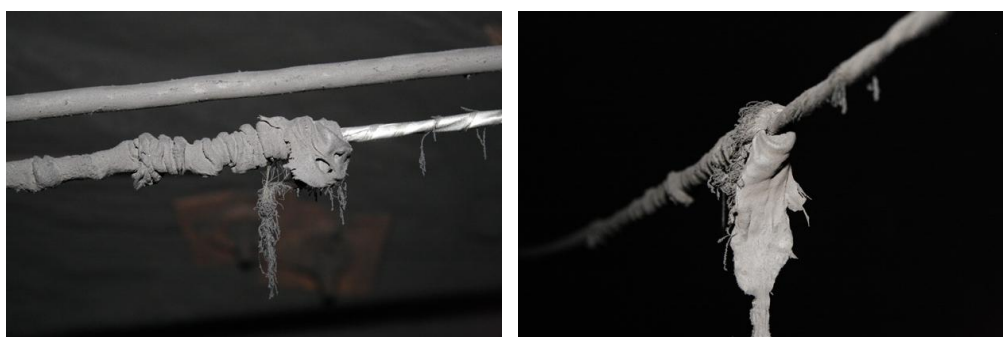
Figure 16. (LEFT) Shielded cable; North Glory Mains, 20-ft inby spad 20440, looking SW. Bunching is in the direction of Final Forces (to the SE).

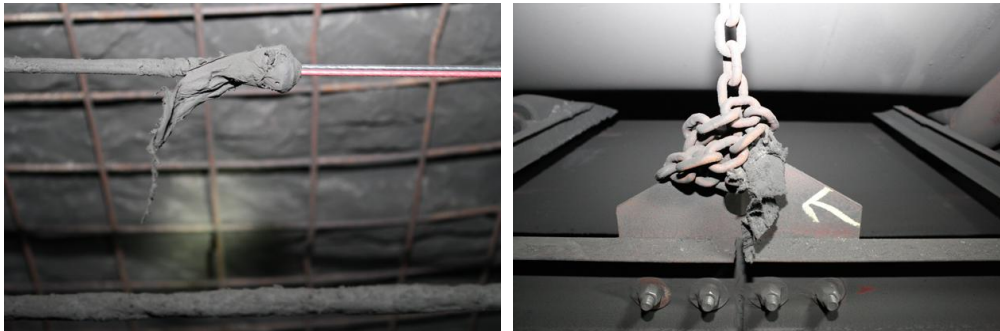
Figure 18. (LEFT) North Glory Mains: 50-ft SE of spad 20045 (SW view). The heated outer insulation of the phone line is bunched in the direction of Final Forces, which were directed SE. (Note: The original photograph was taken from the opposite side of the belt. It has been inverted here to a comparable SW view).

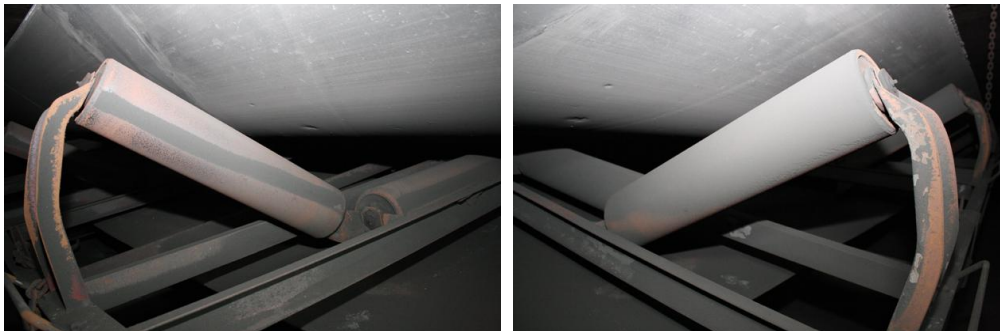
Figure 20. (LEFT) North Glory Mains, 60-ft NW of spad 20048 (looking SE). This is an example of a belt roller with an Impacted “V” Dust Cone on the windward side of the indicated Final Forces, which were directed SE. The impacted “V” is well-developed, most likely because the belt is not tight to the roller.

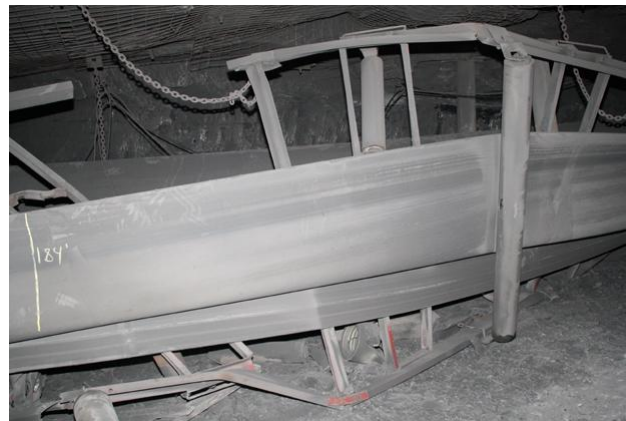
Figure 1B. In crosscuts, explosion forces entering perpendicular to the belt and from the SW side cause a CCW rotation of the belt structure, which would be from the LEFT side, looking inby (left lateral). This example view is near spad 19835 in NGM, looking to the SW from the edge of the crosscut.

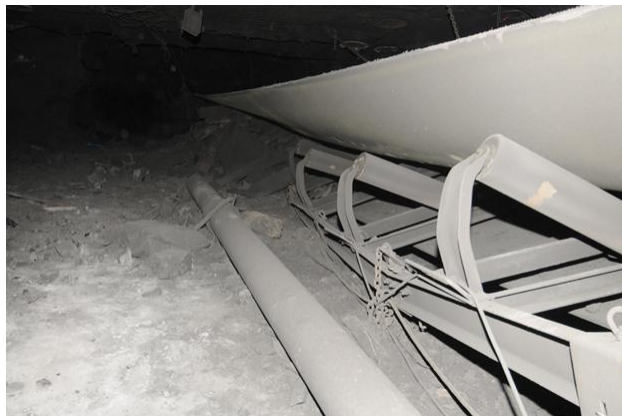
Figure 1C. After the CCW rotation the chain on the windward side may be broken, or the chain on the leeward side may become unhooked, dropping one side of the belt structure. This example view is in the North Glory Mains near spad 19852, looking inby.

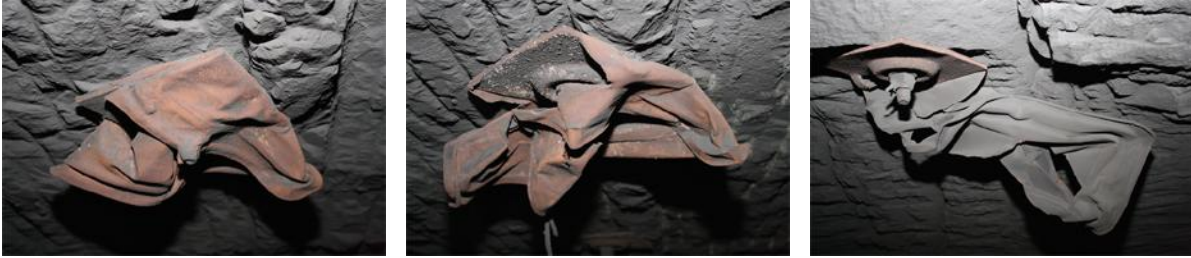
Figure 7. Examples of severe roof pan damage in the region of #21 Tailgate south of the the #21 Cross-over.

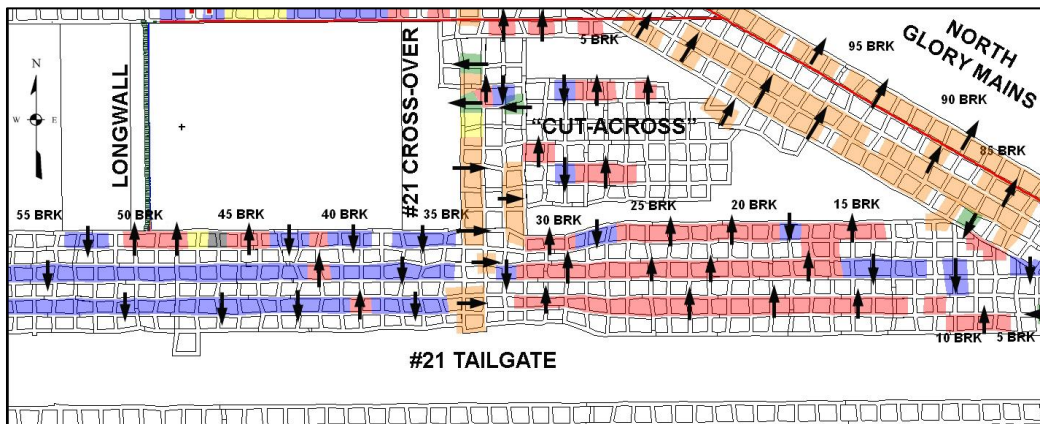
Map 3A. This map summarizes the direction of stopping failure, due to Initial Forces of the explosion. Note that the breach directions west and east of the #21 Cross-over are opposite each other.

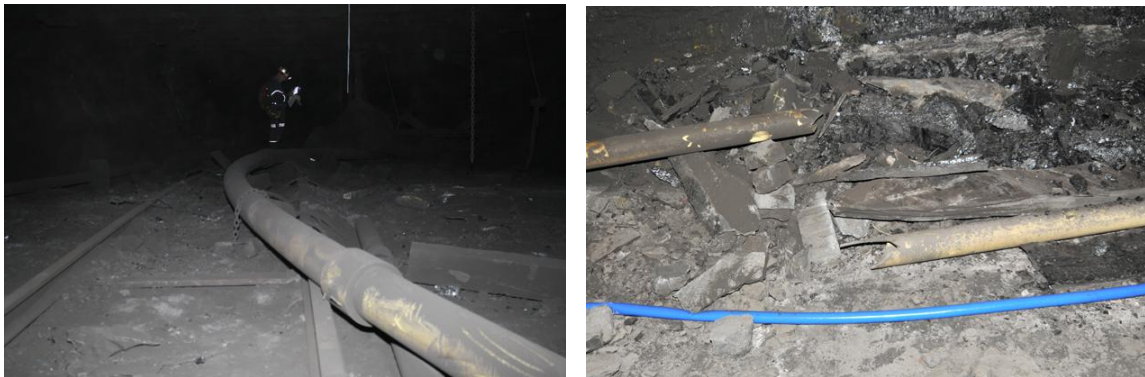
Figure 8. (LEFT) Example of a waterline moved by explosion forces. (RIGHT) An example of a small waterline broken (perhaps by explosion forces).

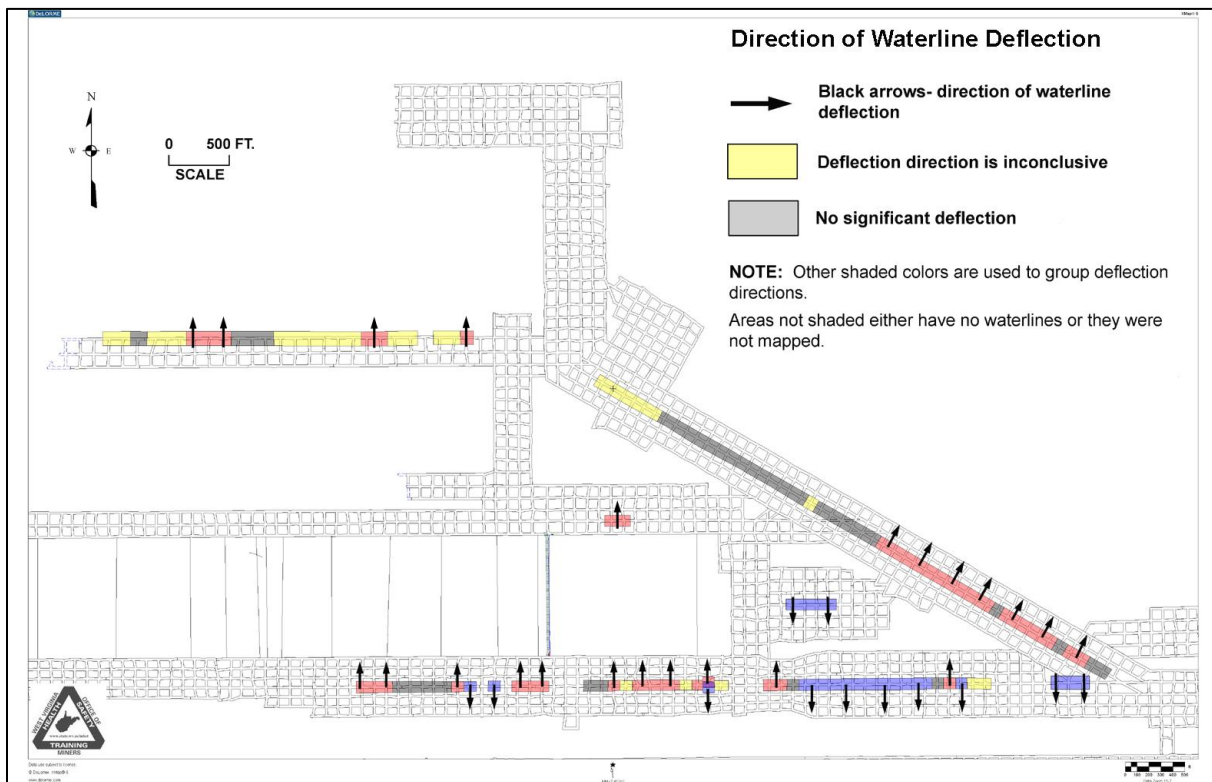
Map 4. Lateral displacement of discharge water lines, attributed to explosion wind forces.

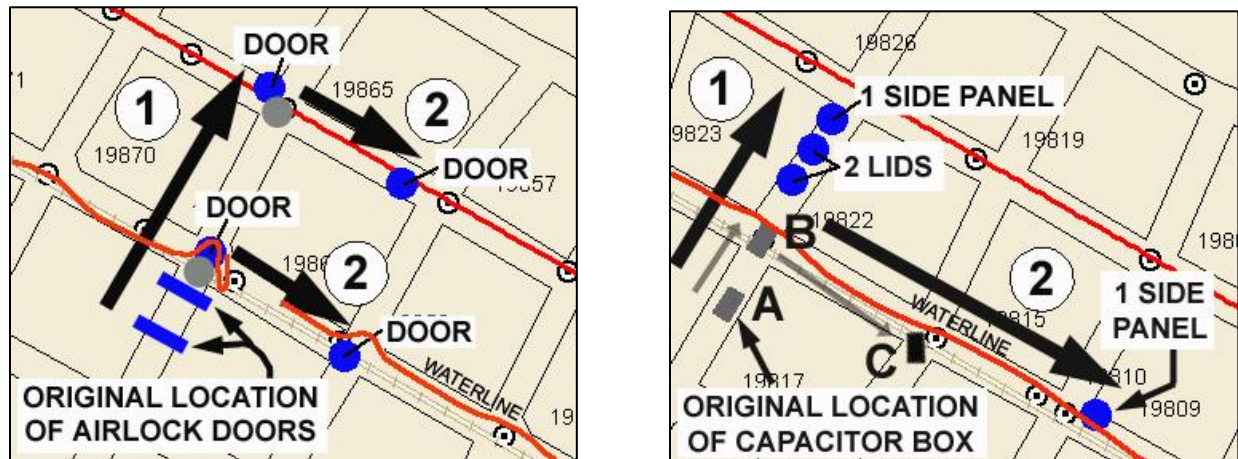
Figure 12. (LEFT) Four airlock doors that were found crumpled on the mine floor, appear to have originally been the doors that were hanging just SW of spad 19862 prior to the explosion. They were transported first NE. Two became tangled in debris, and the other two were subsequently transported SE.

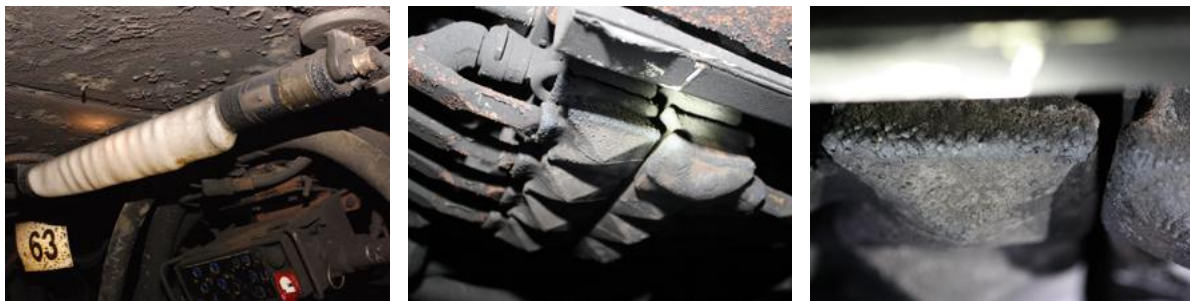
Figure 2. (LEFT): Melted fluorescent light cover at Shield 62; (MIDDLE): Evidence of heat on the rubber cover for manual shield control box; Shield 62; (RIGHT): Close-up of cover for manual shield control box; Shield 62.

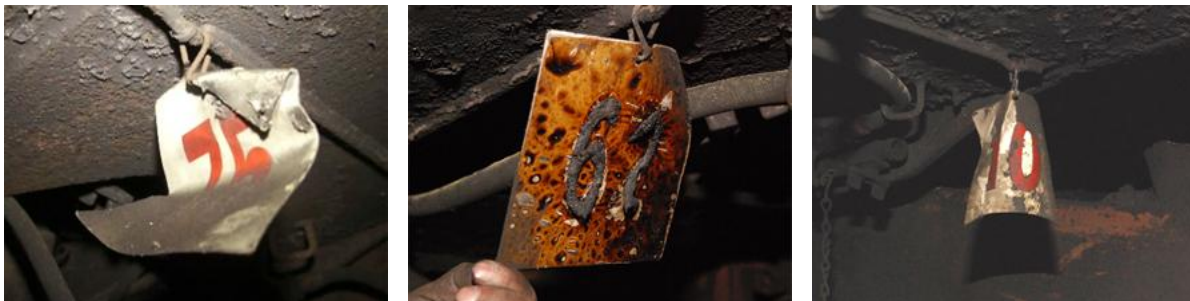
Figure 3B. (LEFT): Typical bending of shield sign south of Shield 56 is to the SOUTH, along a horizontal fold axis, (MIDDLE): Shield 62 sign is generally unbent, but heat damaged, (RIGHT): Typical bending of shield sign north of Shield 56 to the NORTH, along a vertical fold axis. There are exceptions.

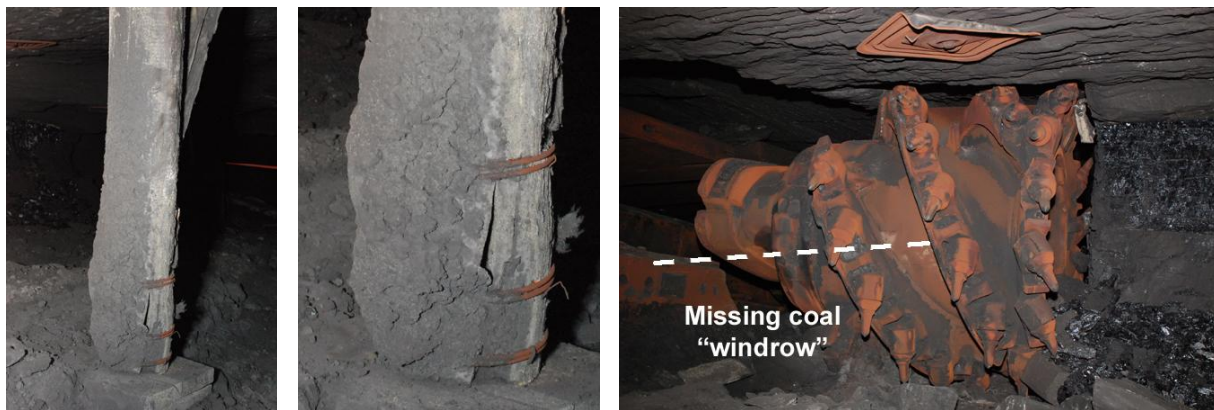
Figure 5B. (LEFT): Impacted wet coal and dust along the bottom half of the first propsetter outby the shearer. This points toward the back (west) side of the shearer cutting head; (MIDDLE): Close-up view. (RIGHT): The coal “windrow” (coal berm) that normally develops here is missing.

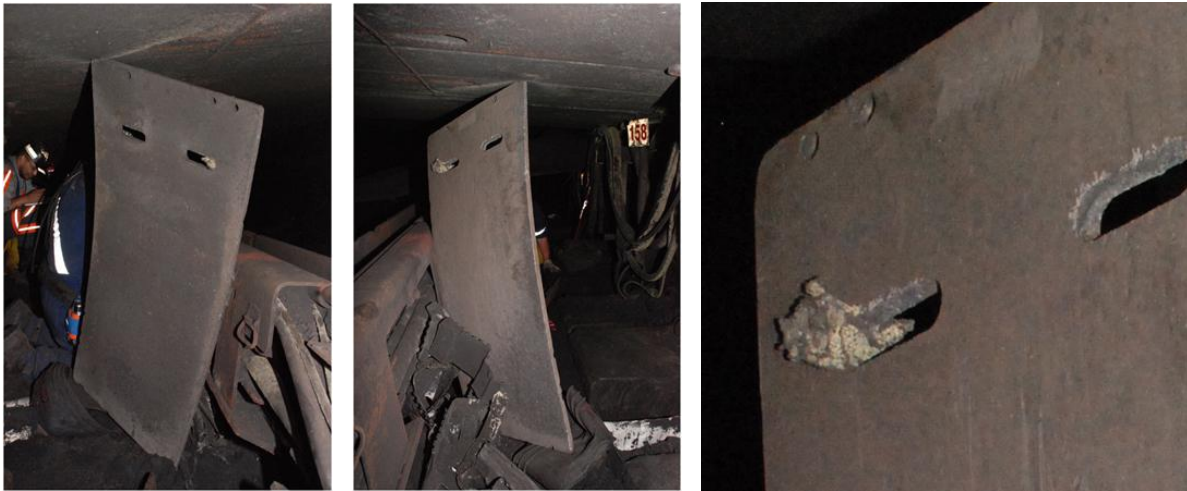
Figure 8. (LEFT): Aluminum cover off the tail-drive motor that came to rest in an upright position, wedged under the canopy at Shield 157 (view looking north). Because it was stopped this way the pressures responsible for its transport could not be calculated. (MIDDLE): South view, showing debris piled against north side. (RIGHT): South view, close-up of paper fragment caught in a grip hole.

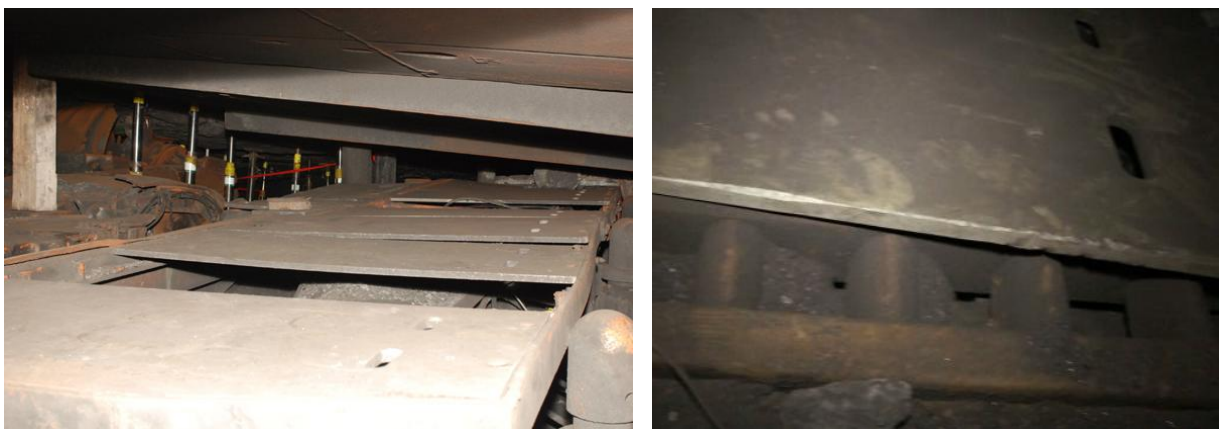
Figure 9. (LEFT): A view of the tail-drive; where two aluminum covers were removed by wind forces which came from the south. (RIGHT): One of the covers was found in the panline at Shield 130, having traveled approximately 256 feet.

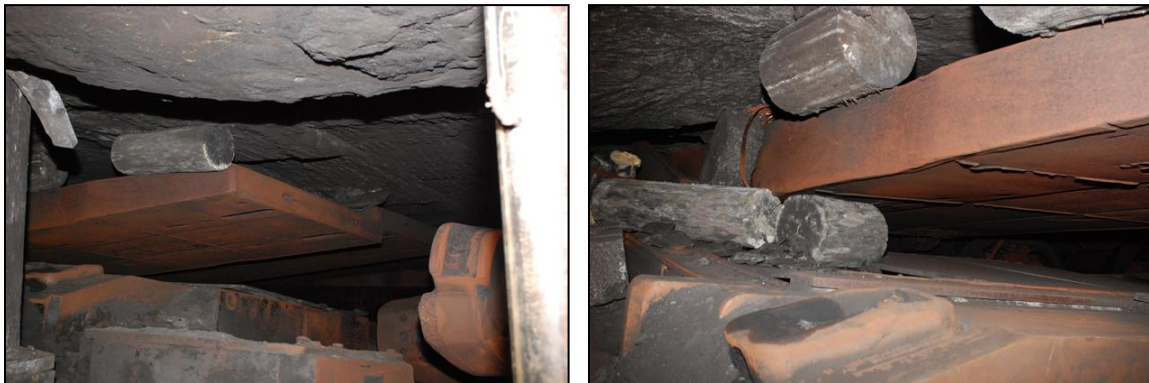
Figure 10. (LEFT): Short lengths of support posts were carried by winds entering the tailgate, traveling north, and impacted between the roof and top of Shield 176. This is a view from the tailgate, looking NW. (RIGHT): Any subsequent winds from the north were not sufficient to blow these back down.

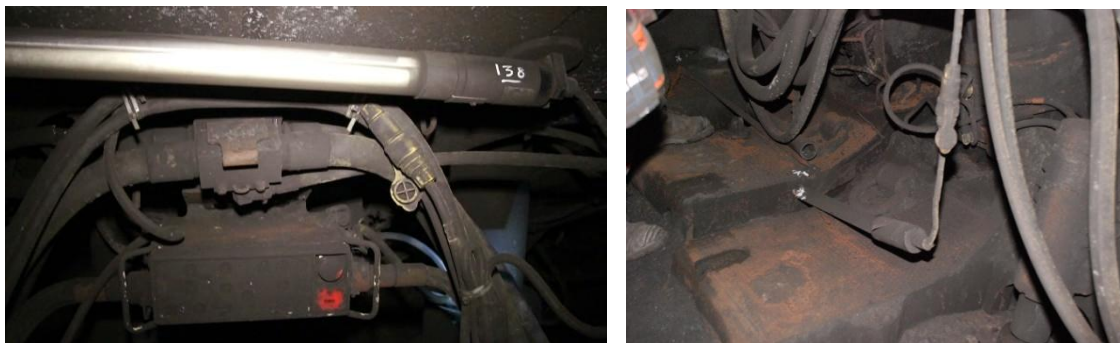
Figure 12. (LEFT) Fluorescent light hanging intact at Shield 138. (RIGHT) Fluorescent light, partially intact, but pulled off its mounts and down at Shield 74

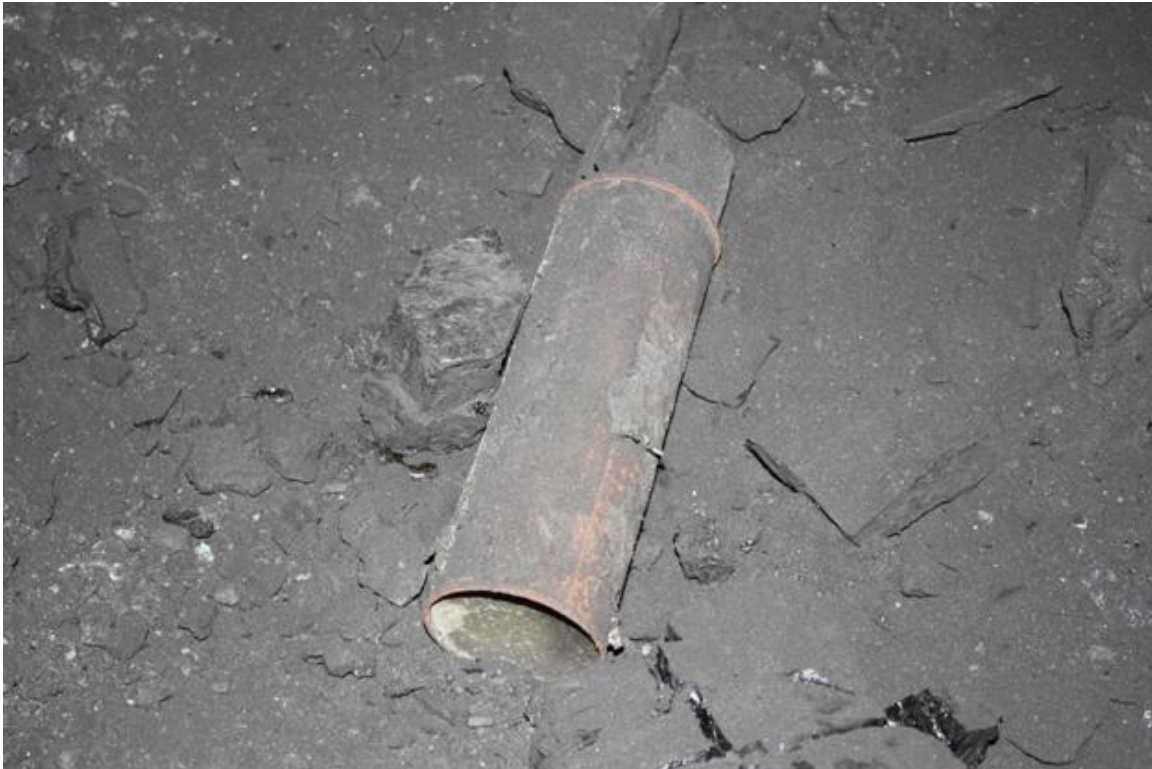
Figure 10. Spray can in crosscut 48 between entries 6 and 7 outby LW shearer View looking WEST.

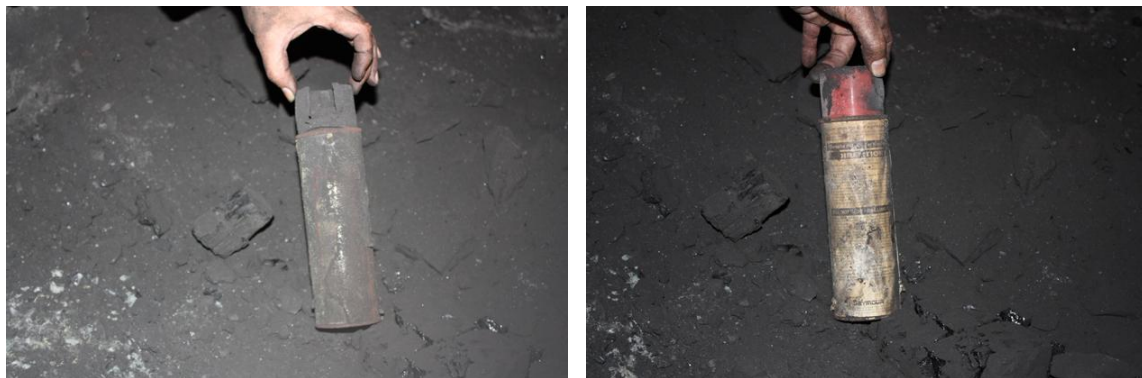
Figure 12. The paper label on the exposed side (LEFT) of the spray can is partially burned away, while the paper under the can is intact (RIGHT).
