**REPORT of INVESTIGATION
into the
MINE EXPLOSION at the
UPPER BIG BRANCH MINE**

APRIL 5, 2010

BOONE / RALEIGH CO., WEST VIRGINIA

**WEST VIRGINIA OFFICE of MINERS' HEALTH,
SAFETY & TRAINING**

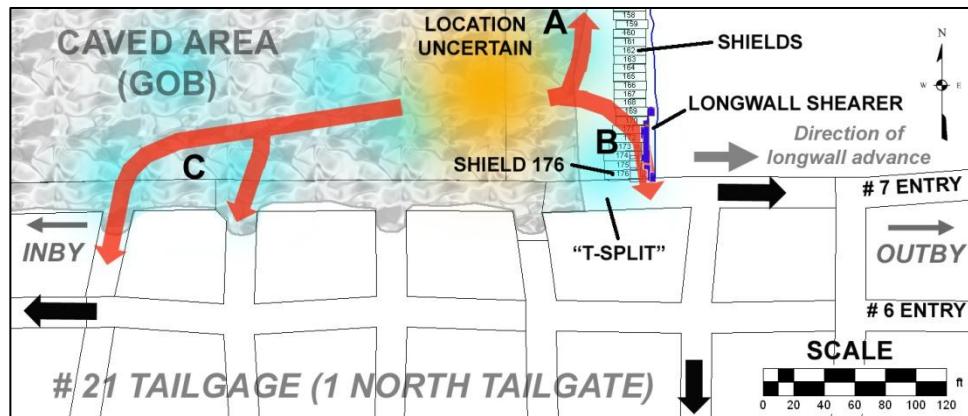
Figure 6: Evidence suggests the explosion began in the gob behind the longwall shields. RED arrows indicate the inferred path of the initial explosion. BLACK arrows show the initial paths of propagation once these forces found their way into #21 Tailgate. The actual ignition may or may not have occurred at the explosion origin.

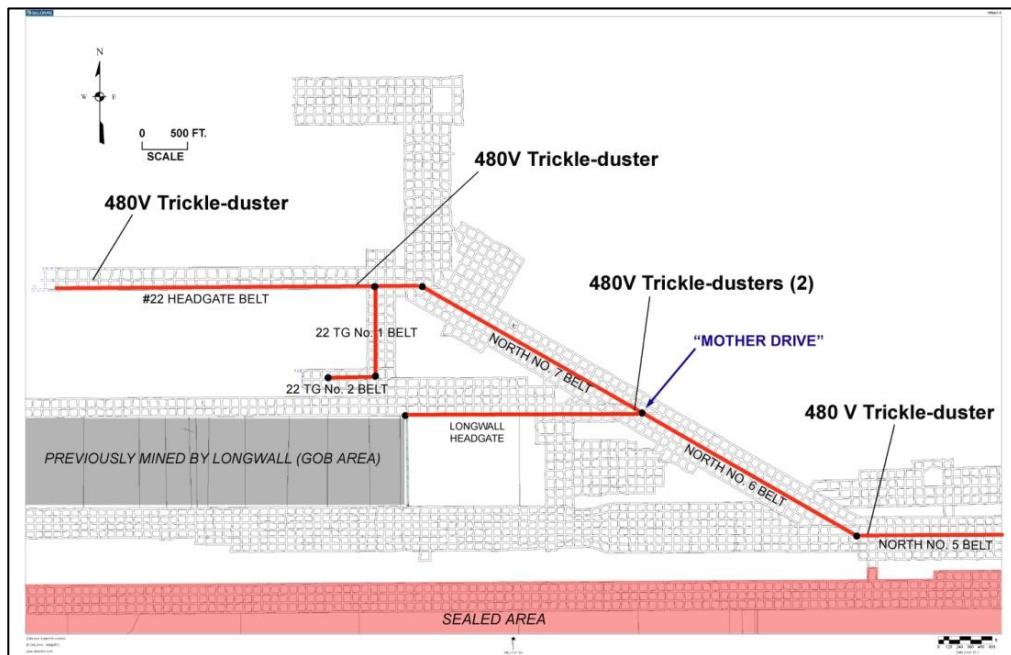
Another disturbing fact is that even though trickle rock dusters were placed near the Mother Drive, the #22 Headgate Drive and the 6 North Glory Mains Belt Drive, firebosses who traveled these areas on a daily basis routinely recorded in their examination books that these areas still needed additional rock dust (see **Figure 1**). These examination book entries were frequently carried over for days and even weeks at a time.

Figure 1. Location of “trickle dusters” found in the explosion area during the investigation.

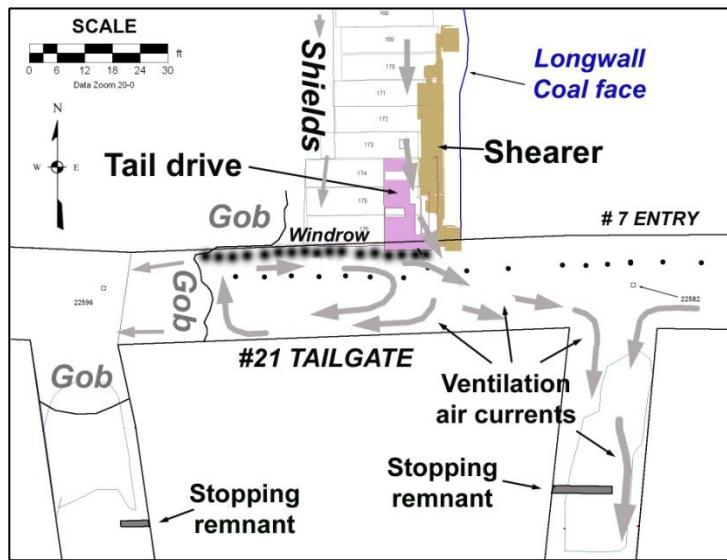
Figure 6. Junction of the Longwall with the #7 entry of #21 Tailgate. Normal ventilation path is blocked by gob.

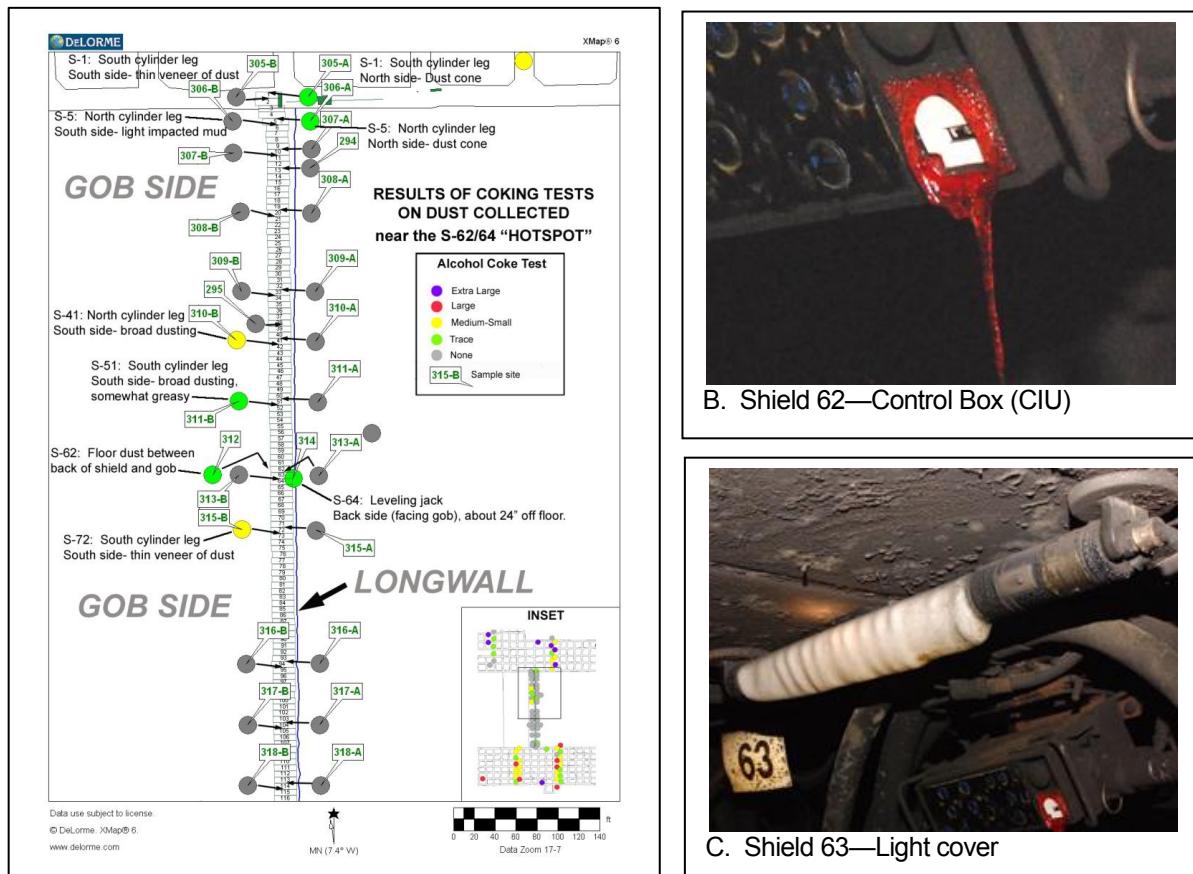
Figure 8. Except for the headgate and tailgate regions, coked dust inside the longwall was found only between shield 41 and shield 72, together with other indicators showing evidence of flame and heating at this location. (A larger map can be found in **Appendix 7.9-1, Map 4**).

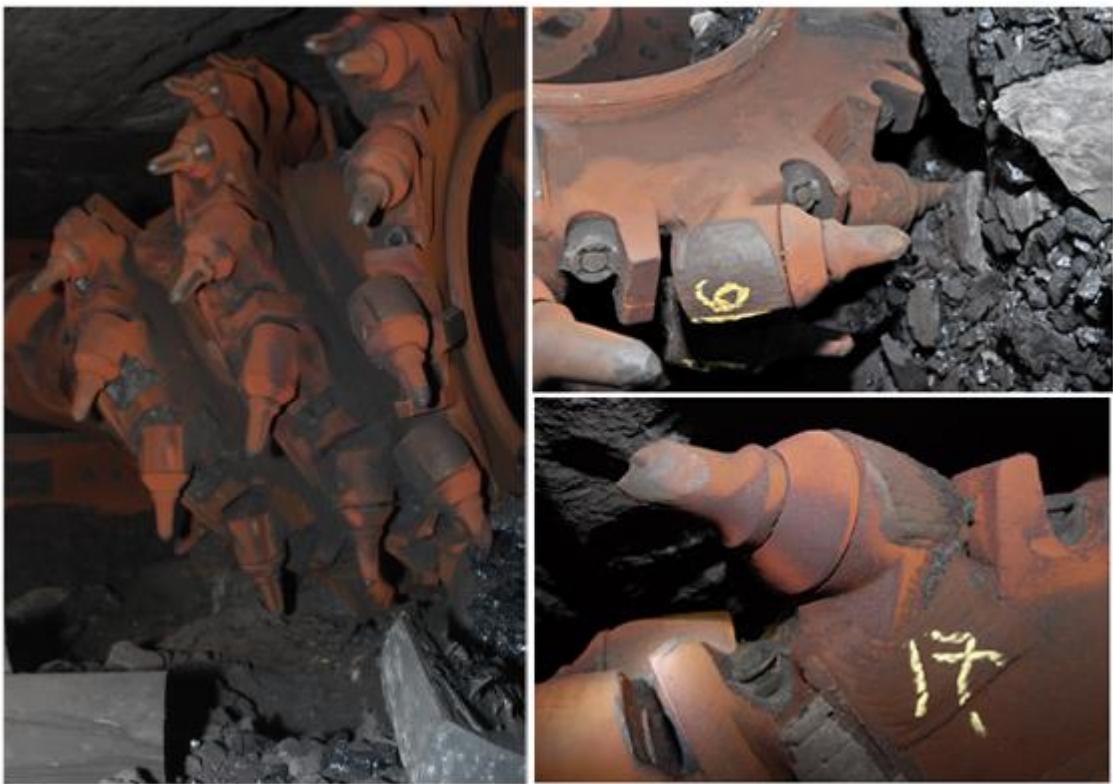
Figure 9: View of the tailgate shearer drum showing the cutter bits with tungsten-carbide tips. The bit lacing is designed to maximize the interactions of the bits as they cut away the coal and /or rock. Bits #16 and #17 are worn past most or all of their carbide tips.

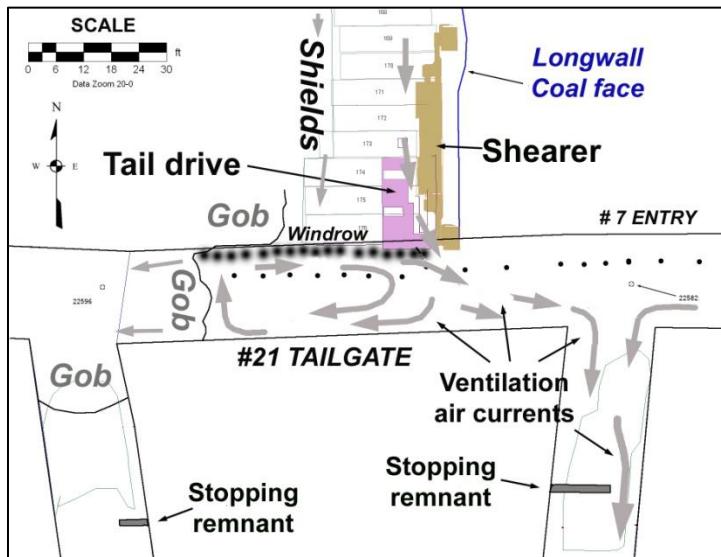
Figure 1. Junction of the Longwall with the #7 entry of #21 Tailgate. Normal ventilation path is blocked by gob.

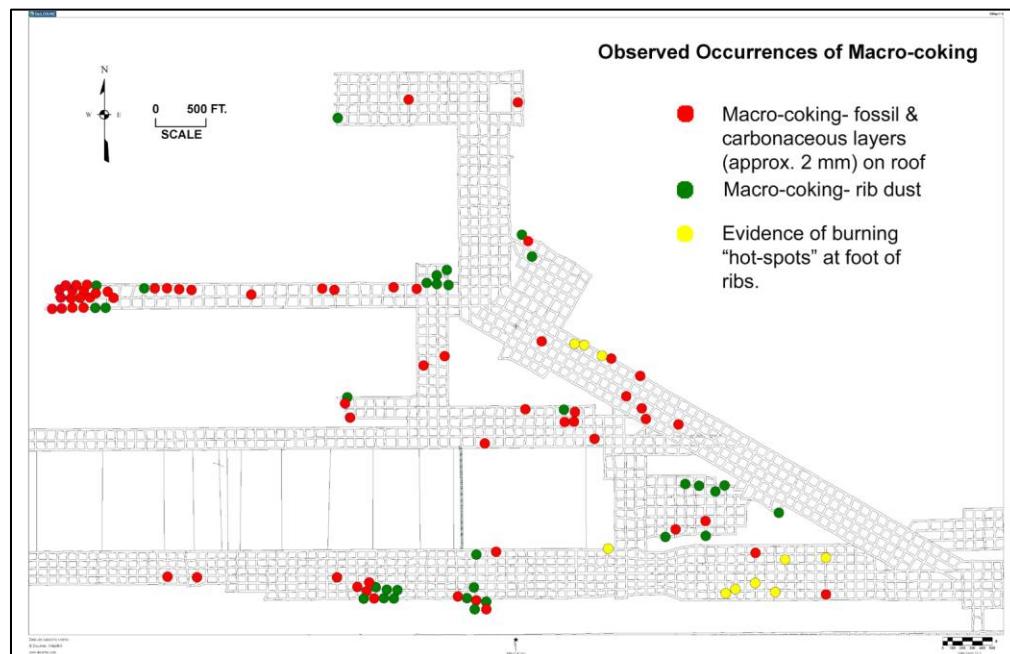
Figure 7: Locations where large amounts of coke and burning were found during the investigation.
