West Virginia Office of Miners' Health, Safety & Training

August 4, 2007

Fatal Underground Machinery Investigation Report
Rockhouse Creek Development Corp.
No. 8
Permit No. U-5002-04

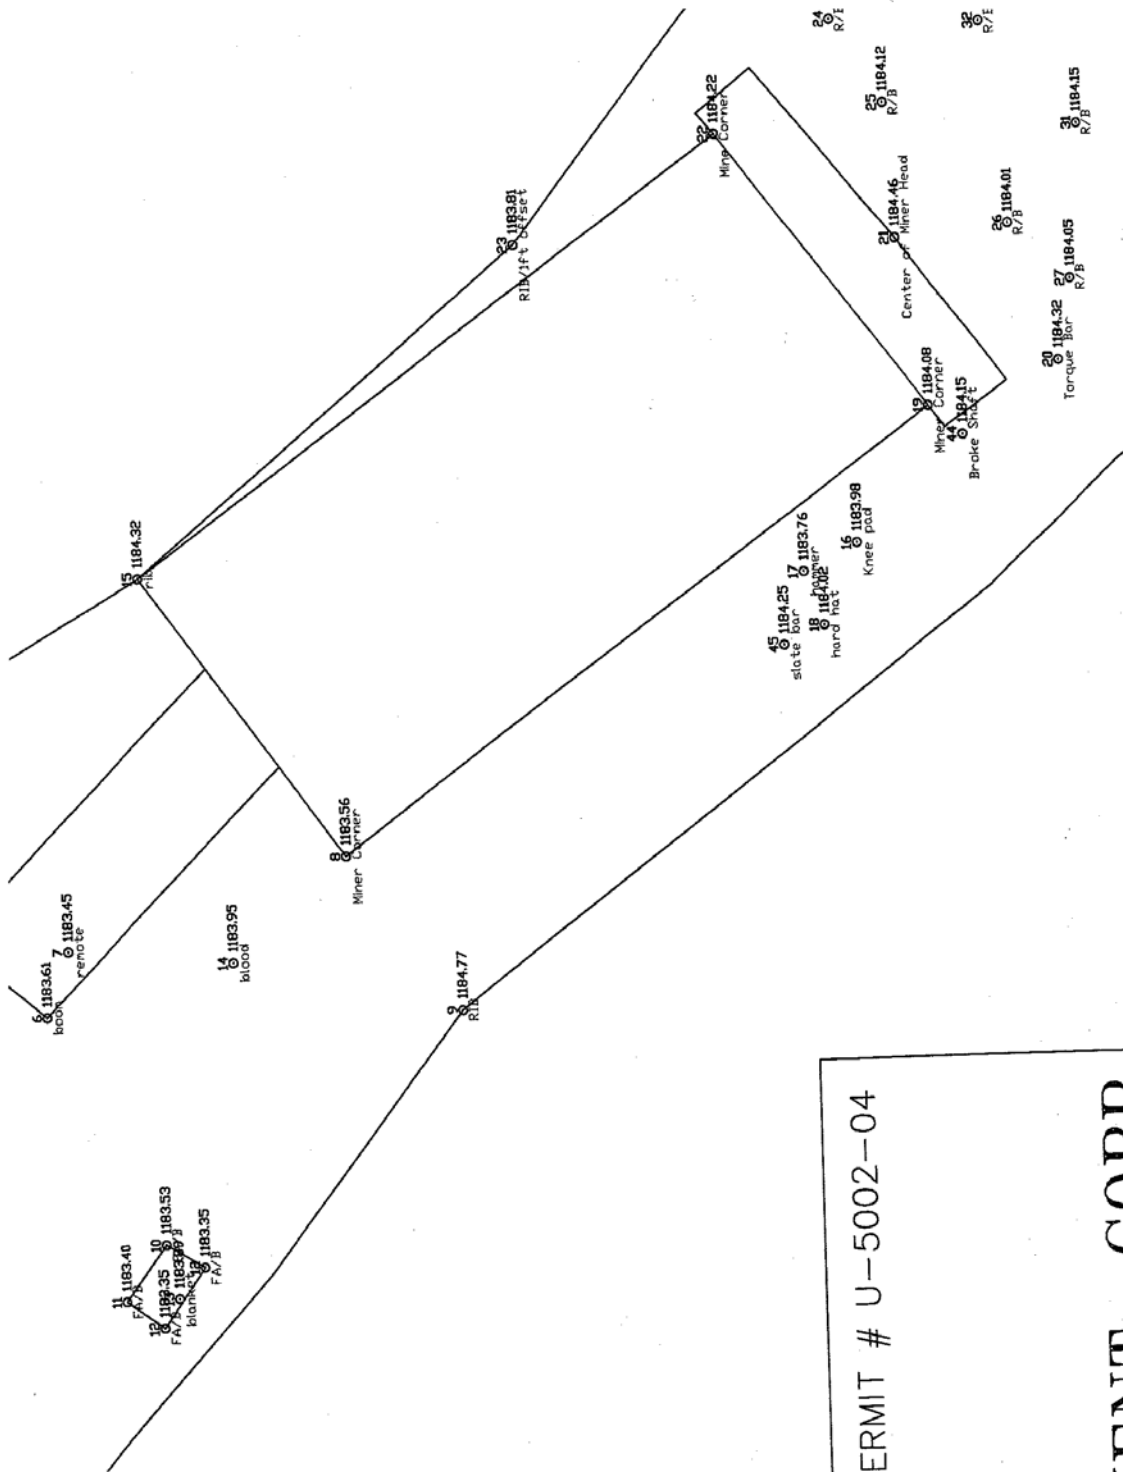
ERMIT # U-5002-04

Mr. Stevie J. Browning, Jr. was replacing a torque shaft for a Joy 14/15 continuous mining machine when he was fatally injured. One end of the torque shaft came out of the speed reducer and the other end remained attached to the cutter motor, causing the torque shaft to whirl around striking Mr. Browning.
