West Virginia Office of Miners' Health, Safety and Training

November 20, 2004

Highwall Failure Fatality Investigation Report
Independence Coal Company, Inc.
Red Cedar Surface Mine
Permit No. S-5030-97A

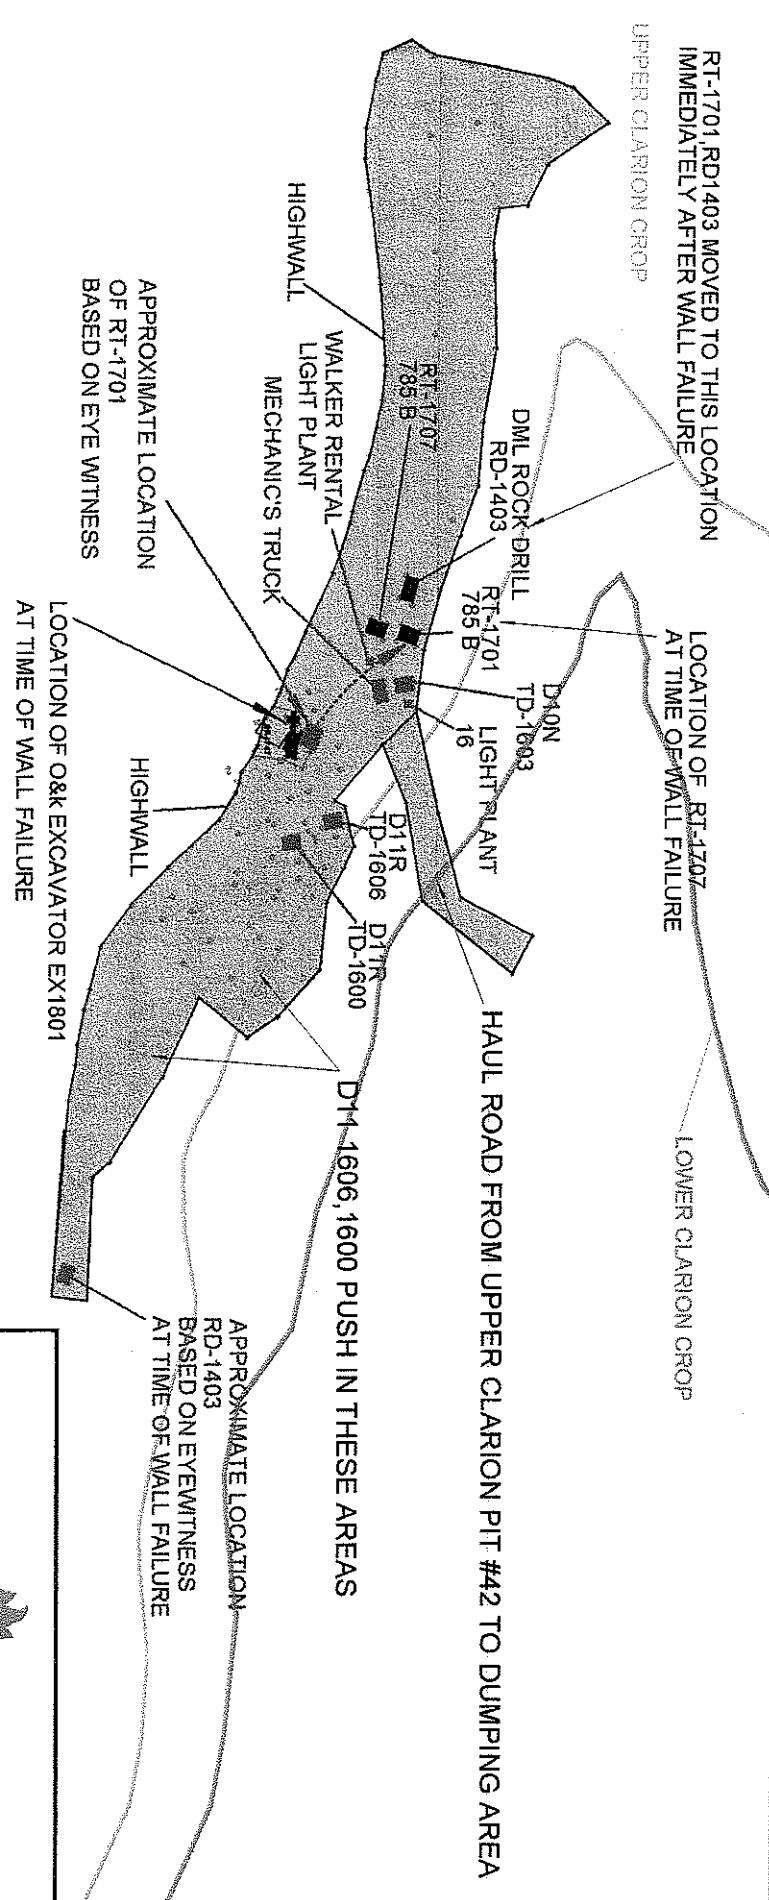
GLOVE SURFACE MINE
 UPPER CLARION BEAM
 POST ACCIDENT SCENE PIT AREA 42

O&K WAS APPROXIMATE 29.5 FEET FROM WALL AT TIME OF FAILURE

WALL HEIGHT IS 54.98 FEET FROM TOP OF PAD TO TOP OF WALL

APPROXIMATE LOCATION BASED ON EYEWITNESS

EQUIPMENT IN BLACK ARE SURVEYED LOCATIONS
EQUIPMENT IN BLUE ARE APPROXIMATE LOCATION BASED ON EYEWITNESS
