West Virginia Office of Miners' Health, Safety and Training

March 12, 2008

Report of a Preparation Plant Fatality
Workman Repair Service, Permit Number C-7619
Contractor for
Appalachian Fuels, LLC
Alloy Preparation Plant, L-829

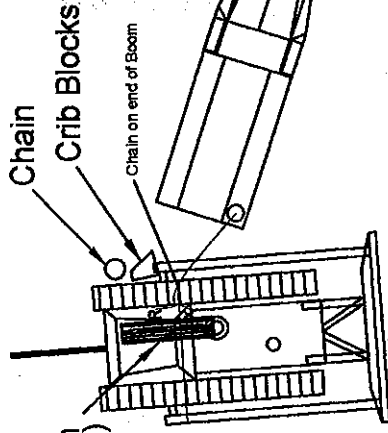
Appalachian Fuels, LLC
Alloy Prep Plant #1
MSHA ID # 46-07968
WV OMHS&T Permit # L-829
Fatal Accident Scene
March 12, 2008

Caterpillar
980 Loader
(Co. Unit # 02-9409)

Berm

Caterpillar
D-10 N Dozer
(Co. Unit # 01-1165)

Victim
(Approx Location)

Caterpillar
D-11 Dozer
(Co. Unit # 01-0356)

Mechanic Truck
Ford F-750
Owned by Victim

Chain
Crib Blocks
Chain on end of Boom

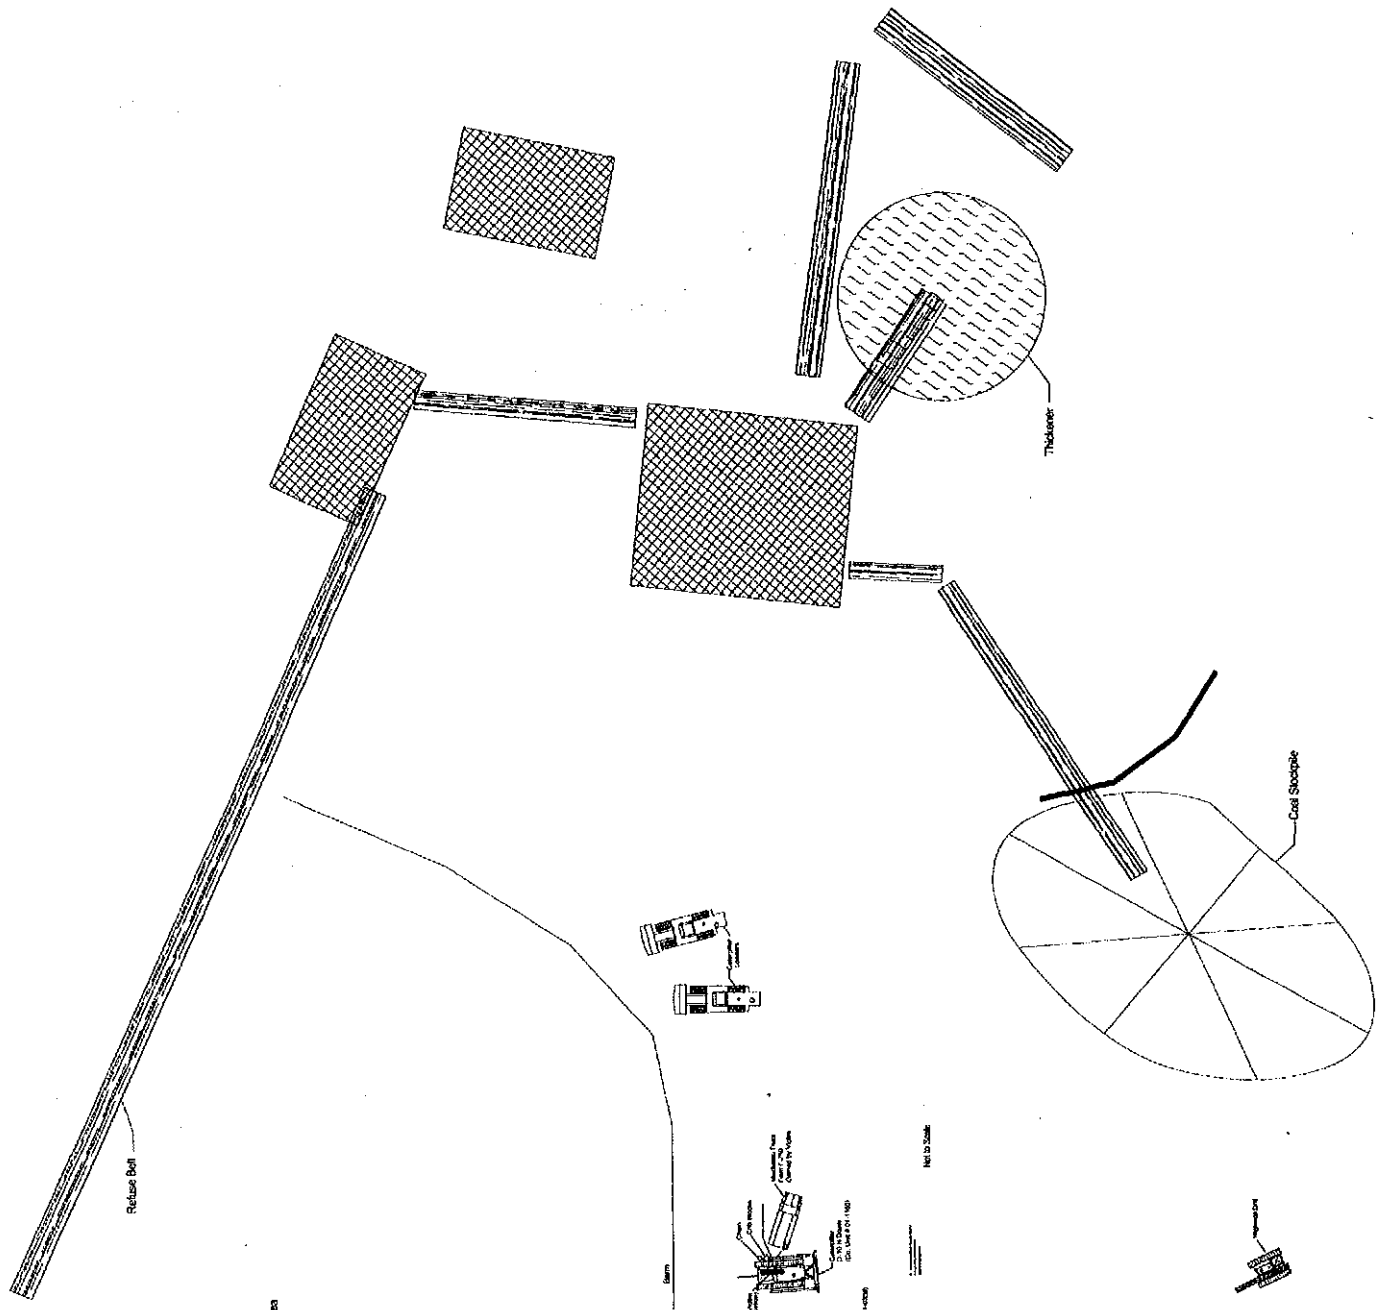
Appalachian Fuels, LLC
 Alloy Prep Plant #1
 MSHA ID # 46-07968
 WV OMS&T Permit # L-829
 Fatal Accident Scene
 March 12, 2008

R = Location of Winch Remote Control
X = Location of Air Winch
(approximate locations)
