West Virginia Office of Miners' Health, Safety and Training

July 1, 2010

Report of Investigation
Underground Coal Mine Fatality
(Haulage Accident)

White Buck Coal Company
Pocahontas Mine
Permit Number U00300705A

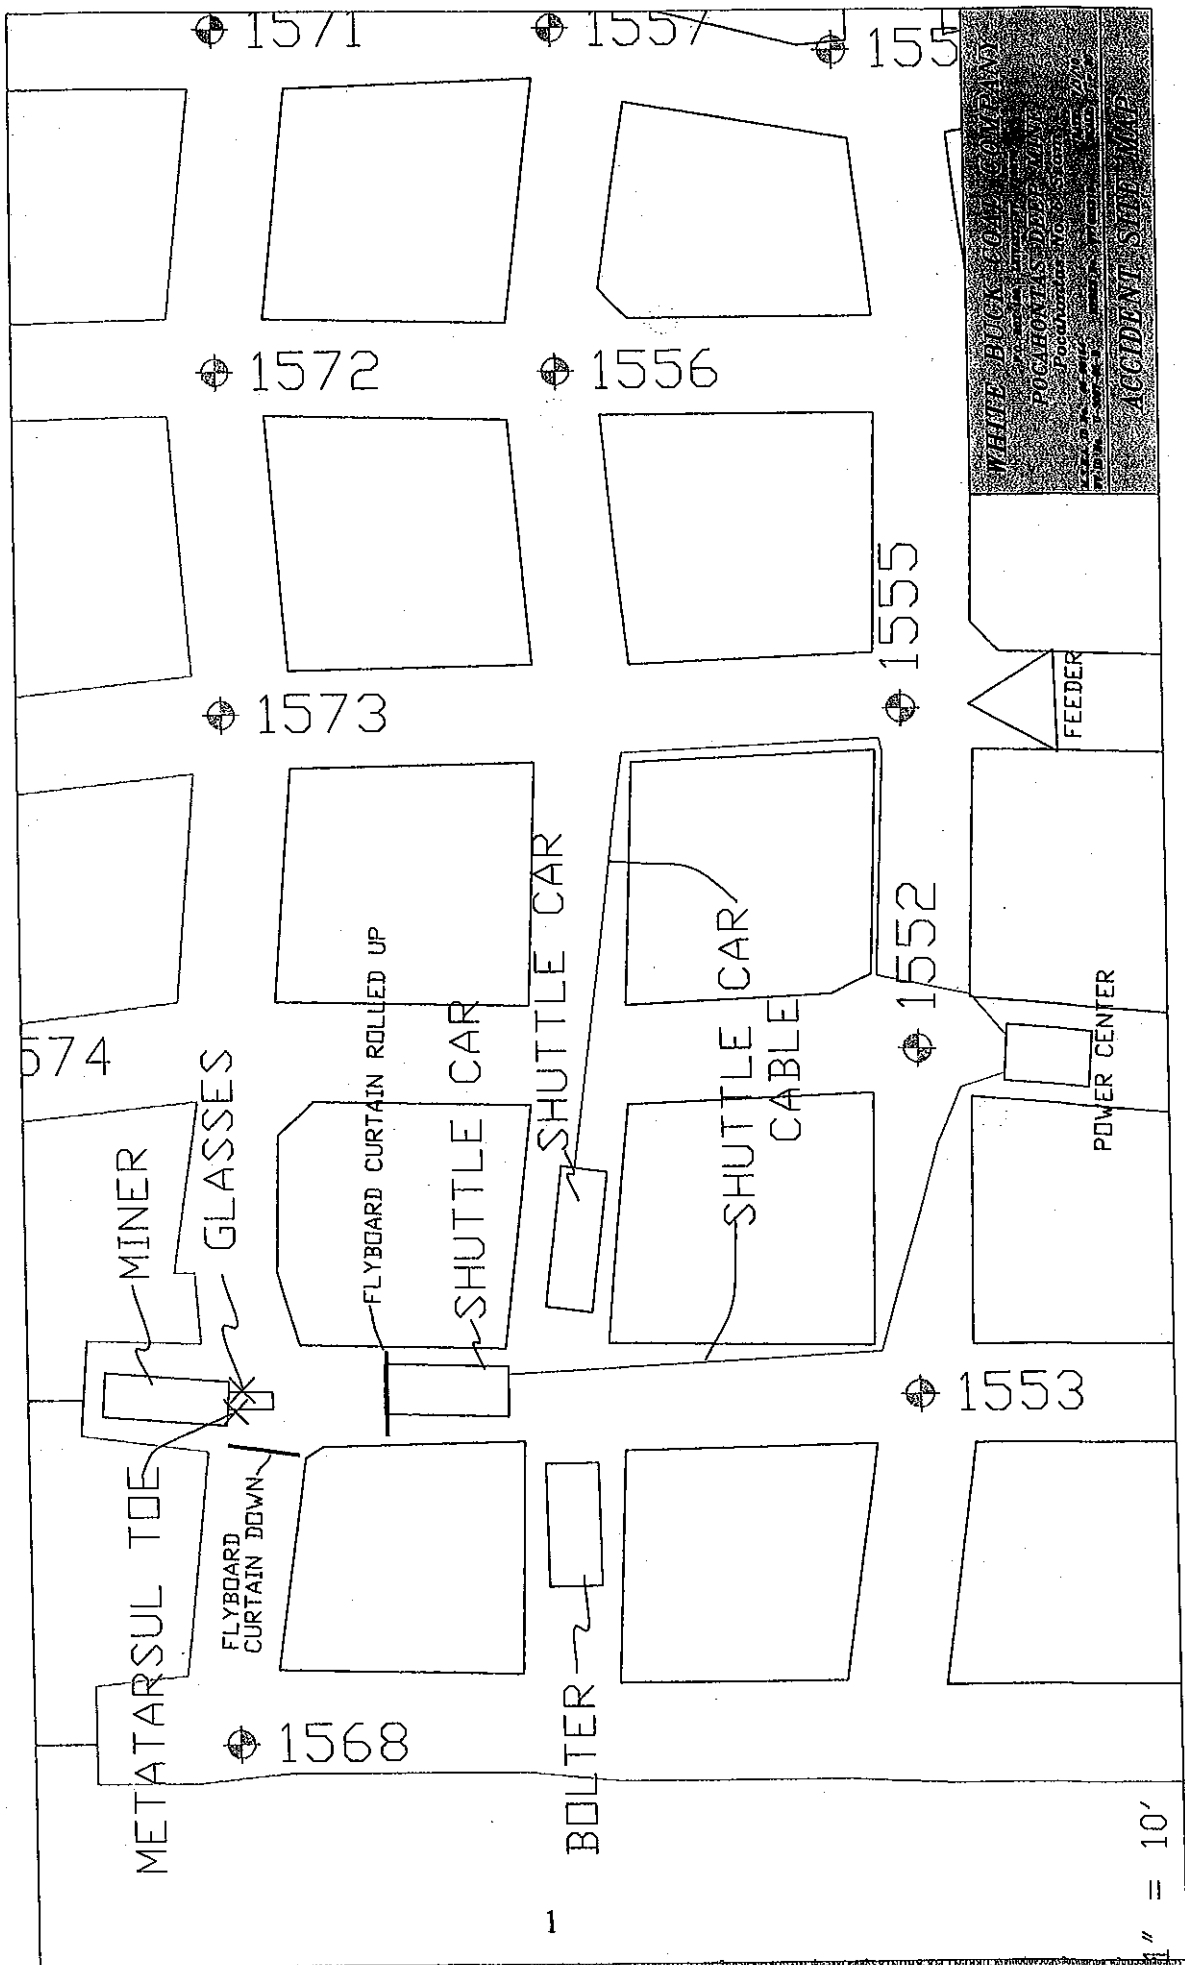
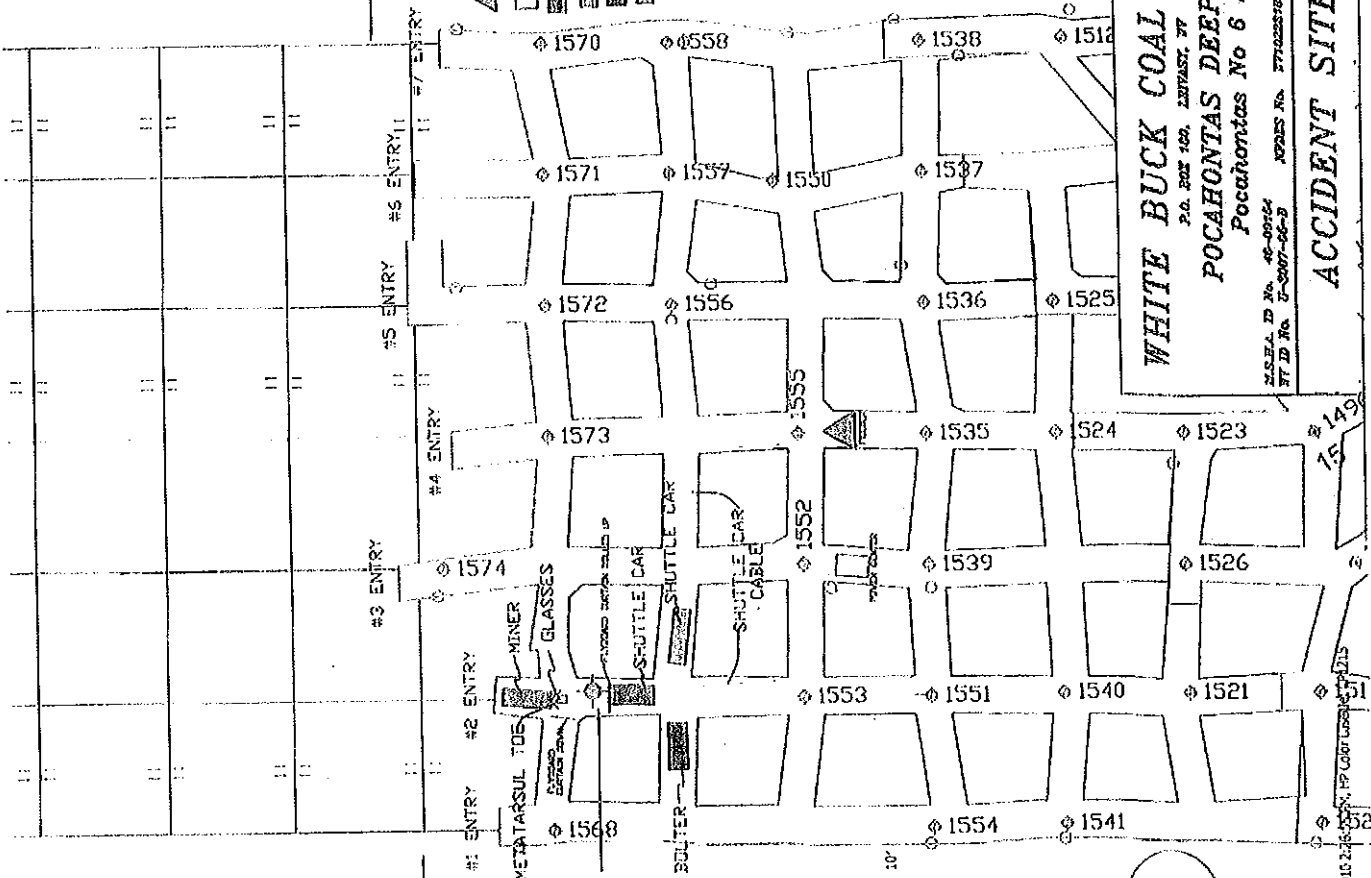
ACCIDENT SITE MAP

The victim was apparently struck from behind and run over as he was attempting to travel up the No. 2 entry within the shuttle car's path of travel. The operator of the shuttle car was unable to see him as he was approaching the continuous miner to be loaded.
