West Virginia Office of Miners' Health, Safety and Training

October 11, 2010

Report of Investigation
Underground Coal Mine Fatality
(Roof Fall)

Kingston Mining, Inc.
Kingston #1 Mine
Permit Number U00300496

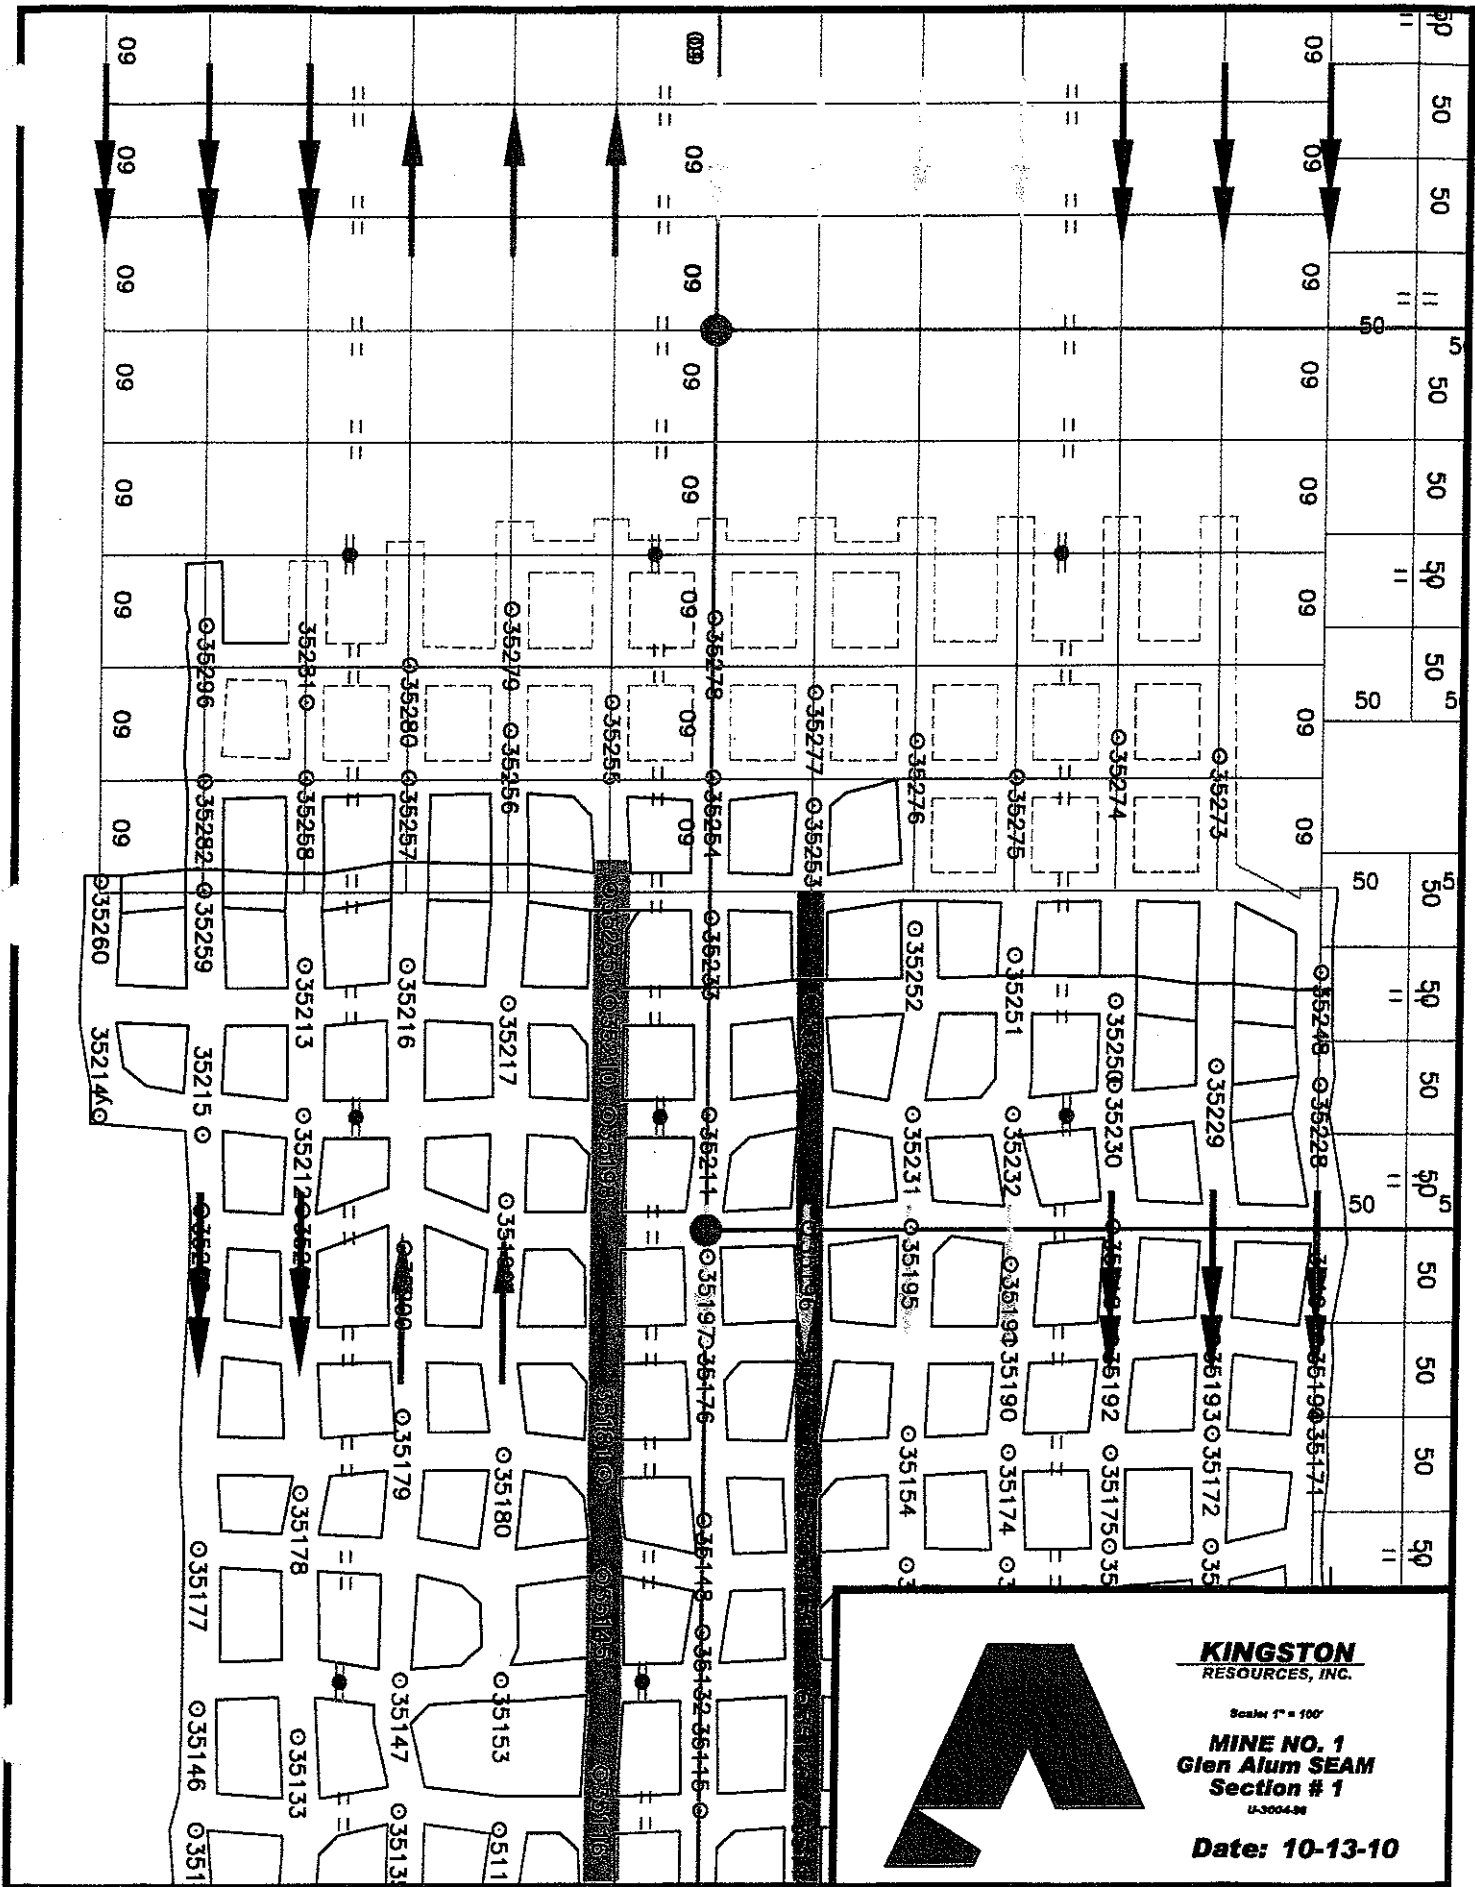
KINGSTON
RESOURCES, INC.
Scale: 1" = 5'
MINE NO. 1
Section # 1 MMU-001
Entry # 1 Detail
Date: 10-11-10

Deepest Point of Face

Bottom Step Down

Top Step Down

Mr. William Roger Dooley was fatally injured when he was struck by a piece of rock that fell from the vertical step area of the mine roof.

The approved roof control plan is not being complied with on the No.1 section in that roof bolt spacing between the 3rd and 4th rows outby the face of No. 1 entry, inby spad No. 35296, has three (3) of the four (4) bolts spaced lengthwise 56½ inches to 59 inches apart. The roof control plan only allows no more than 48 inches spacing lengthwise. A fatal accident has occurred to a roof bolting machine operator due to a large piece of draw rock falling out between these two rows of bolts.

1. When mining in face areas and abrupt vertical steps greater than twelve (12) inches occur in the mine roof, due to geological conditions or when reducing the mining height, the mine roof will be sloped or tapered from the upper horizon to the lower horizon to facilitate roof bolt installation in these areas.

2. In the event the areas defined in safety precaution No. 20 above can't be sloped or tapered and a vertical step of twelve (12) inches or greater exists, the vertical step shall be supported by installing mesh, wire screening, or straps that properly support the vertical step from the upper horizon to the lower horizon for the first row of bolts installed in the lower horizon. Roof bolts in the lower horizon shall be a suitable length to anchor at least two feet into the upper horizon for the first two rows of roof bolts installed in the lower horizon. In the event the mining height is too low for the primary supports being installed to anchor two (2) feet into the upper horizon, one row of cable bolts (4 per row) can be installed on cycle after each of the first two (2) rows of permanent roof bolts of normal length have been installed in the lower horizon.
