West Virginia Office of Miners' Health, Safety and Training

July 19, 2003

Report of an Electrocution Fatality
(Underground Coal Mine)

Performance Coal Company
Upper Big Branch Montcoal Eagle Mine
Permit No. U-3042-92

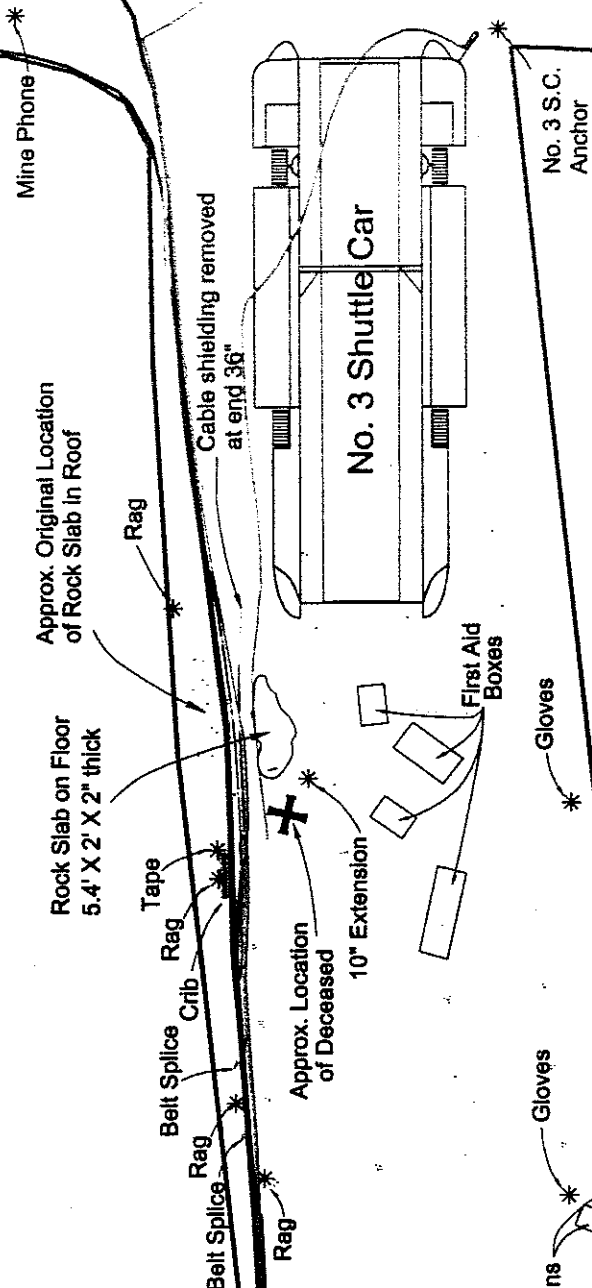
No. 3 Shuttle car
Cathead unplugged
and locked out

Note: This Sketch depicts the accident site after the recovery activities took place.

1. No. 3 shuttle car cable being worked on by the victim was de-energized and locked-out, but not tagged. The cable was cut in two at a temporary splice.
2. Muddy water, mud and wet conditions existed at the accident scene.
3. A three-phase, 460 volt AC # 2 AWG cable powered the No. 1 shuttle car. Two damaged places were found in the insulation of No. 1 shuttle car cable. Both damaged places were located near the accident scene and both leaked current when tested with a volt-ohm meter. Each damaged place on the cable exposed a different un-insulated phase conductor.
4. Several energized power cables were laying in the area where the accident occurred. They included the left miner cable, the feeder cable, the No. 1 shuttle car cable, and the No. 2 shuttle car cable. However, only the energized No. 1 shuttle car cable was damaged at the accident scene.

Mr. Rodney A. Scurlock, II was electrocuted when he contacted the exposed power source of the No. 1 shuttle car cable. The cable was energized in the area where he was working to repair the de-energized, locked-out No. 3 shuttle car cable.

1. Select a safe, dry work area at a location away from other power sources when performing any temporary or permanent cable repairs.
2. If a safe, dry work area is not available that is away from other energized power sources, then de-energize all other power sources in the work area before performing any temporary or permanent cable repairs.
3. All persons shall be retrained concerning the above recommendations.
