REPORT of INVESTIGATION
into the
SAGO MINE EXPLOSION
which occurred JANUARY 2, 2006
UPSHUR CO. WEST VIRGINIA

**WEST VIRGINIA OFFICE of MINERS' HEALTH,
SAFETY, AND TRAINING**
DECEMBER 11, 2006
RON WOOTEN, DIRECTOR

The cause of the explosion has been determined to be a methane explosion that occurred at 6:26 AM and 35 seconds behind the seals of the Old 2nd Left Section (sometimes referred to as Old 2nd Left Mains or even 3rd Left). Ten (10) mine seals built of Omega blocks to seal off this part of the mine from the active mine were completed exactly one year prior to the date of this report (December 11). It was 22 days after December 11, 2005 that an explosion involving up to 400,000 cubic feet of methane gas destroyed these seals. The effects of this blast—the dust, the smoke, the debris across the entries—resulted in entrapment of the men of Two Left Section, who perished there, with the exception of Randal McCloy. Also partly at fault were self-contained self rescuers that did not perform in the manner expected.

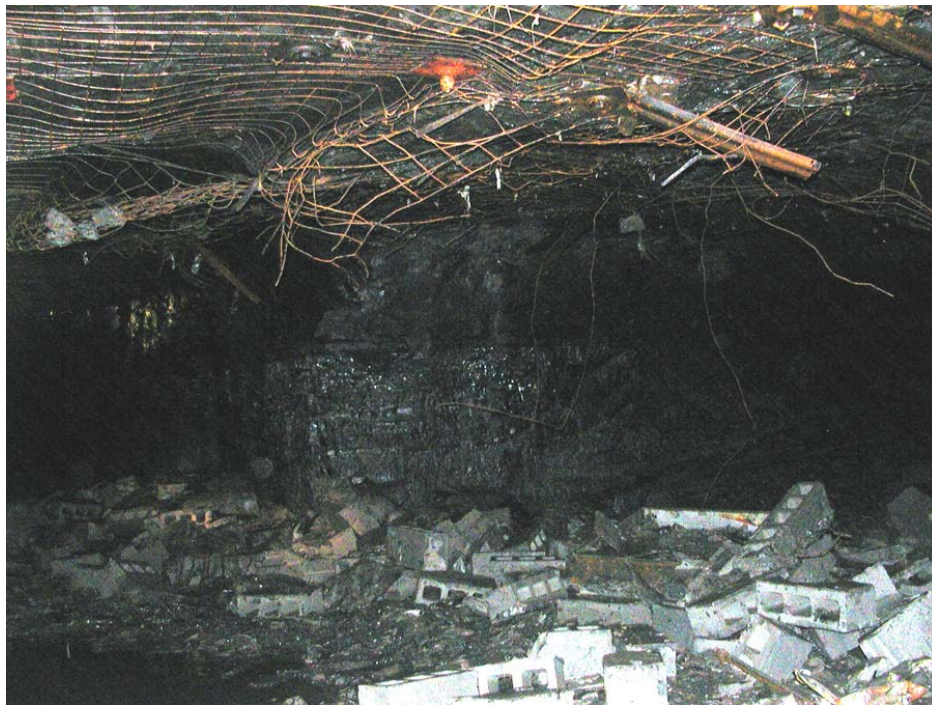
Photo 1 shows the remains of the second stopping outby from the waters edge knocked down in a southwesterly direction but with the individual 6” hollow-core cinder blocks substantially intact. The wire roof mesh was bent back in the same southwesterly direction and provided corroborating evidence from two or more features to show the dominant direction of the forces of the explosion at this location. Had the stopping not been at least partially submerged, it too would likely have been pulverized.

Photo 1. About 15’ outby spad 3716 (STA-2) in #2 entry. Stopping of 6” cinder block, down. Wire roof mesh partially down.

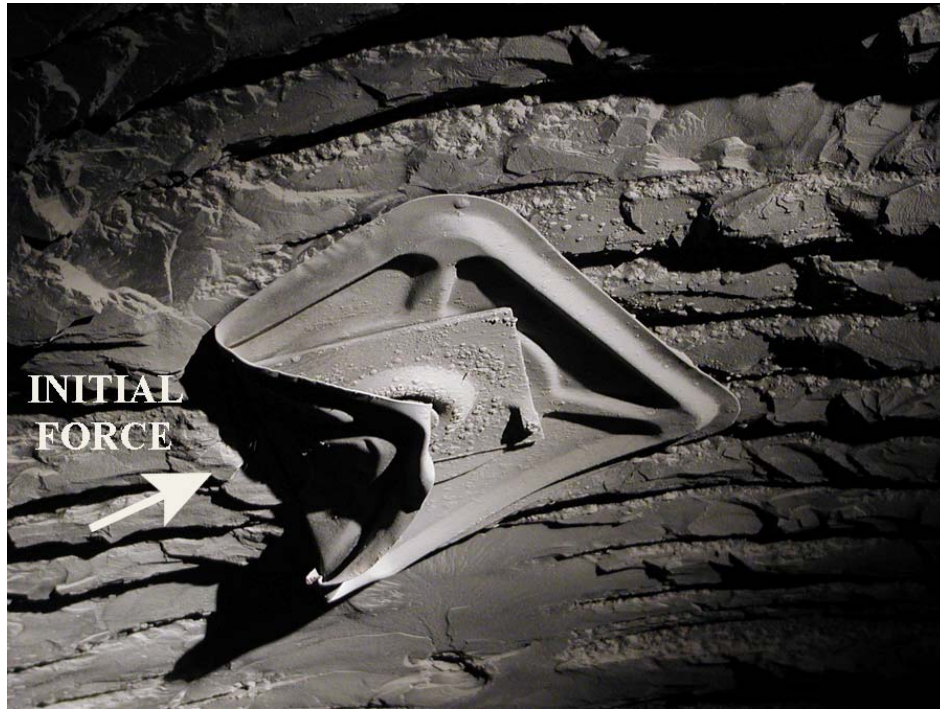
Photo 3. Simple plate bending of a roof pan in one direction. When neighboring pans also showed bending in the same direction this was plotted on the *Flames and Forces Map* as a single black arrow.

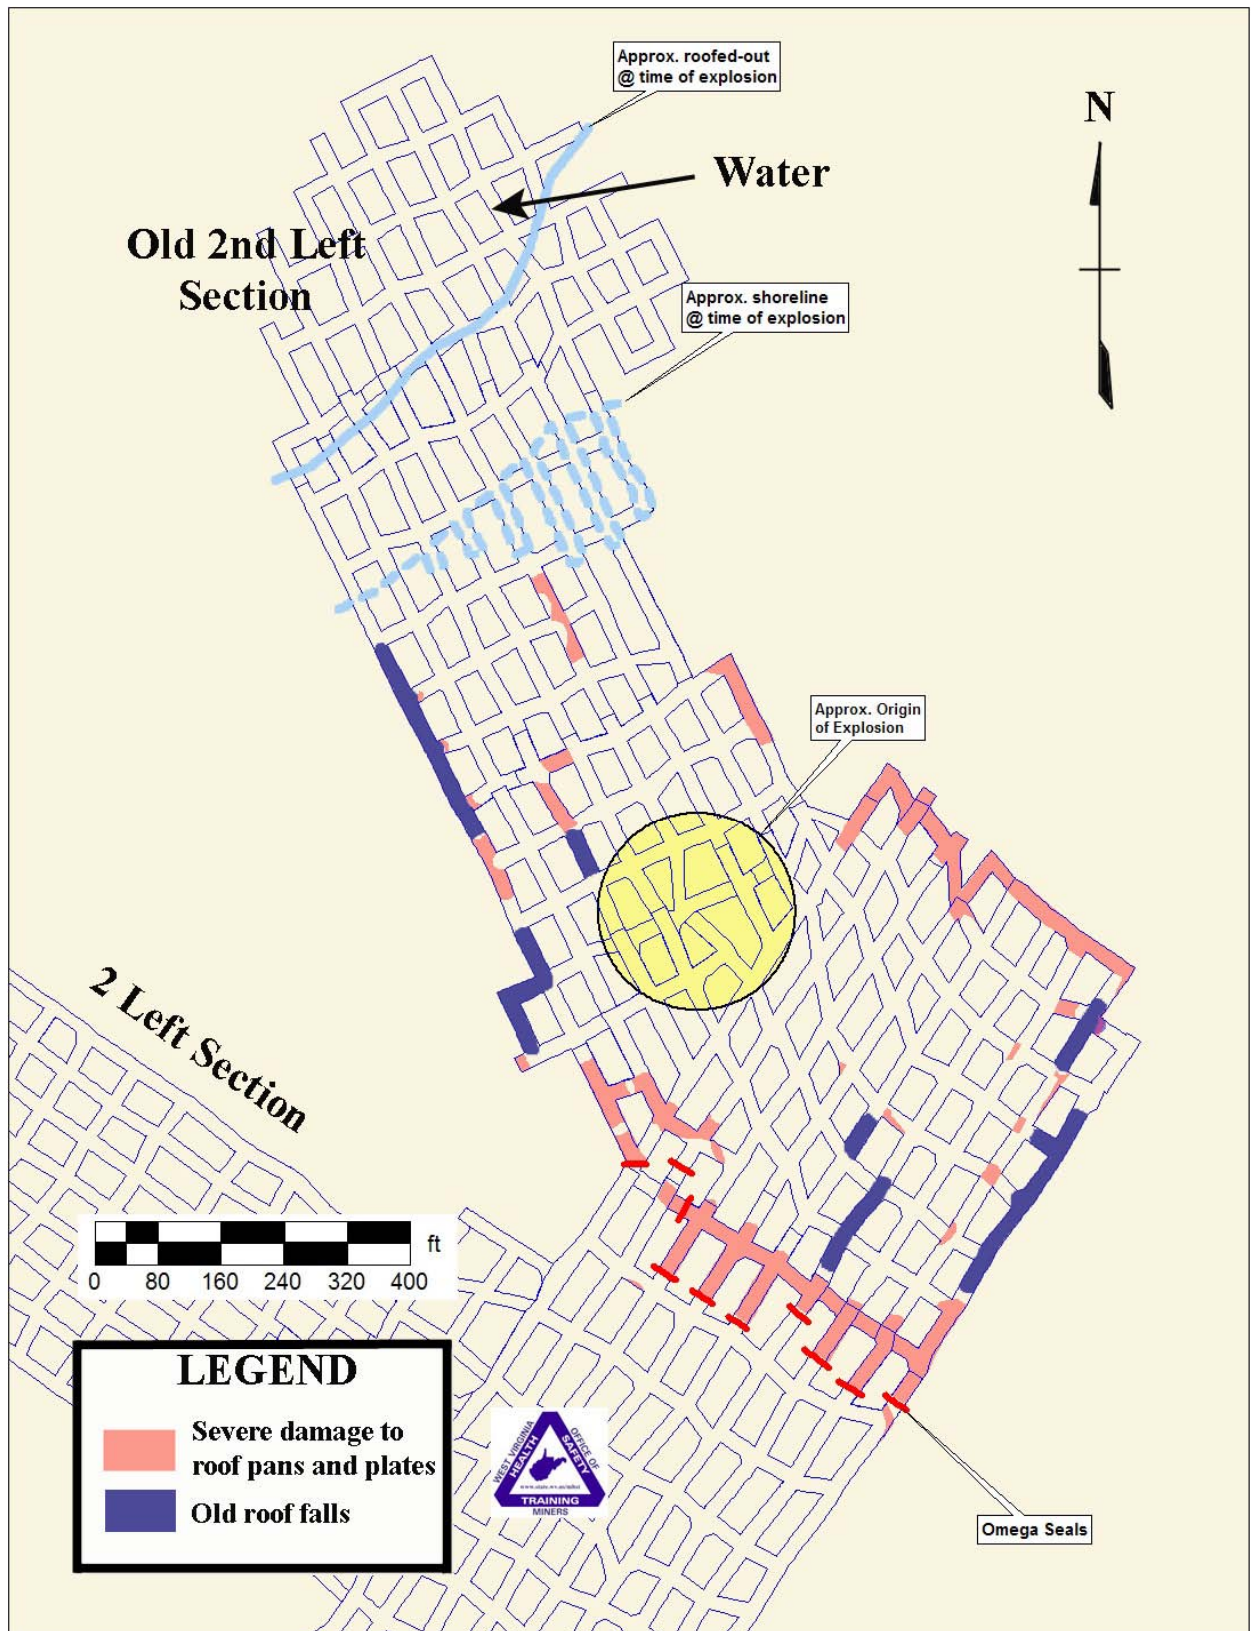
MAP 1. Areas where pan and plate deformation was severe were noted during the course of the mapping effort. These areas were all above the water pool, mostly where bottom-mining had not occurred, and where obstructions impeded blast propagation such as along the solid coal perimeter, next to existing (old) roof falls, and also at the seals themselves.

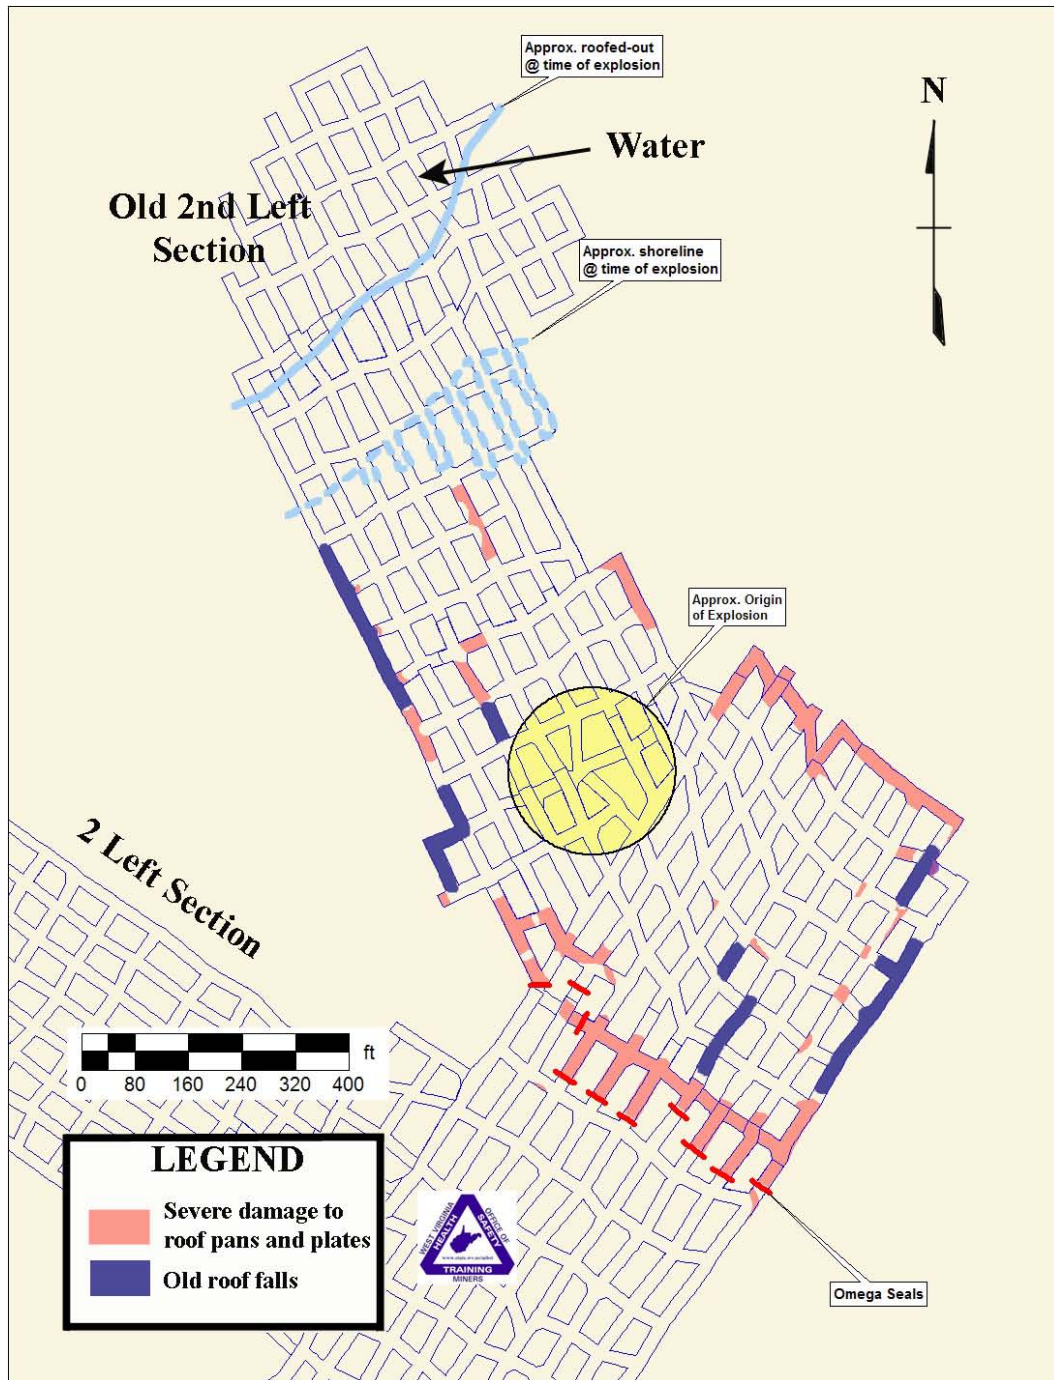
Figure 10. Areas or severe plate damage are viewed as indicators of high dynamic and reflected pressures. Areas shaded in red appear to indicate zones of encountered turbulence and/or obstruction in the path of the blast wave propagation.

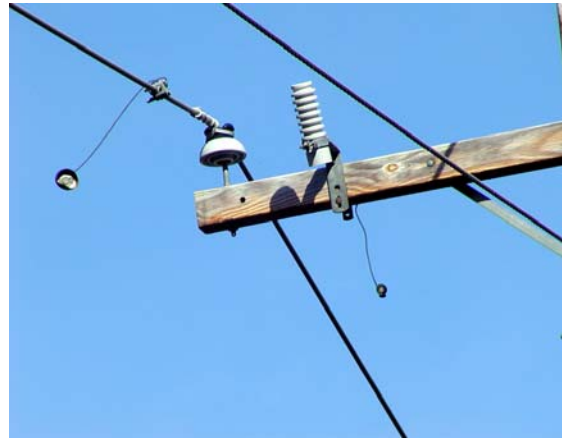
Photo 9. Damaged lightning arrester on the outside phase of the branch line feeding the Sago sub-station

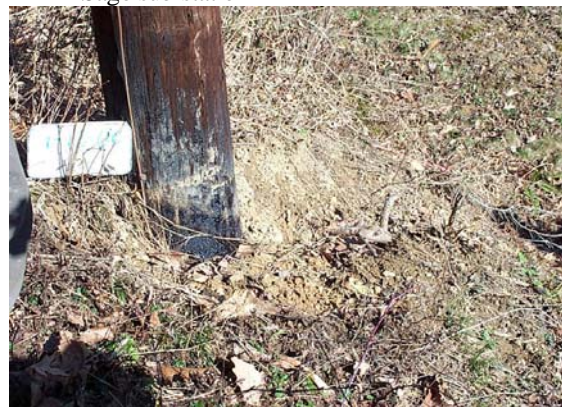
Photo 11. Disturbance at base of pole with the damaged insulators
