5.4 FLAMES and FORCES

5.4-1 Mapping of Explosion Forces

5.4-2 Origin of Explosion

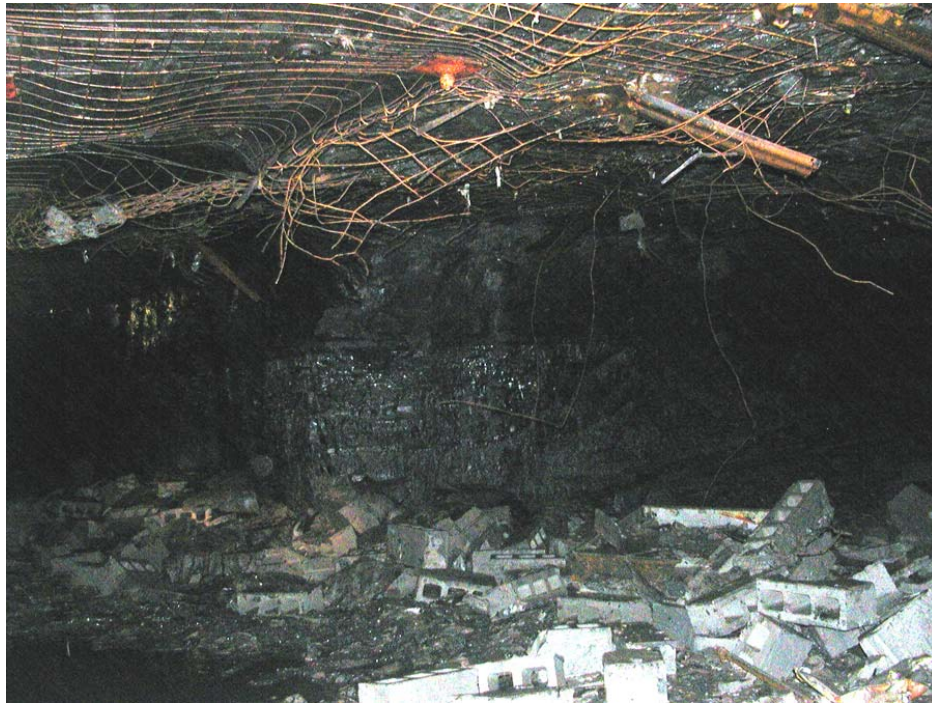
Photo 1 shows the remains of the second stopping outby from the waters edge knocked down in a southwesterly direction but with the individual 6” hollow-core cinder blocks substantially intact. The wire roof mesh was bent back in the same southwesterly direction and provided corroborating evidence from two or more features to show the dominant direction of the forces of the explosion at this location. Had the stopping not been at least partially submerged, it too would likely have been pulverized.

Photo 1. About 15’ outby spad 3716 (STA-2) in #2 entry. Stopping of 6” cinder block, down. Wire roof mesh partially down.

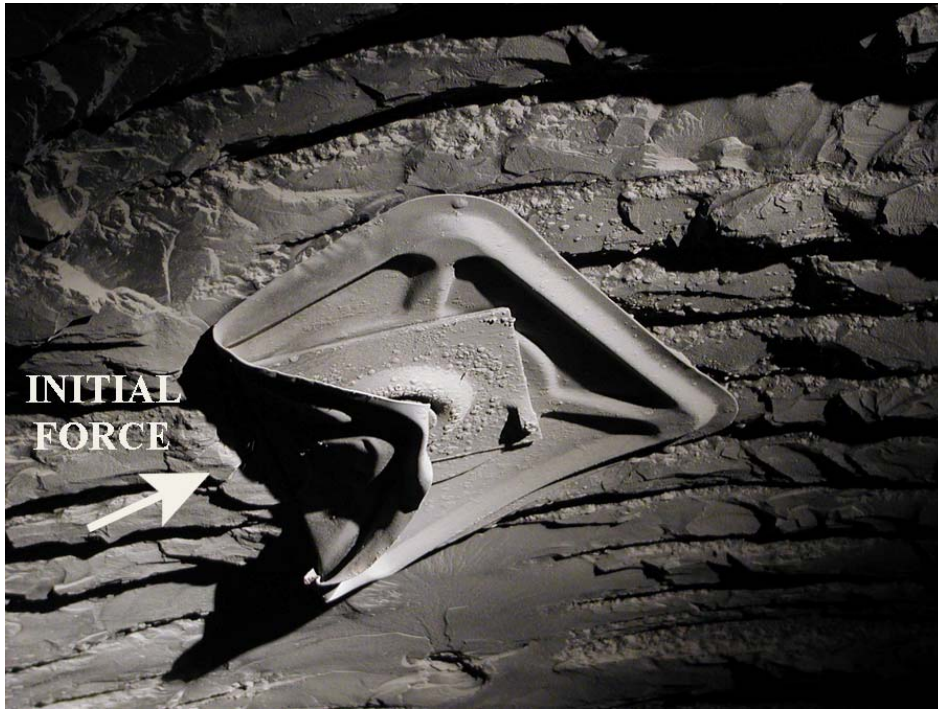
Photo 3. Simple plate bending of a roof pan in one direction. When neighboring pans also showed bending in the same direction this was plotted on the *Flames and Forces Map* as a single black arrow.

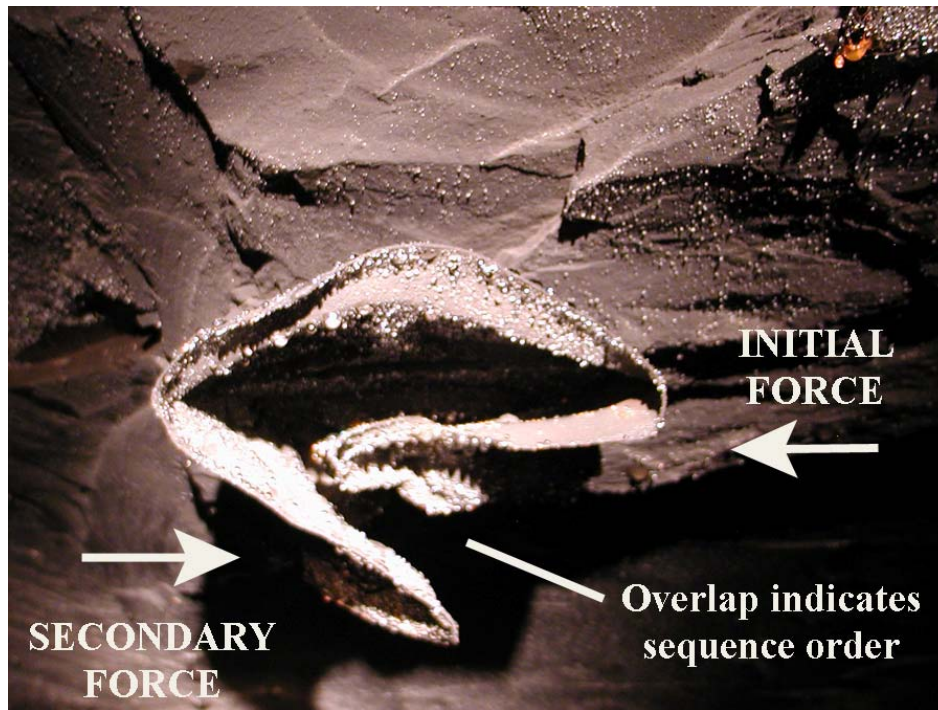
Photo 4. The relative order of initial and secondary pressure waves was interpreted in this example to be from the right, then the left, respectively, based on the overlapping sequence of the pan ends.

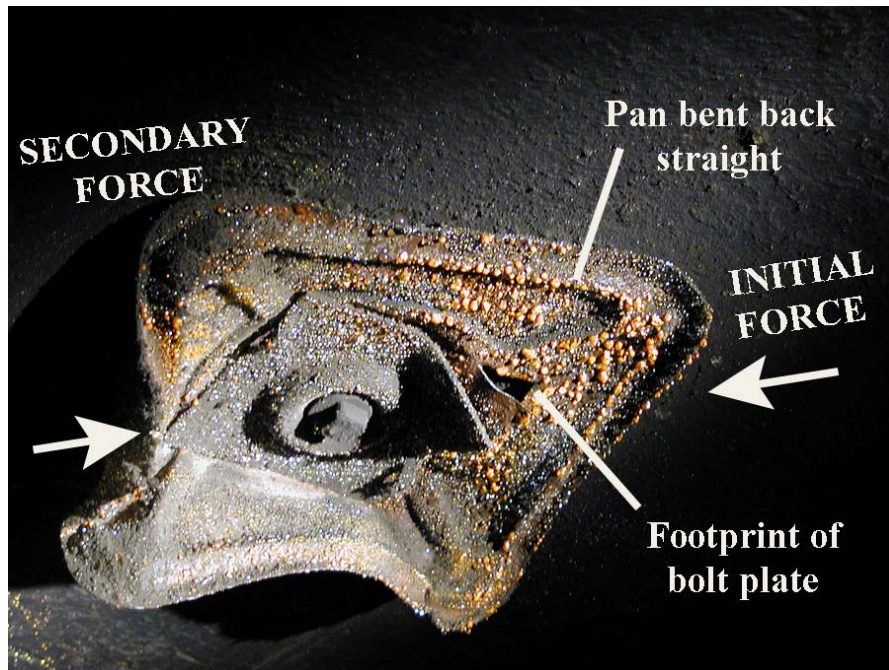
A variation of this interpretation of bending morphology is shown in **Photo 5**. Here, there is one direction of bending at first glance but on the side-opposite the bent left edge of the pan the corner of the bolt plate is bent to nearly 90° -- with a hole punched into the roof pan with the same shape and location as the bolt plate—which showed that it had been originally bent together with the bolt plate from the opposite direction (right to left). A secondary wave subsequently straightened the pan back to being flush with the mine roof (forces acting left to right) but left the bent edge of the bolt plate at its original 90° deflection. This type of pan bending morphology was fairly common. Evidently, a primary pressure wave from the right was followed by a secondary pressure wave from the left.

Photo 5 also indicates another complicating factor in that reflections from nearby solid vertical surfaces (such as a solid coal rib or a ledge of uneven roof) can produce localized variations in the bending. In this case the bent edge not identified by an arrow is the edge closest to the coal rib. This bend is likely an effect of local reflections off the coal rib.

Photo 5. Initial forces bent the right side of this pan and bolt plate, leaving a footprint in the pan where the edge of the bolt plate punched through. This was followed by a secondary set of forces coming from the opposite direction which pushed the bolt plate back flush to the roof but leaving the corner of the bolt plate as originally bent.

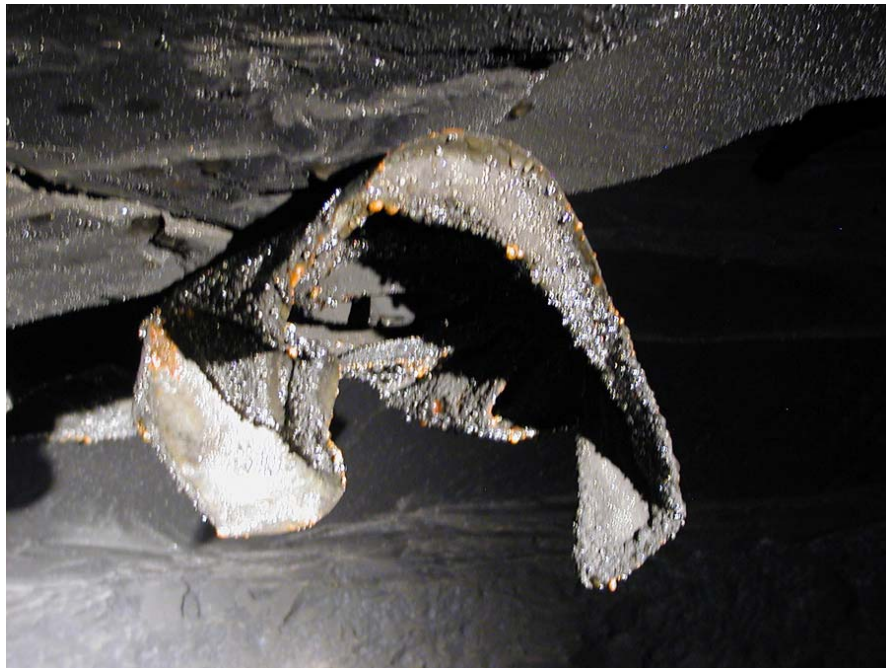
Photo 6. An example of a severely deformed roof pan ("spider plate") that was found in the #9 entry just inby Seal #10. This is typical of the degree of bending and damage found between the seals and just after the first line of crosscuts inby the seals. This type of damage was also found in other areas of the mine where there were significant obstructions and where there was first-mining only (no "bottom-mining" done on retreat).

A special category of pan deformation included roof pans that were severely deformed in all directions around the bolt-head⁵. This type of plate bending was found in areas where turbulence and physical barriers to the propagation of the blast forces existed, such as gob piles, dead-heads against solid coal ribs, etc. An example of this is shown in **Photo 6**.

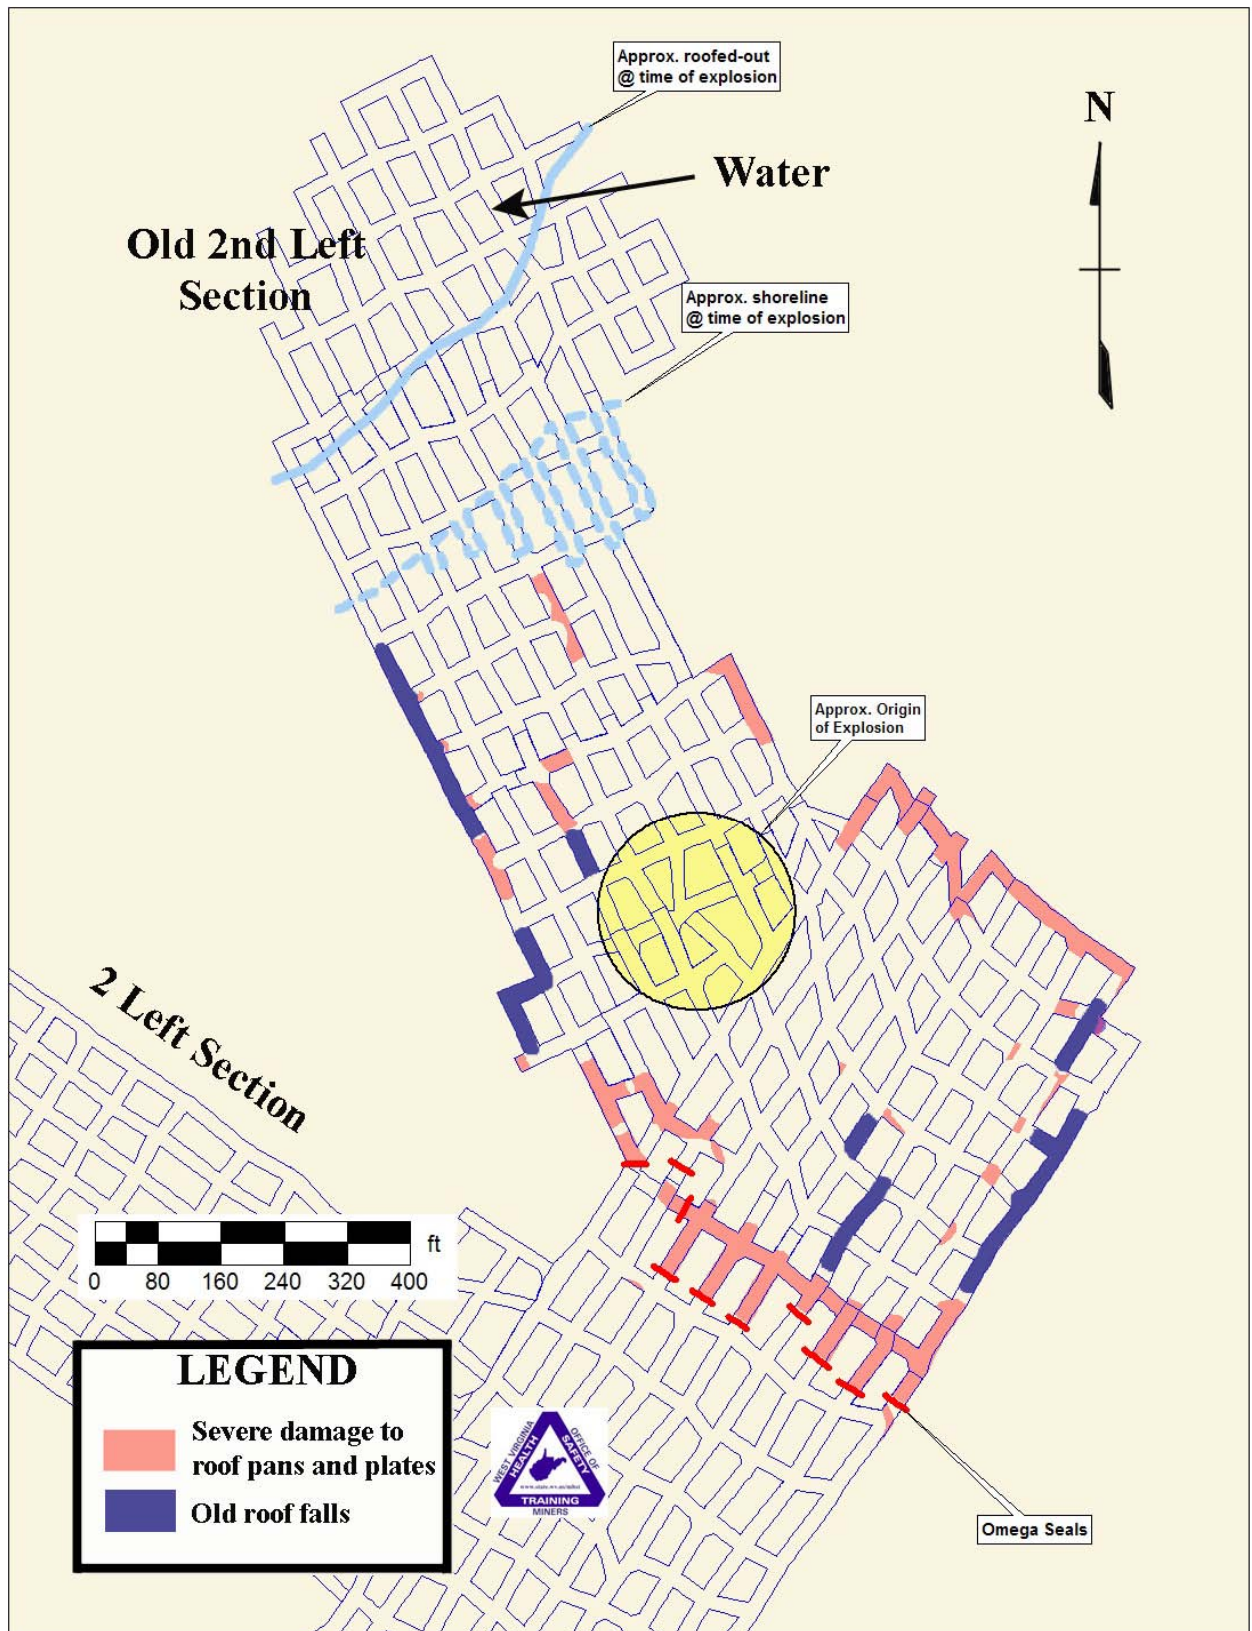
MAP 1. Areas where pan and plate deformation was severe were noted during the course of the mapping effort. These areas were all above the water pool, mostly where bottom-mining had not occurred, and where obstructions impeded blast propagation such as along the solid coal perimeter, next to existing (old) roof falls, and also at the seals themselves.

It should be noted that there were many examples of pans and plates that showed less damage interspersed with these examples of high damage. Clearly, local turbulence played an important role in the type and severity of pan/plate deformation.

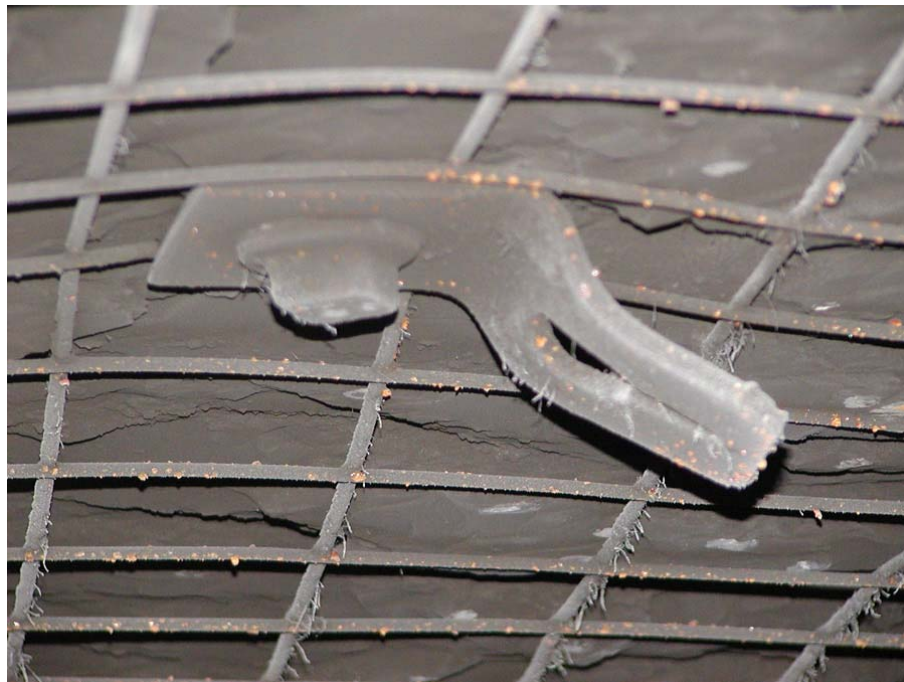
Photo 7. An example of a bent belt hanger, which were usually bolted directly to the mine roof with no pan underneath. Their purpose is to provide an anchor point to hook chains to suspend the conveyor belt structure. This is a smaller version of the 4" x 4" belt hanger flanges that were typically used throughout the mine. Originally the angle of the flange was 90° (+/- 1 degree). This bending was studied as another source of information to interpret blast force direction and magnitude.

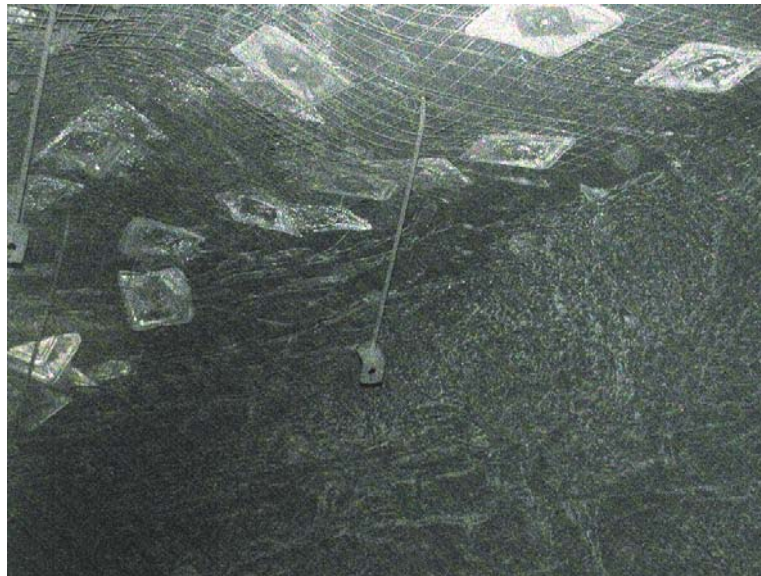
Photo 8. Occasionally, belt hangers were suspended from roof bolts when the height of the mine roof was excessive. In this case, either the last pressure wave or the most forceful pressure wave left these structures bent as shown.

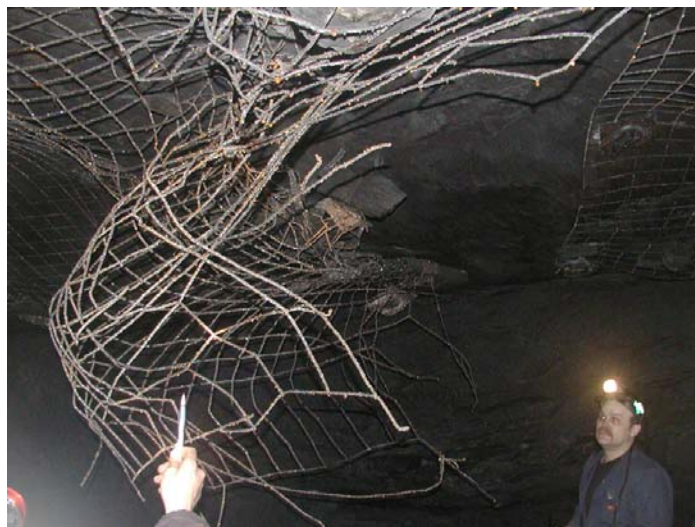
As mentioned previously the wire roof mesh was also used as an indicator of the direction of explosion forces. Often a sense of the primary blast direction could be discerned from the deformation it sustained. An example of this is shown in **Photo 9**.

Photo 9. Wire roof mesh used as an indicator to establish apparent direction of blast forces propagating toward the top end of Old Second Left Section. Photo taken at location STA-3 on *Flames and Forces Map* (Appendix 5.4-1): view facing approximately N 40° E.

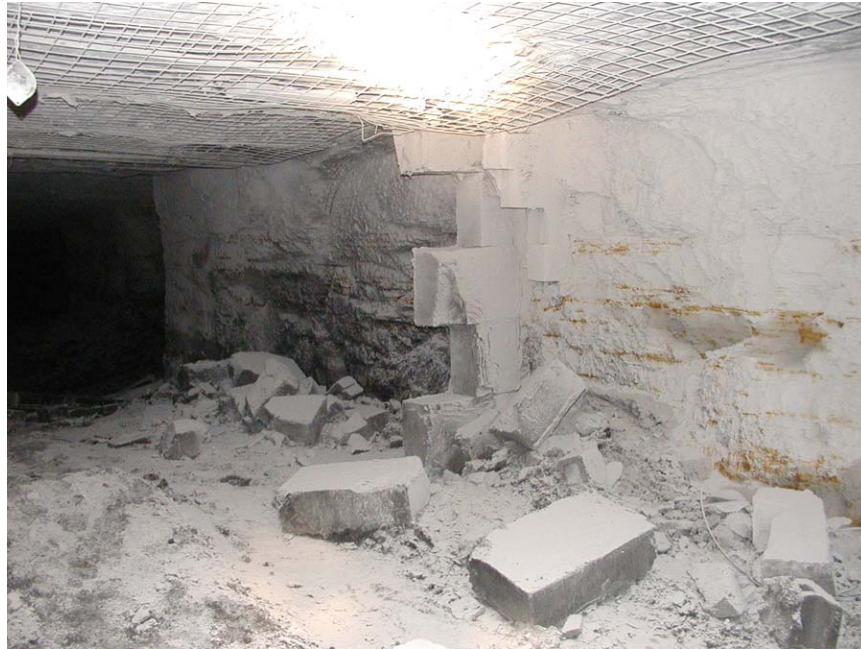
Photo 10. Remnants of a stopping in an area outby the seals.

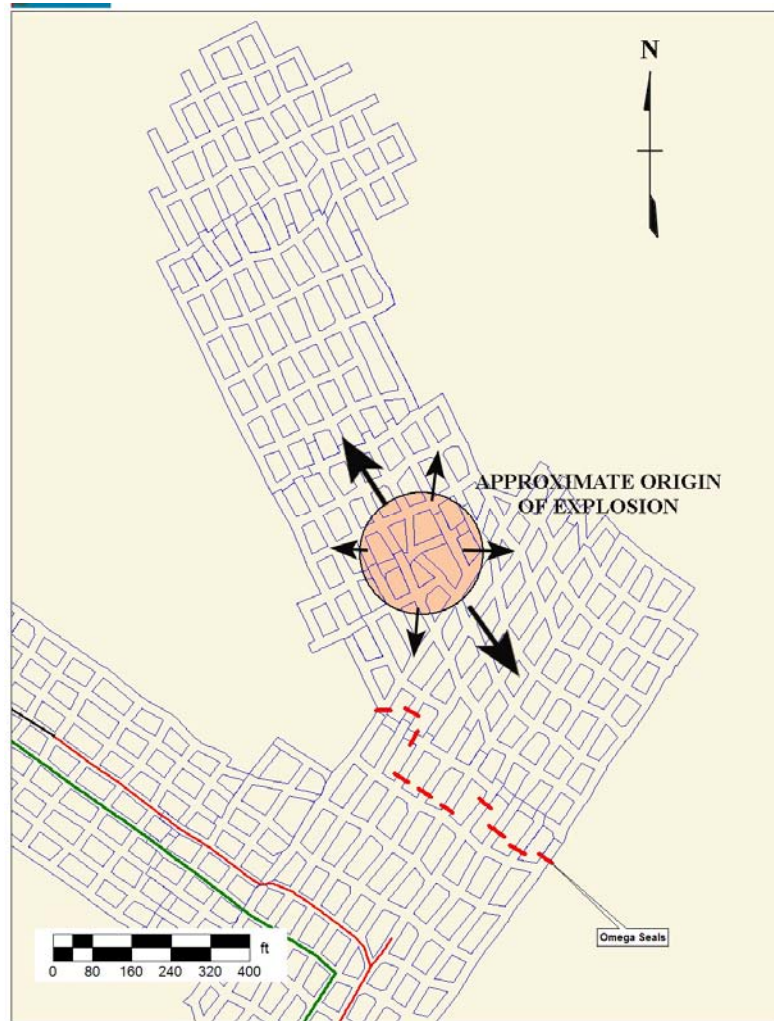
The bending of roof pans and plates occurred in areas that were first-mined, only, and this appeared to be the rule for most of the sealed area¹⁰. The area encircled on **Map 1** was the exception. Comprising an area approximately 250-ft in diameter this area is also shown shaded in yellow on the Flames and Forces Map (**Appendix 5.4**). It was conspicuous in the relatively light damage sustained there in the explosion, compared to the adjacent and surrounding first-mined areas.¹¹ The first-force bending directions generally radiated outward from this location. This is also the general location where the explosion is believed to have originated. A brief discussion in **Section 5.4-2** contains more details.

What was found during the course of the investigation, however, was that the explosion originated approximately 1/3 of the way into the sealed area at a distance of approximately 350 feet inby from the closest seal (#1 seal) and 700 feet from the farthest seal (#10 seal).

Map 1. The explosion is believed to have originated in the vicinity of the area encircled. The initial blast forces generally radiate outward from this location. It is also an area that has relatively slight damage.

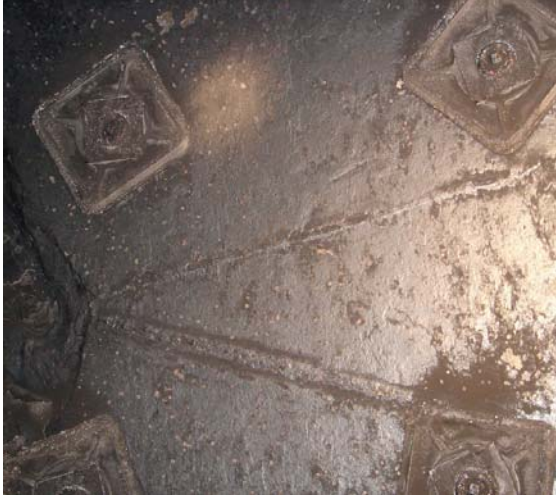
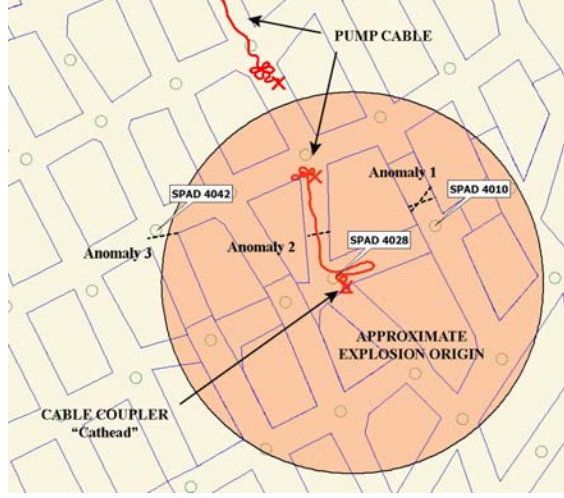
<p>Photo 1. These tracks in the mine roof are near the suspected explosion origin. They were examined in detail for possible evidence of involvement.</p>	<p>Map 1A. General location of “anomalies 1, 2, and 3” and part of an abandoned pump cable located within a zone where the explosion is believed to have originated.</p>

Interest waned somewhat when nothing unusual about their composition was discovered. A third “anomaly” was discovered nearby at spad 4042 and at approximately the same stratigraphic level in the roof as the others (diminishing their uniqueness), and geological analysis suggested they were simply an unusually straight cast of a plant fossil. In the end, there was no evidence that these unusual features were anything more than just unusually straight fossils casts.

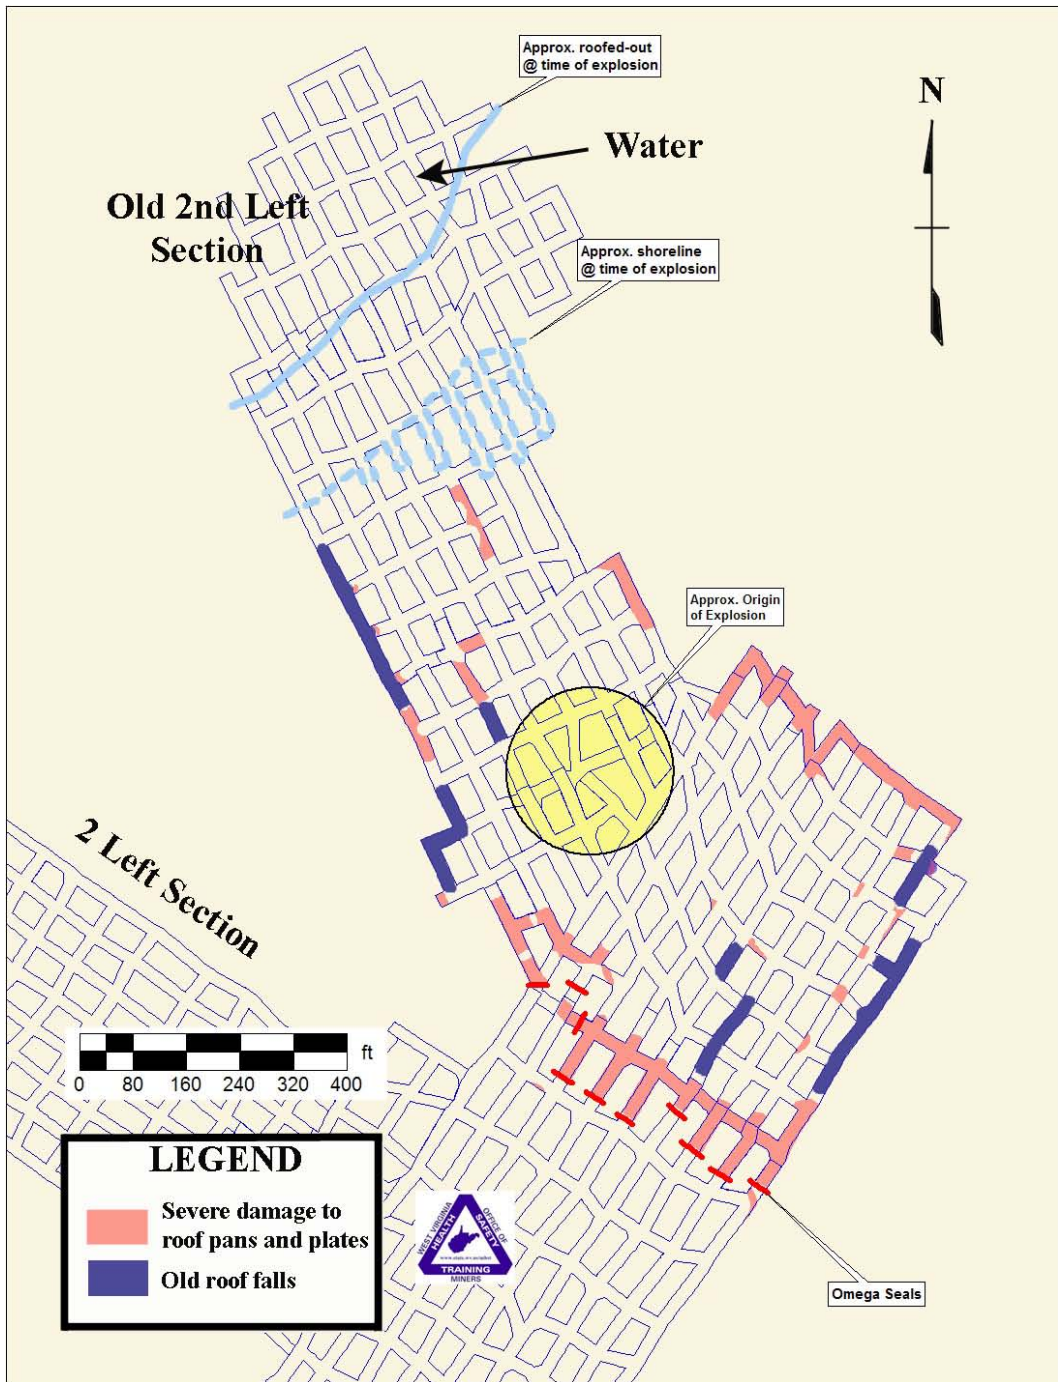
These areas were noted in red shading on the *Flames and Forces Map* (**Appendix 5.4-1**) and are similarly indicated generally on **Figure 10**. After notes and locations of this style of plate damage were compiled on a map covering the general region of the sealed area it became clear that this type of damage occurred mainly in areas of first-mining, only, and where blast waves impacted at and created pressure reflections at solid boundaries, such as along the outer perimeter of roof falls and areas where entries dead-ended or were butted-off against solid. Also, notably, the area inby each of the ten (10) Omega seals similarly exhibited this degree of pan deformation

Therefore, we can draw two conclusions: first, the explosion forces were of such a magnitude that reflected pressures were very significant (much greater than 20 psi), and second, that the seals did not fail at the instant of pressure arrival, but rather held on momentarily to effectively reflect and amplify the initial incident blast pressure. In the end, the seals did let go catastrophically, but apparently not until presenting resistance.

Figure 10. Areas or severe plate damage are viewed as indicators of high dynamic and reflected pressures. Areas shaded in red appear to indicate zones of encountered turbulence and/or obstruction in the path of the blast wave propagation.

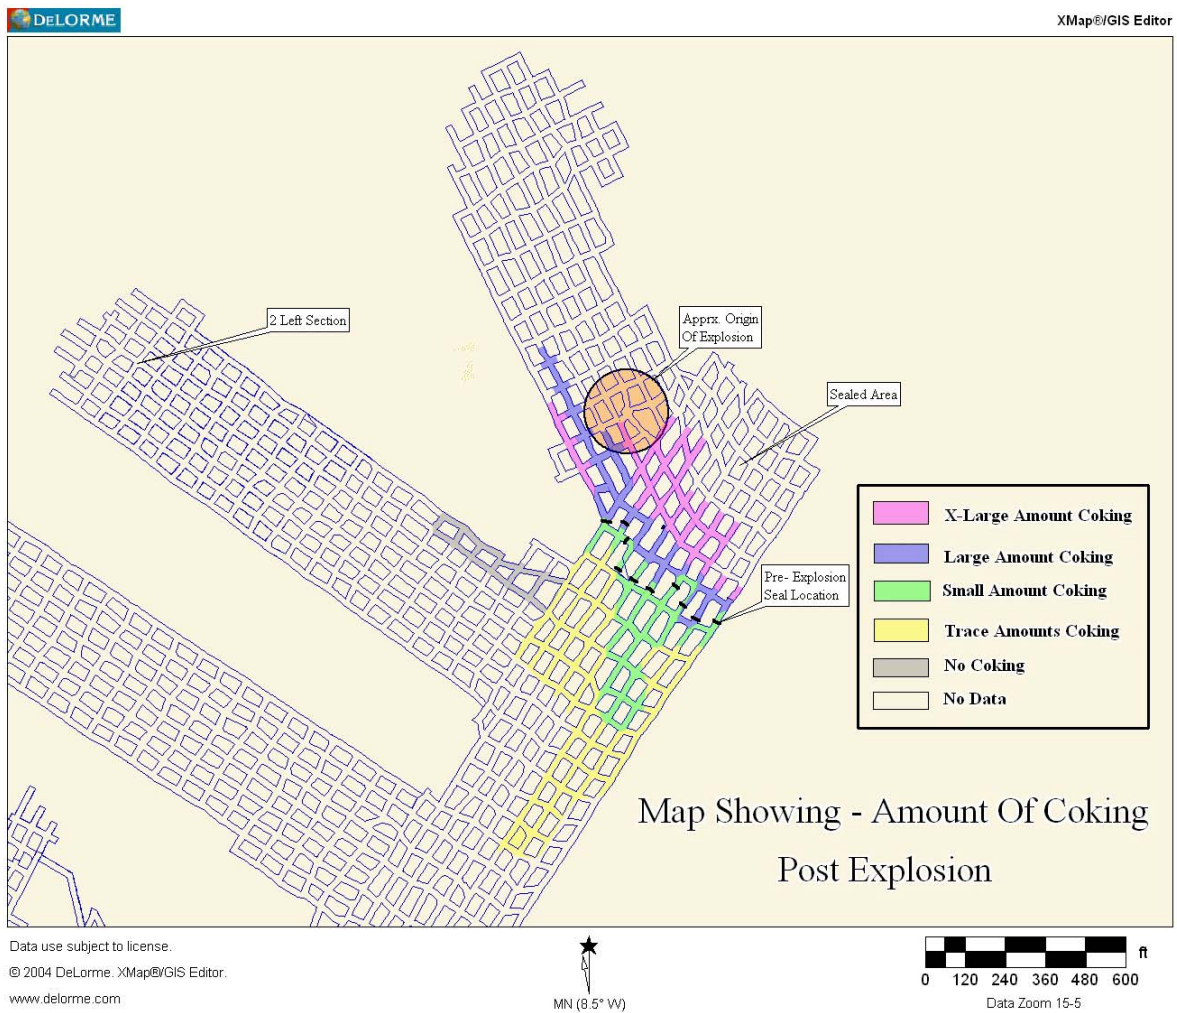
MAP 1: The amount of coal coking is an indicator of the amount of heat and duration of that heat. The symmetry of the coking trends is similar to the symmetry of the Omega block debris field (see MAP 2).

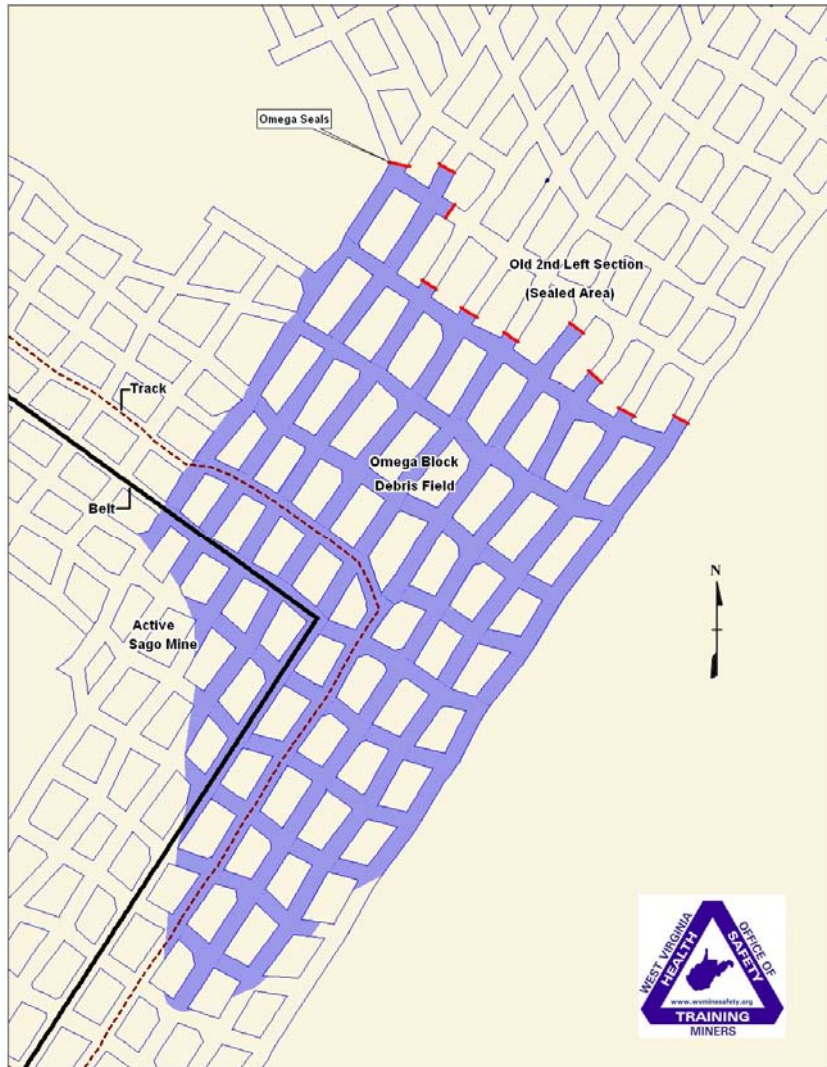
MAP 2: This illustration shows the approximate distance and symmetry of the debris field created by the ten (10) destroyed Omega seals.
