5.5 Cause of Explosion

5.5-1 What caused the explosion?

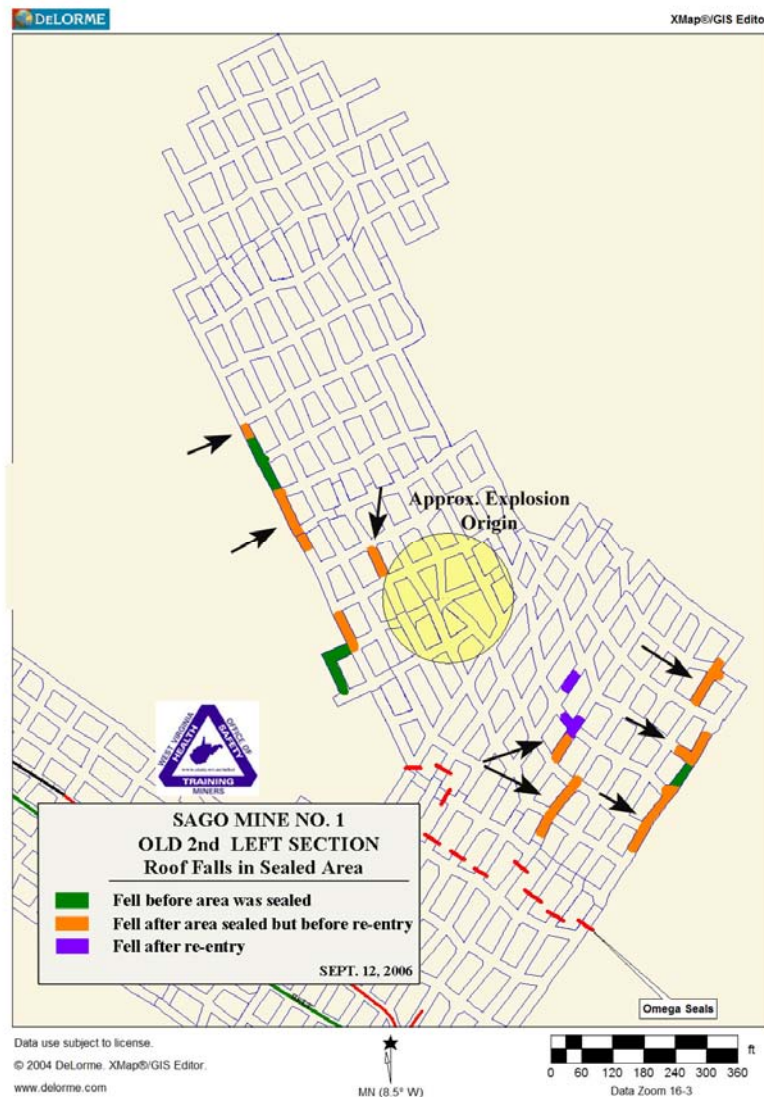
There are several roof falls that have been identified and mapped within the sealed-off area of the mine. **Map 1** illustrates the location of known roof falls. Rocks of certain types² are capable of creating sparks if they strike metal objects such as roof bolts.

Map 1.—The location of known roof falls in the area behind the seals. Arrows indicate those falls which occurred after the seals were built but before mine re-entry.

Several of these falls are known to have occurred either before the explosion or after the explosion, and so have been discounted. Of the remaining falls (indicated with arrows), only one (1) is in the region where the balance of the evidence indicates the explosion originated.

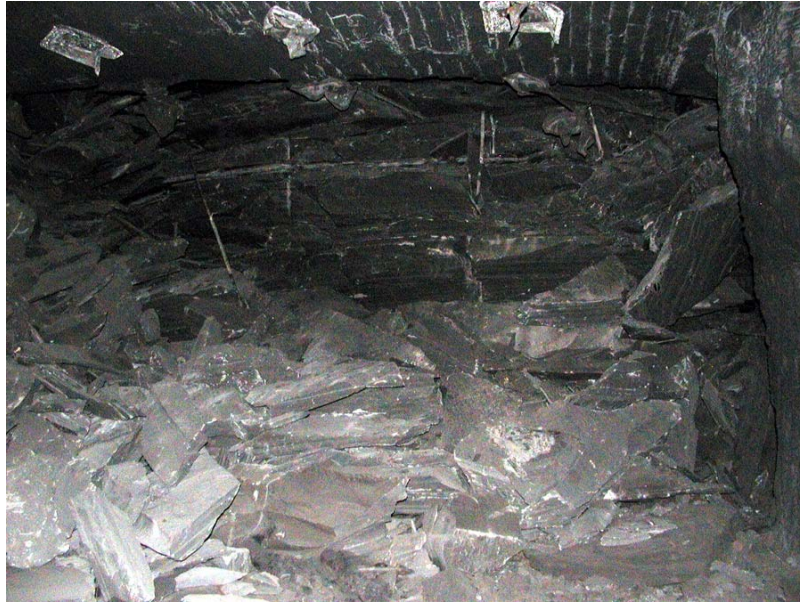
Photo 1. Roof fall in Old 2nd Left Section. In some cases, a determination of whether the fall occurred before or after the explosion could be made by the relative abundance of soot covering it. A heavy soot typically covered falls that occurred before (or possibly during) the explosion.

The domed top of the fall contains inter-bedded layers of sandstone that, under the right conditions, could have produced the necessary spark. However, after examining this area several times since the explosion, no evidence has been found that would indicate that the ignition started there. The balance of the inferred propagation directions of the blast favors a point-of-origin farther to the southeast.

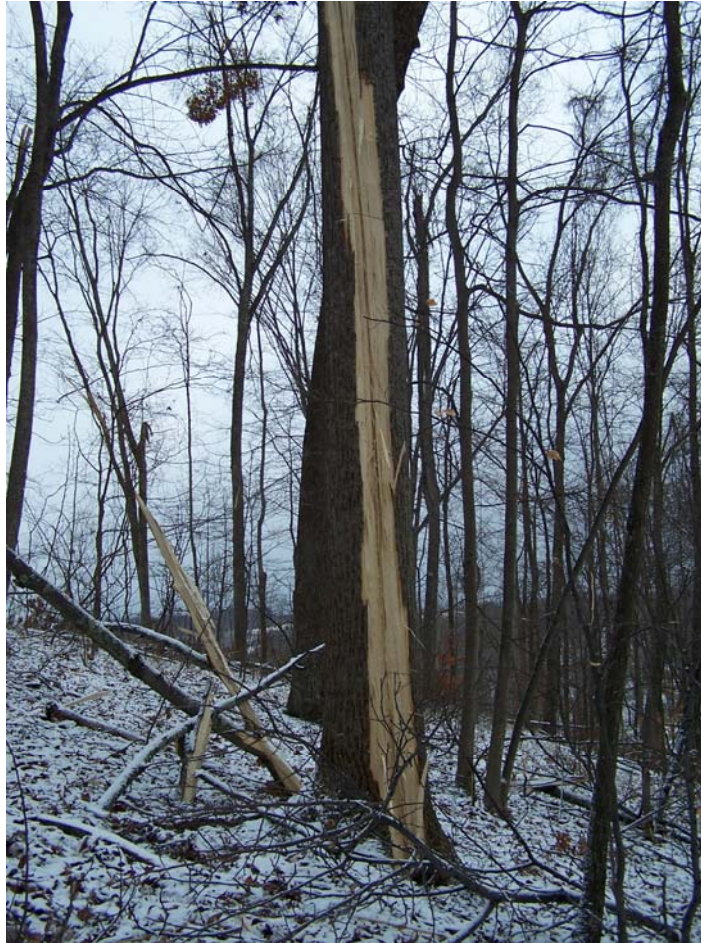
On Friday, January 6, 2006 a representative of OMHS&T accompanied by an engineer from Anker Mining West Virginia Mining Company, Inc.¹ traveled to the closest (and strongest) of the reported lightning strikes using a GPS unit and the coordinates provided by Vaisala—a drive of approximately three minutes from Sago Mine. There, a large poplar tree was spotted with conspicuously fresh damage in its top. Closer inspection confirmed it to be the result of a very recent lightning strike. A wide gash extending from the top to the bottom of the 50-ft. tree spiraled 360-degrees (**Photo 1**). The force of the lightning produced a small gouge in the ground at the base of the tree. The poplar tree is located approximately 197 ft. from the coordinates provided by Vaisala.

Wood debris from the lightning strike was found around the tree and this was documented in a survey performed on January 13, 2006 by Allegheny Surveys, Inc., based out of Birch River, WV² (see **Appendix 5.5-2: Forensic Survey of Poplar Tree**). Disintegration of the top portion of the tree left splintered wood fragments ranging from several feet to just inches in length, scattered symmetrically within a radius of approximately 150-feet.

Photo 1. A poplar tree recently struck by lightning was located on 1-6-06 near the location where Vaisala recorded a +101kA lightning strike on 1-2-06 at 6:26:35AM. Photo by Kermit Melvin

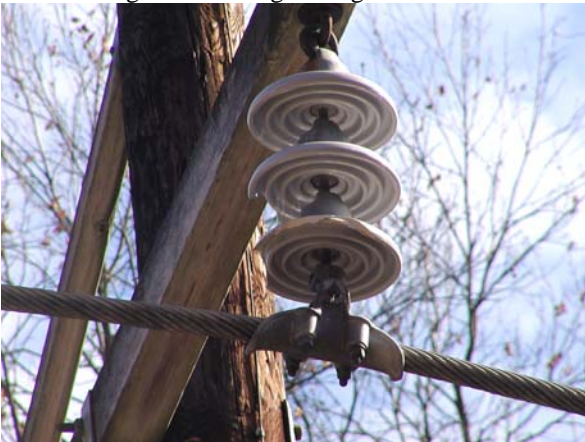
Photo 8. Damaged insulators on the middle phase wire on the main 12KV line

¹³ The damaged lightning arrester on the branch line to Sago Mine was likely caused by lightning and could have occurred that day. The cracked insulator and ground disturbance shown in Photos 8 and 11 may or may not be lightning-related.

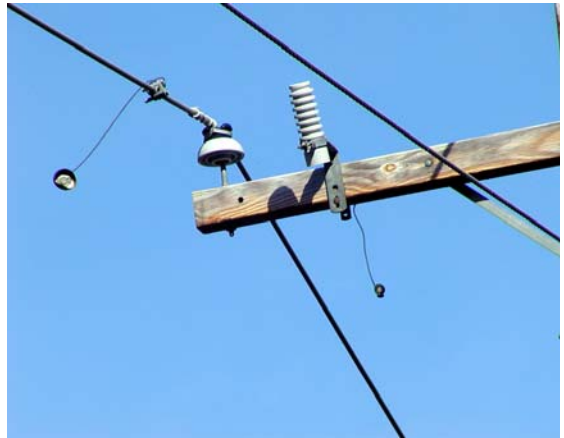
Photo 9. Damaged lightning arrester on the outside phase of the branch line feeding the Sago sub-station

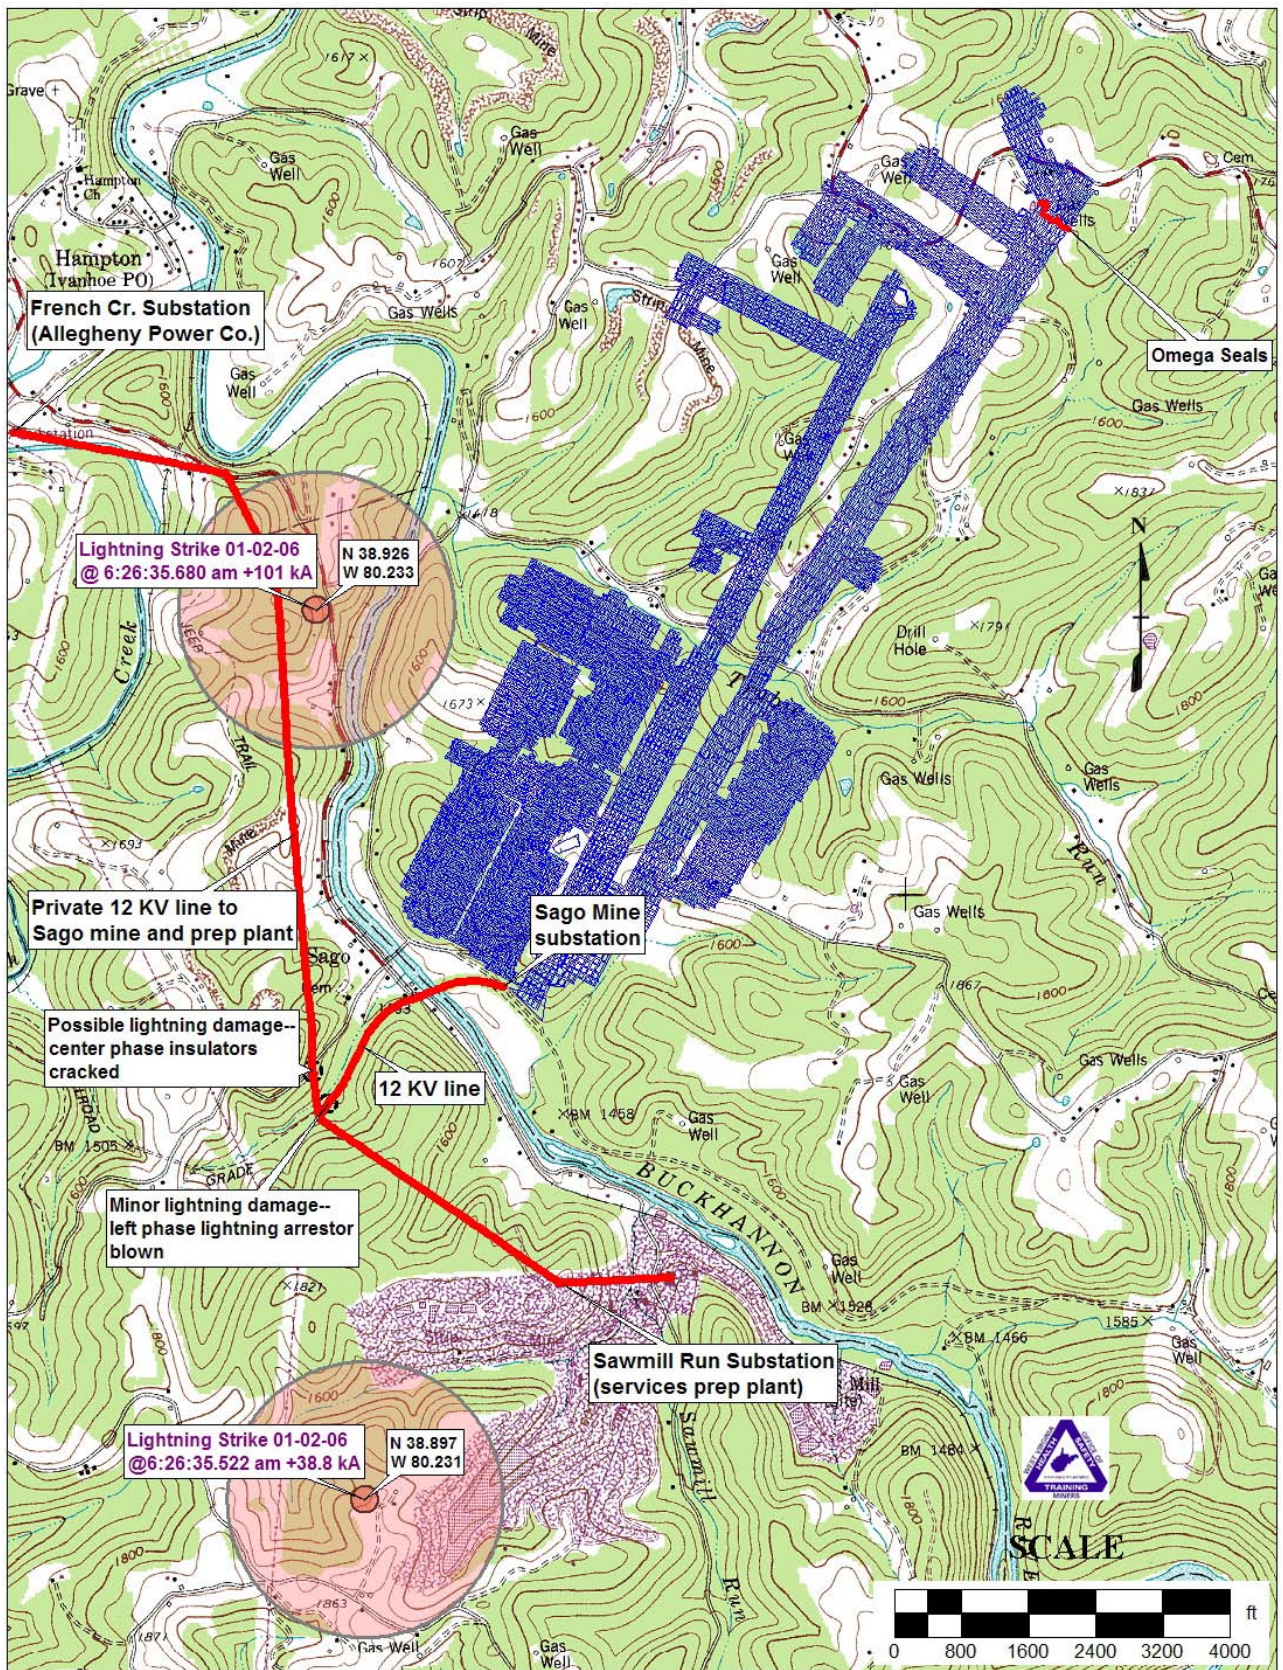
Map 2. Location map showing Sago Mine No. 1, the Sawmill Run and Sago substations, the 12 kV power distribution line, minor damage found on those lines, and the lightning strikes recorded at 6:26:35 AM EST.

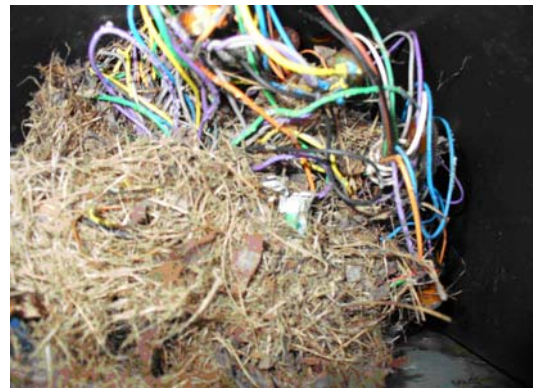
Photo 18: Mouse nest in 1970's junction box closest to lightning strike.

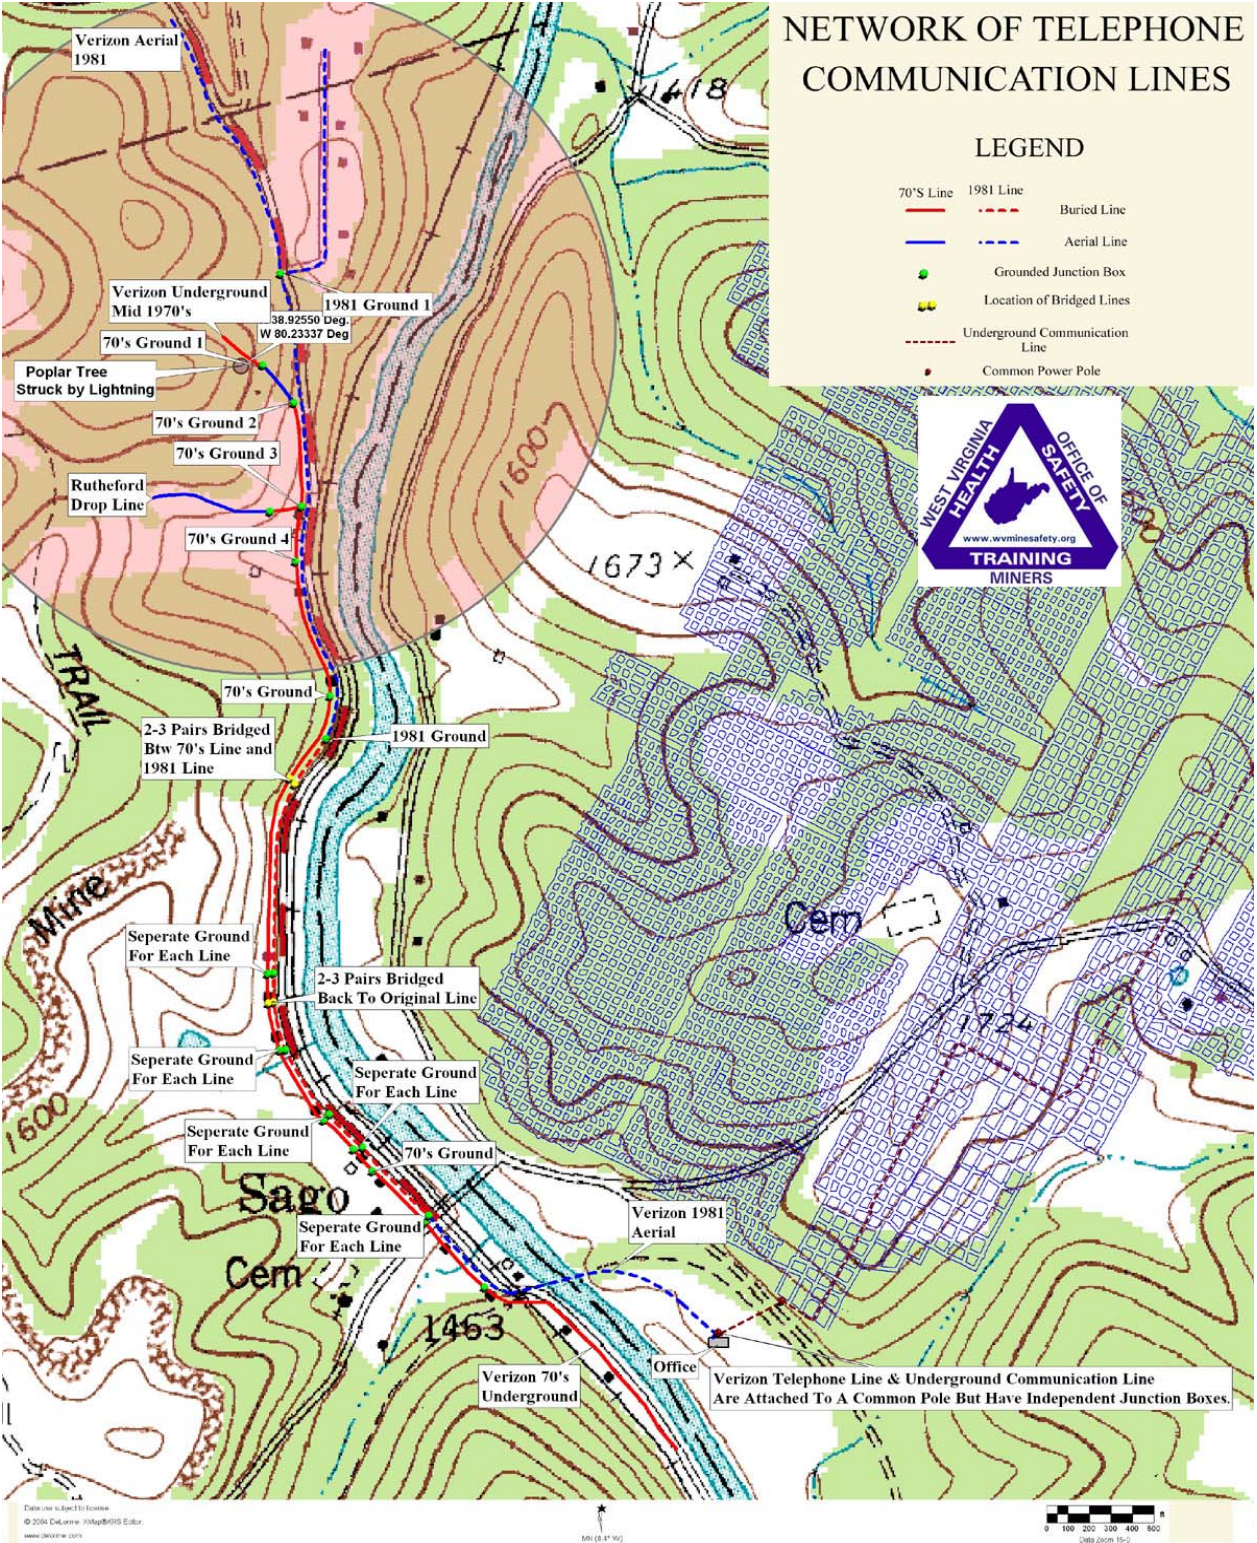
Map 7. Map showing layout of Verizon telephone lines. A larger version of this map is contained in **Appendix 5.5-3: Map of Telephone Lines**
