5 THE INVESTIGATION

The purpose of this investigation was to carefully observe, inquire and examine systematically the events surrounding the January 2, 2006, Sago Mine Disaster. The WVOMHS&T investigation started on the morning of January 2, 2006, and certain aspects of it continue.

5.3 Omega Seals

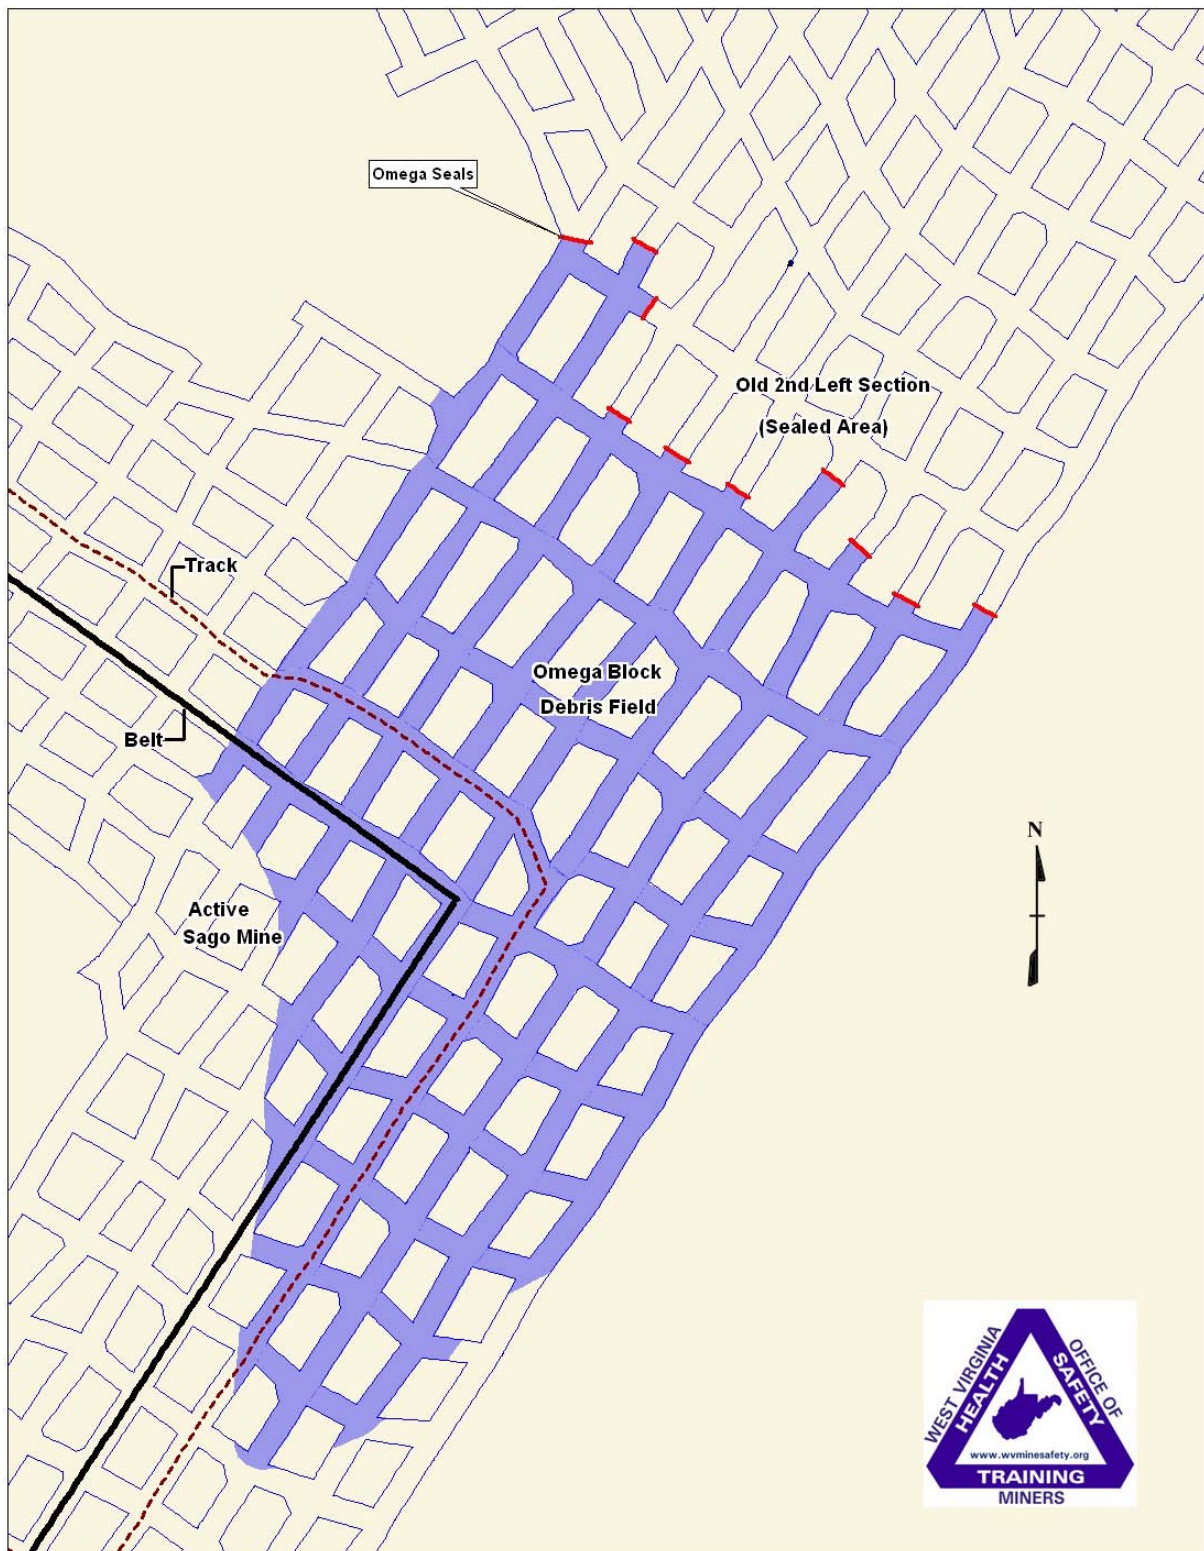
All ten (10) Omega Block seals were totally destroyed in the explosion. Remnant pieces of Omega blocks ranged in size from baseball-sized pieces to sand-sized. The majority of the debris appeared golf ball-size or smaller².

Mapping of the seal remnants and debris was performed in order to document the manner and the extent of damage. The force of the explosion completely removed and pulverized the seals to the point that mapping teams could determine the location of the seals only by locating the concrete and mortar attached to the roof, ribs or floor. Only three (3) seals had Omega blocks still remaining at their installed seal locations (seals #1, #2 and #9). The debris from the seals was distributed in an outby direction from their installed location over a distance of several hundred feet. This, together with other evidence, led to a determination that the explosion forces originated from inside the sealed area (see **Figure 2**).

Figure 2: This illustration shows the approximate distance and symmetry of the debris field created by the ten (10) destroyed Omega seals.

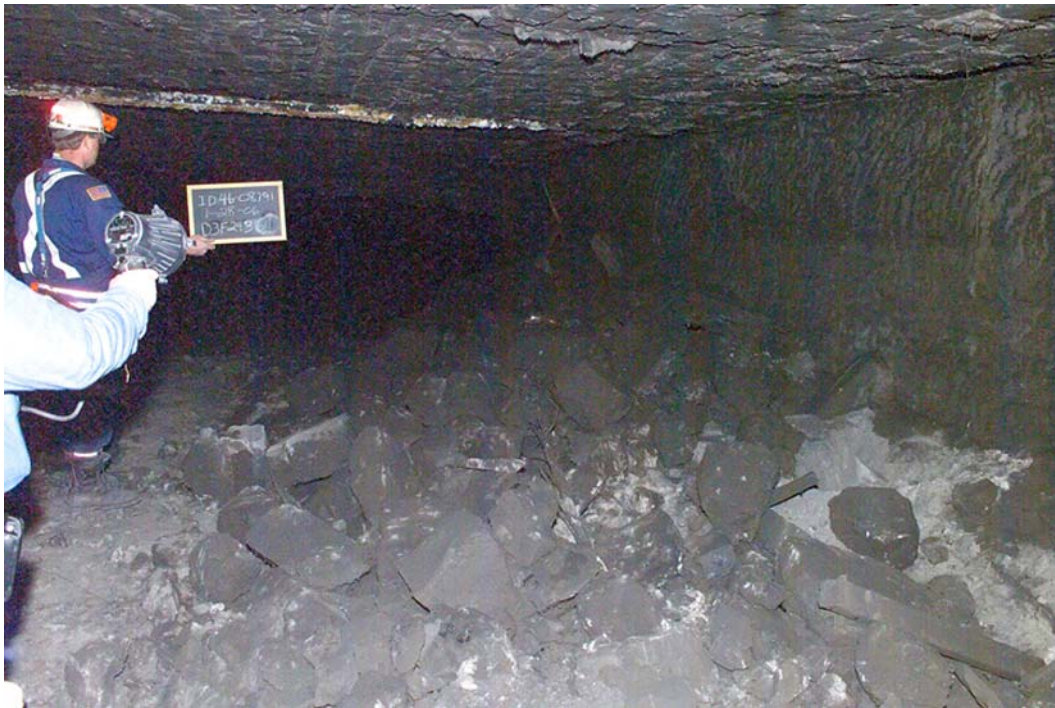
Photo 1: Omega Debris - In First Outby Crosscut Between Seal #1 & #2 (Courtesy of MSHA)

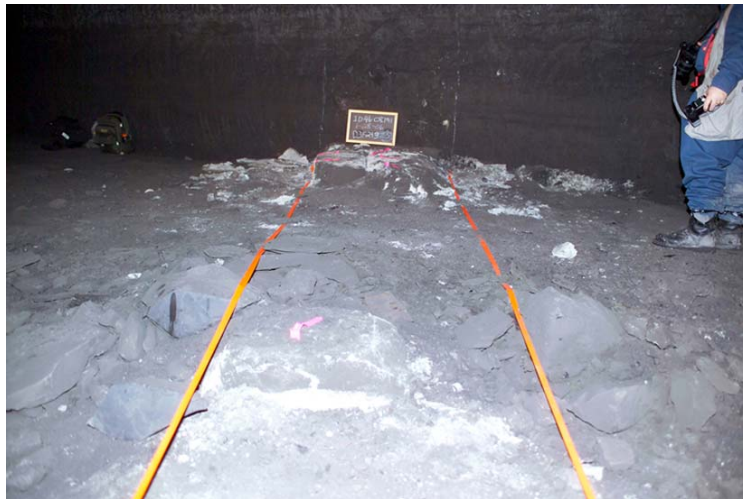
Photo 2. Location: Seal #1 (Courtesy of MSHA)

² The exception was Seal #1 which had a large number of pieces that were 1/4-size or larger.

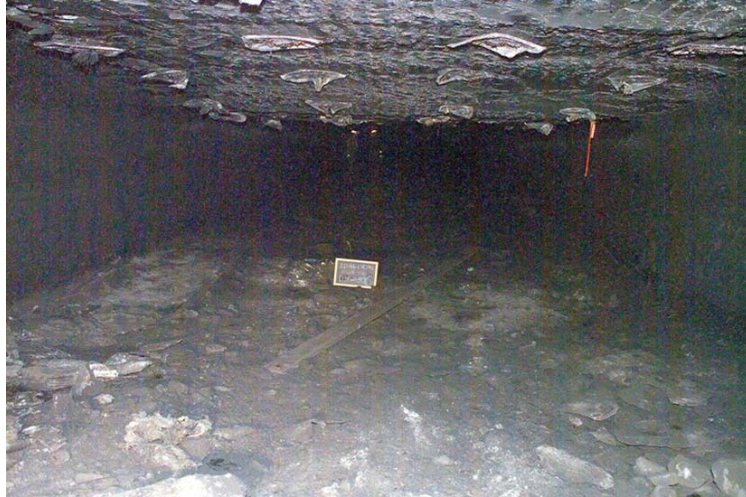
Photo 11. Location: Seal #10 (Courtesy of MSHA)

Two water traps in #1 seal were constructed of non-metallic pipe. No confirmed components of the water trap were discovered during the investigation. The gas monitoring sample pipe in #10 seal was steel pipe, as prescribed in the approved plan. Except for the required sample tube, no other metallic structures were found which may have crossed the seal barrier.
