REPORT OF FATALITY

JANUARY 16, 2014

METTIKI COAL, LLC (WV)

METTIKI E MINE

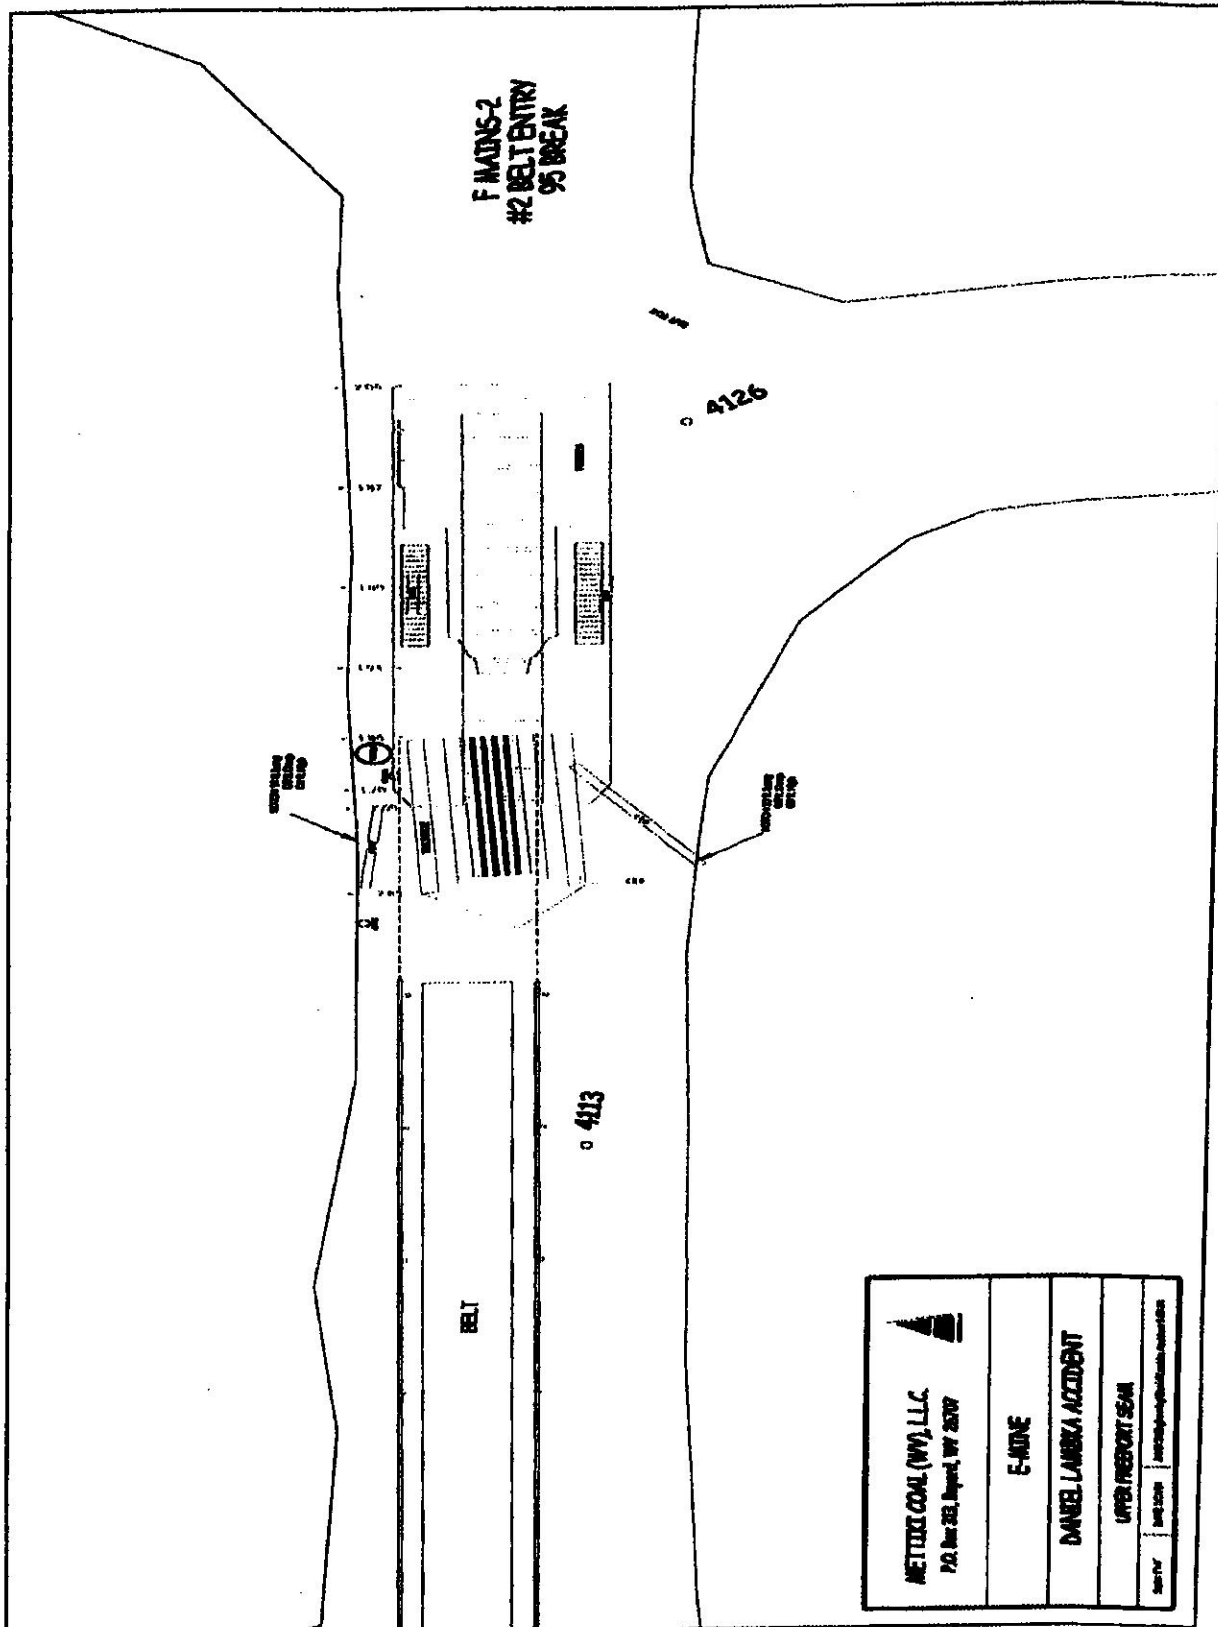
MAP1

21. No violations or hazardous conditions were noted in any examination book regarding the accident site prior to the accident.
22. Mr. Lambka was fatally injured when the outby end of the Oldenburg Stamler Feeder, positioned at the F Mains #2 conveyor belt tailpiece, pivoted toward the tight side coal rib and pinned the victim between the coal rib and the feeder.

Mr. Lambka was fatally injured on January 16, 2014, at approximately 9:05 p.m. The victim was pinned between the Oldenburg Stamler Feeder and the coal rib due to the outby end of the anchoring post installed from the inby end of the tailpiece on the tight side dislodging from the notch in the rib. This allowed the outby end of the feeder which was attached with chains to the inby end of the tailpiece to move. This sudden and unexpected movement resulted in Mr. Lambka being pinned between the solid coal rib and the feeder.

1. The tailpiece will be securely anchored with two inby jacks or posts into the mine rib. In addition, two flag pins inby the tailpiece shall be installed a minimum of three feet into the mine floor and securely anchored by chains to the tailpiece.
2. The notches where the posts will anchor from the rear of the tailpiece into the mine rib will be a minimum of eight inches into the rib.
3. The feeder will be set solidly to the ground and blocked where necessary by cribs or other blocking material from the discharge boom of the feeder to the inby end of the tailpiece.
4. All personnel are to be clear of the conveyor belt tail area and outby the belt tail for at least one block or in a crosscut, at the initial start-up of the conveyor belt.
5. Once the belt has been ensured to be running correctly, the two outby jacks or posts will be set.
