**REPORT OF FATALITY
RIB ROLL
UNDERGROUND COAL MINE**

FEBRUARY 6, 2018

**WOLF RUN MINING LLC
SENTINEL MINE
PERMIT #U00001583D**

**REGION ONE
14 COMMERCE DRIVE, SUITE ONE
WESTOVER, WEST VIRGINIA 26501
EDWARD PEDDICORD, INSPECTOR-AT-LARGE**

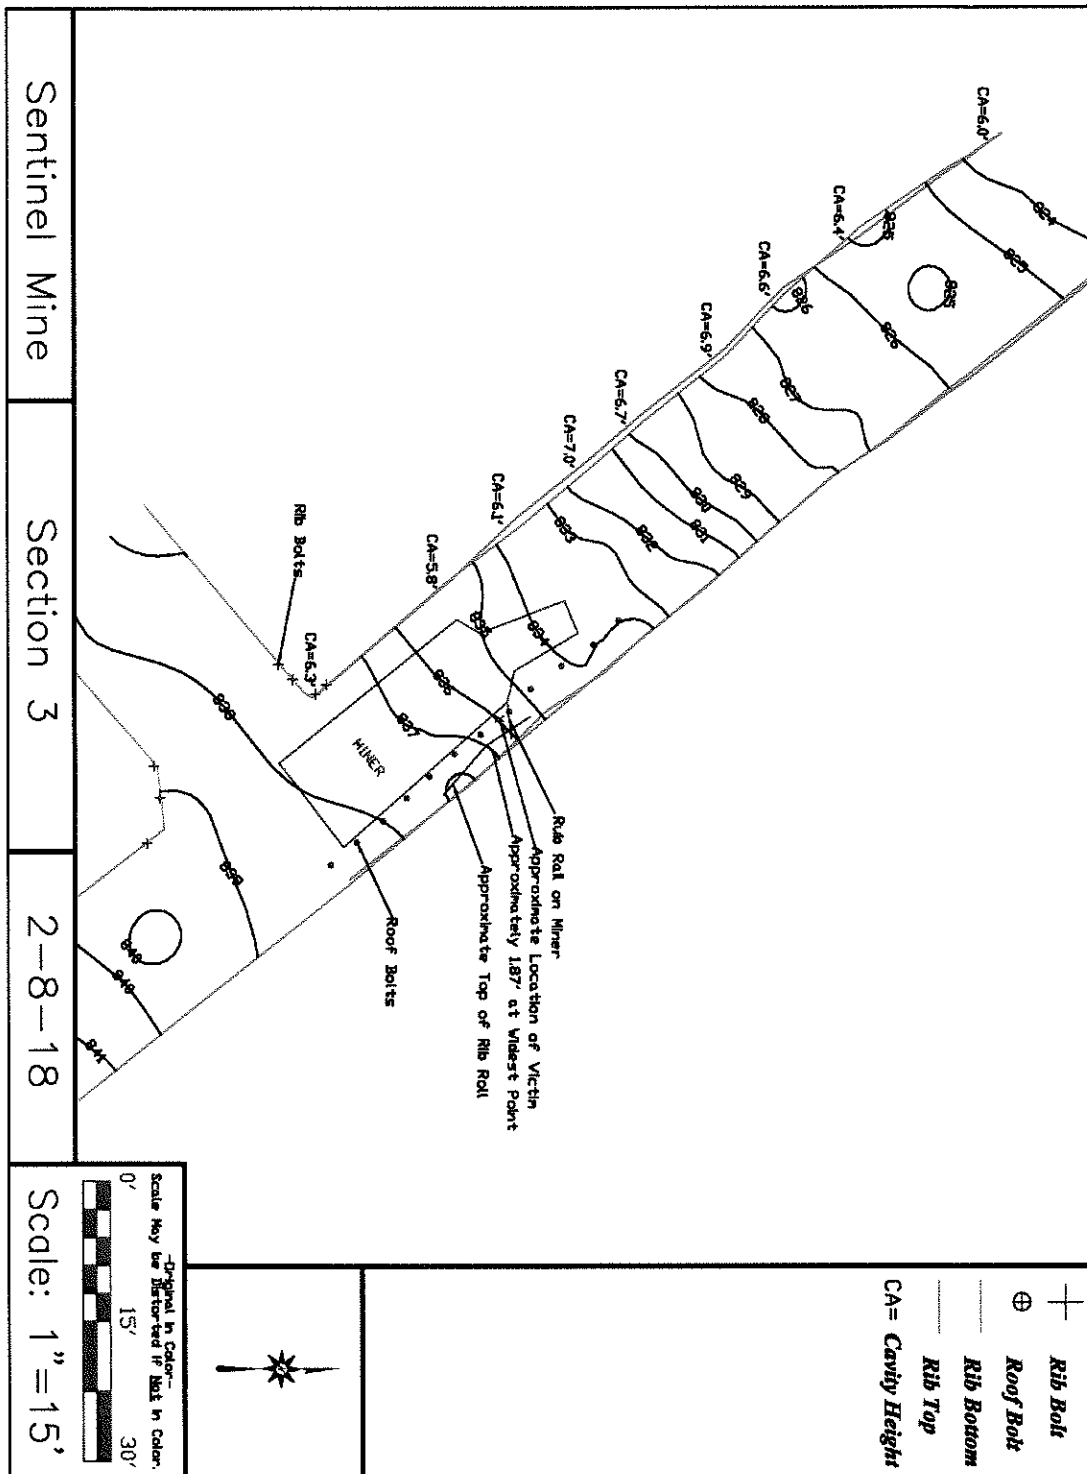
SKETCH.....1

APPROXIMATE LOCATION OF VICTIM

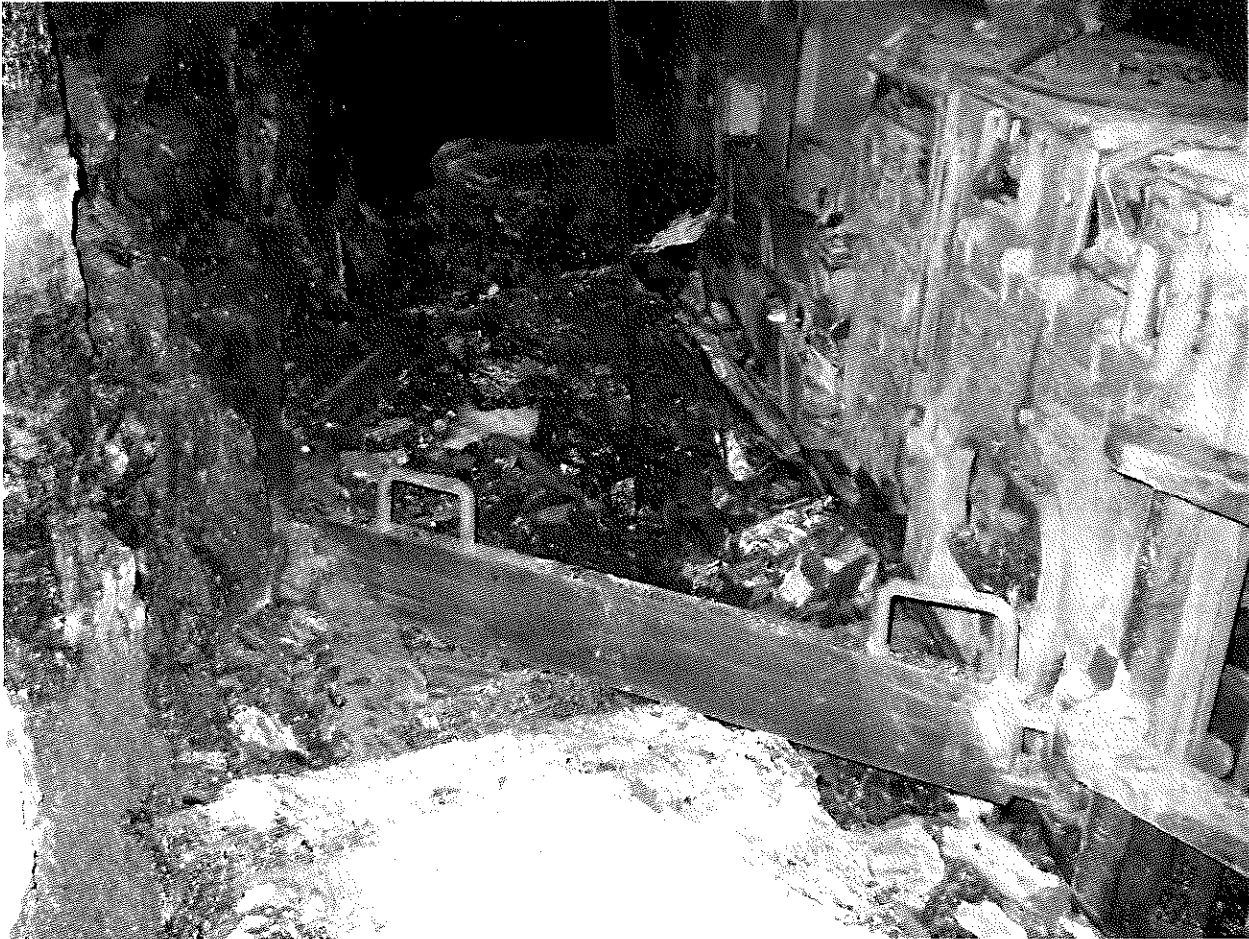
PICTURE.....2

23. The total length of the rib roll measured 18 feet 4 inches, 79 inches in height and up to 17 inches thick.
24. The No. 3 section, including the accident site, was dry. The mining height at the accident site measured 79 inches. The entry width measured 18 feet, 6 inches. The distance from the left rib, barrier side, to the continuous miner prior to the rib roll measured 3 feet. The distance from the left rib, barrier side, to the continuous miner after the rib roll occurred, measured 4 feet, 5 inches.

26. The largest piece of coal/rock from this rib roll struck the victim. This large piece of coal/rock measured 36 inches in width at the bottom, 42 inches in width at the top, 28 inches in height, 14 inches thick and weighed approximately 618 pounds.

27. There are three binders present in the coal rib where the rib roll occurred. The largest piece of coal/rock that struck the victim fell between the middle and top binders. The top and bottom of this large piece of coal/rock where it was formed to the top and middle binders had slickenside surfaces.

29. Additional rib bolts were installed at various locations on No. 3 section, between corner bolts. There were no rib bolts installed at the accident site.

Rib bolts will be installed with every 2nd row of primary roof support in the upper ½ of the rib. Rib bolts will be a minimum of 48 inches in length. Where the mined height exceeds 8.5 feet either a double row of rib bolts will be installed or a single row of rib bolts with a strap or board of at least 36 inches in length. Where a future crosscut will be started or cut through, rib bolts will not be installed, however this location will be marked with ribbon, paint or other appropriate means. The miner operator will not be positioned in by the last rib support. There cannot be two consecutive rib bolts damaged or missing in a row and no more than 4 rib bolts can be damaged or missing in the same entry or crosscut on a block to block basis (including both ribs-right and left). The rib bolts will be installed with an approved plate and pie pan. In areas that will be second mined the rib bolts may be installed without pie pans. In the event the rib bolt becomes loose, a wire rope clamp, wedge, or wooden cap piece may be used to tighten the installation to the rib.

If maintenance needs to be performed on a piece of equipment, the equipment will be located in a four way intersection or if necessary to perform work between the rib and the equipment the rib will be supported with rib bolts, cribs, ribsters or similar supports prior to work being performed.
