West Virginia Office of Miners' Health, Safety and Training

Fatal Accident Investigation Report

Electrocution

Kanawha Eagle Mining LLC

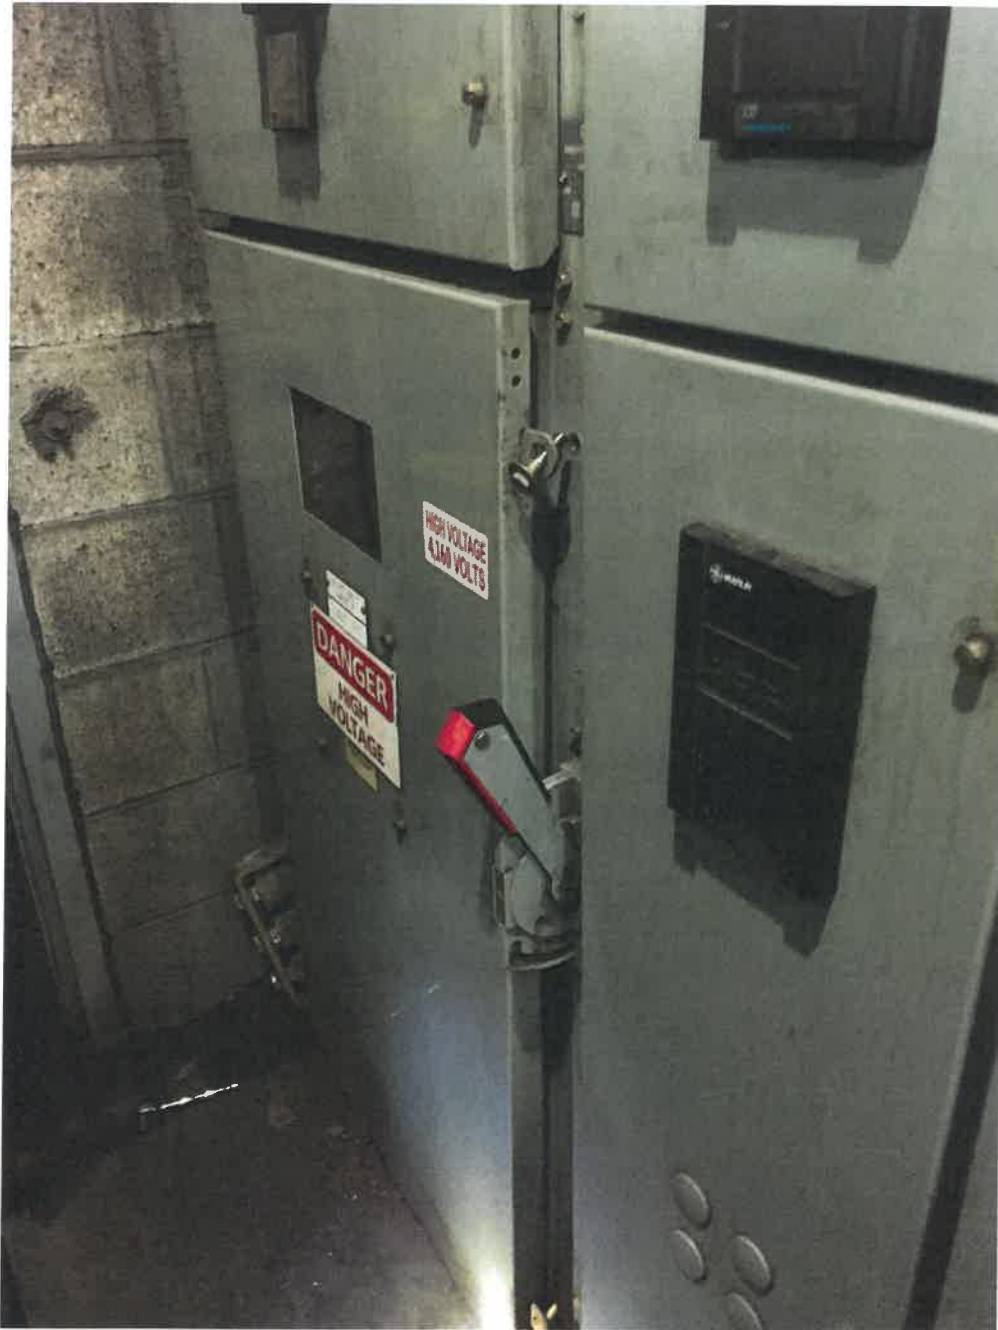
Photo 1.1 Outside of slope belt A drive cabinet

9. The disconnect for the circuit that was involved in the accident was found to be in the closed position. The handle of the disconnect was stuck in this position due to the linkage that connects the vacuum contactor to the safety latch being severely out of adjustment.

10. The disconnect for the circuit that was involved in the accident was never locked and tagged.
11. The high voltage electrical gloves that were found inside of the MCC room were sent off for testing by OMHST. The gloves passed all testing.

*Note- Disconnect handle was found to be in the closed position.

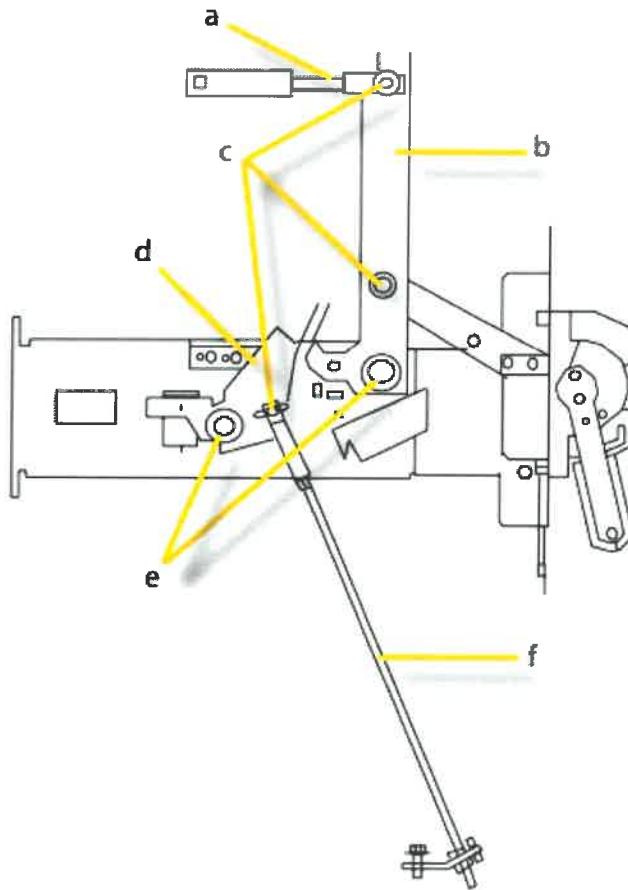
Photo 1.5 Photo of drawing of disconnect linkage that is in the slope belt A drive cabinet.

At this time, they decided that the linkage for the disconnect handle was the problem. This linkage is located inside of the high voltage cabinet. There are two sets of linkage inside of the cabinet. Those two sets of linkages work together, but each has its own purpose. The top linkage is used to connect the disconnect handle which is located on the outside of the cabinet to the disconnect mechanism which is located inside of the high voltage compartment. This allows you to open and close the disconnect from the outside of the cabinet. The bottom linkage is used as a safety device. It is connected to a metal plate on the vacuum contactor that was changed. Its function is to keep someone from opening the disconnect when the contactor is closed and the circuit is under a load. This is accomplished by the linkage being operated when the contactor closes and it pulls a safety latch that will not allow the disconnect to be opened until the contactor opens. (Refer to photo 1.5 on page 26 of this report.)

- a. Threaded Connecting Rod*
- b. Isolation Switch Operating Lever*
- c. Clevis Pins and Cotter Pins*
- d. Switch Interlock Lever*
- e. Lubrication Points (only at replacement)*
- f. Contactor Interlock Rod*
