**Report of Fatality
Electrocution Accident
Underground Coal Mine
September 17, 2019**

**Panther Creek Mining, LLC
American Eagle Mine
Permit Number U00000391H**

**Region IV Office
550 Industrial Drive
Oak Hill, West Virginia 25901
McKennis P. Browning, Inspector-at-Large**

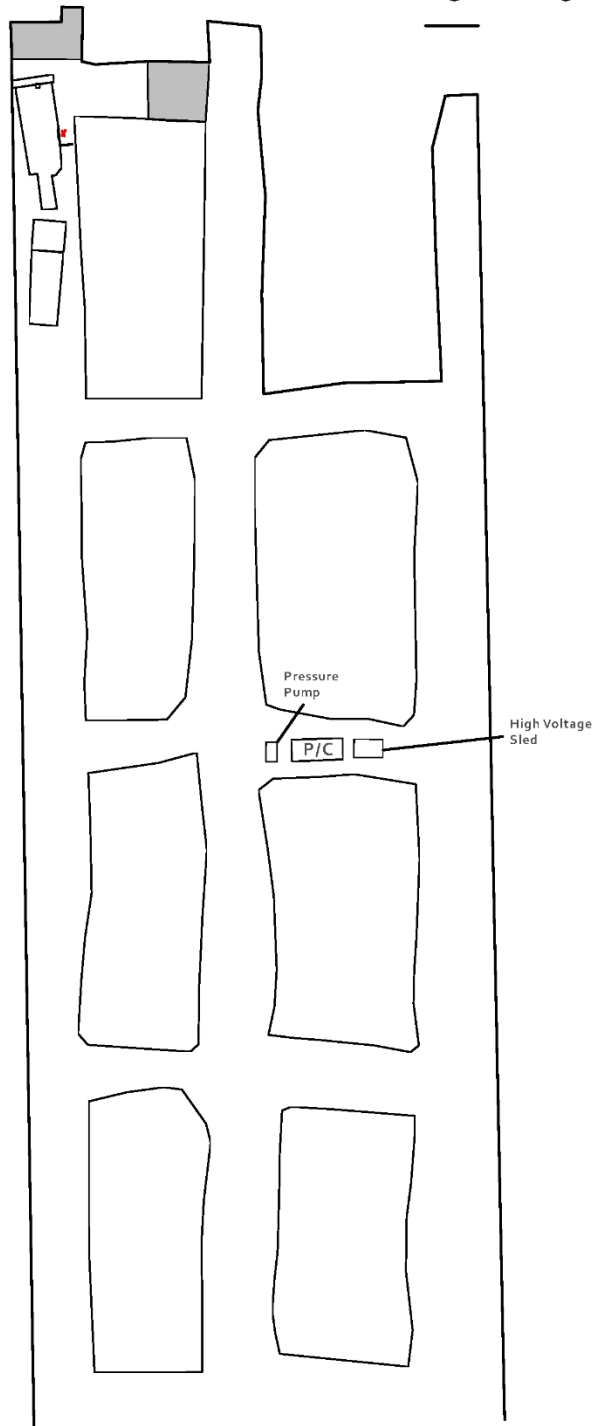
DRAWING #1

6. The accident occurred at the JM6911 continuous mining machine located at survey station spad number 23842 in the number one entry on the #1 Section. This continuous mining machine is powered by a 995 Volt trailing cable.

7. The mine floor was wet and muddy in the area where the victim was working.
8. Upon arrival the WVOMHS&T investigators found that Mr. Keeney had been fatally injured while working in the energized 995 Volt panel toward the rear of the continuous mining machine on the operator's right side.

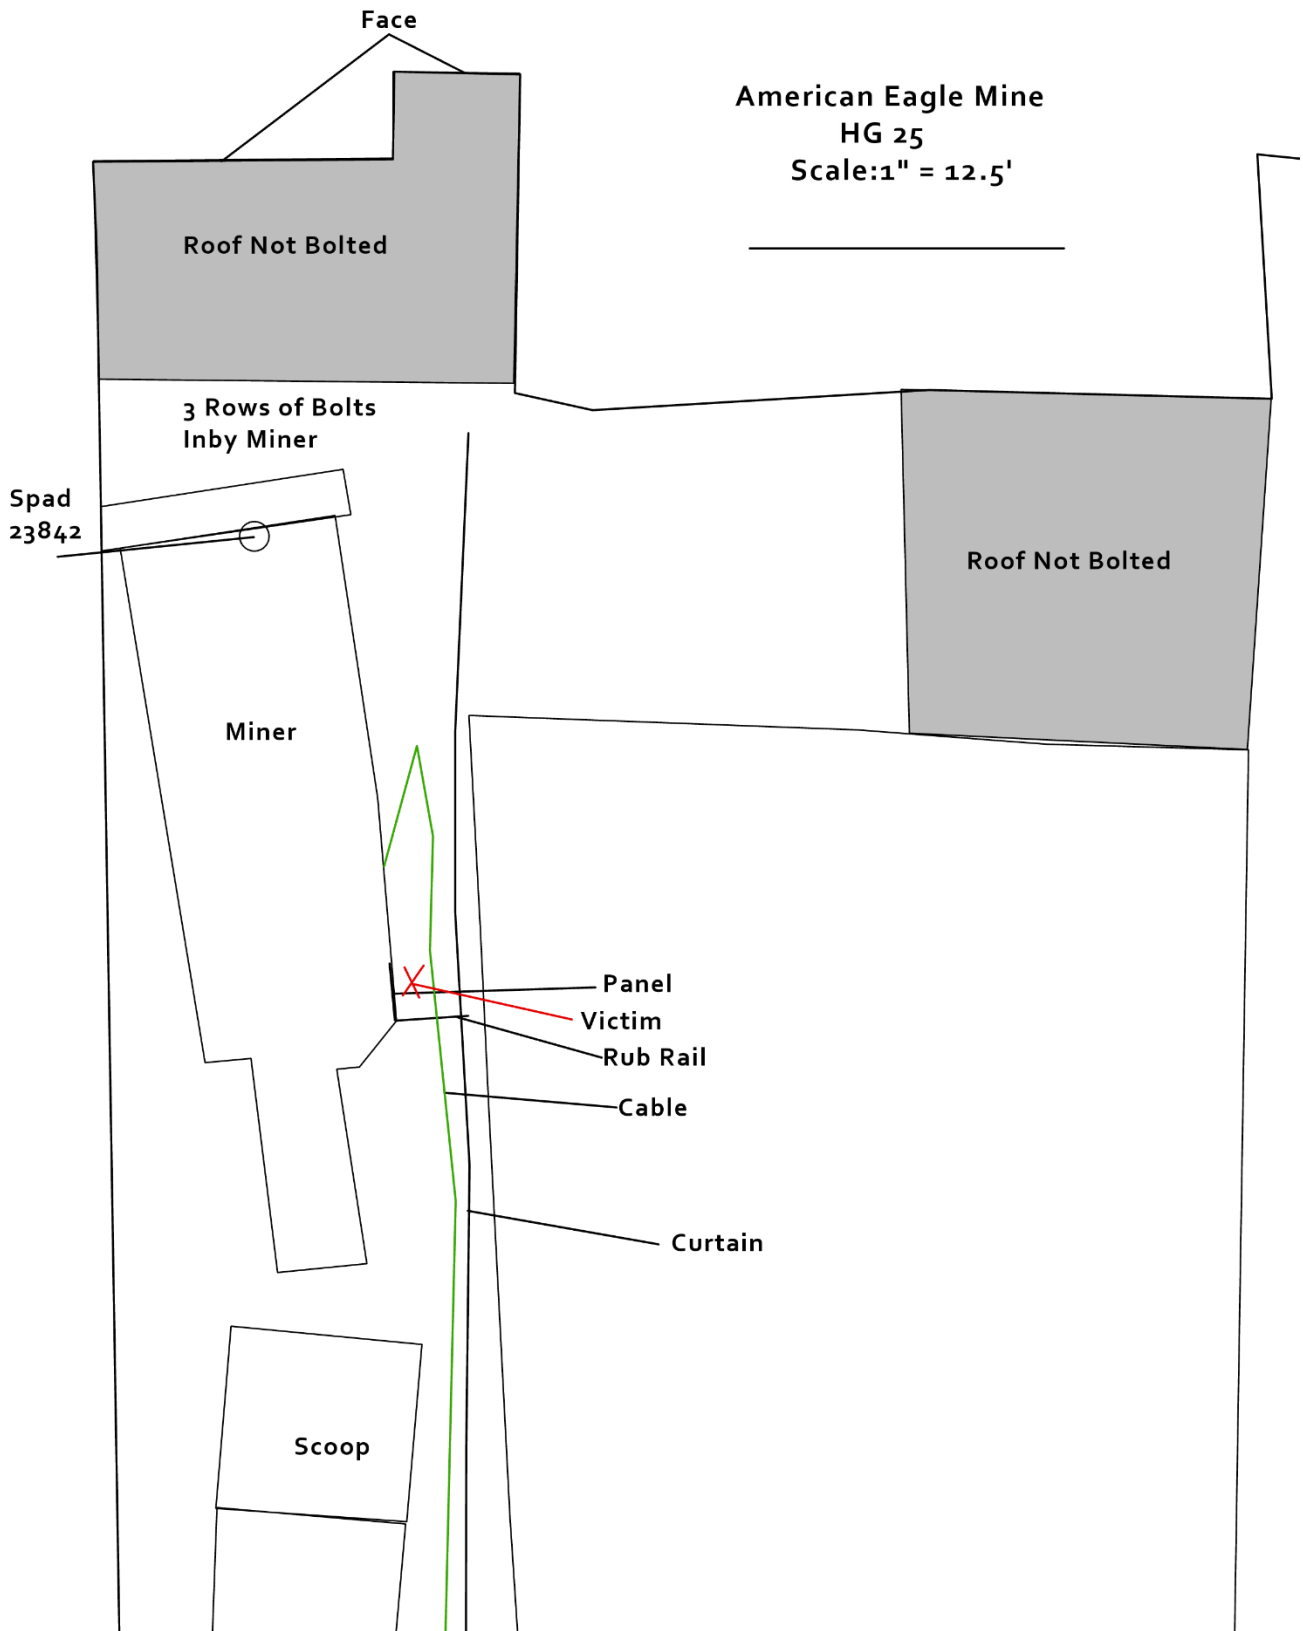
DRAWING #2

12. Mr. Keeney was working on an energized panel on the JM6911 continuous mining machine when he contacted an energized component inside the medium voltage panel.

- III. One electrician was checking the shields on the cutter head on the right side of the machine.
18. The energized disconnecting device (cable coupler/cathead) that supplies power to this machine which is located at the Section Power Center was not locked out and suitably tagged by the certified person performing work.
