Report of Fatal Accident
Auger Accident
Surface Coal Mine
October 17, 2018

Princess Polly Anna & JCT Enterprises
No. 1 Surface Mine
Permit Number S00300212

AUGER ACCIDENT INVESTIGATION PRINCESS POLLY ANNA & JCT ENTERPRISES NO. 1 SURFACE MINE WV PERMIT NUMBER S00300212

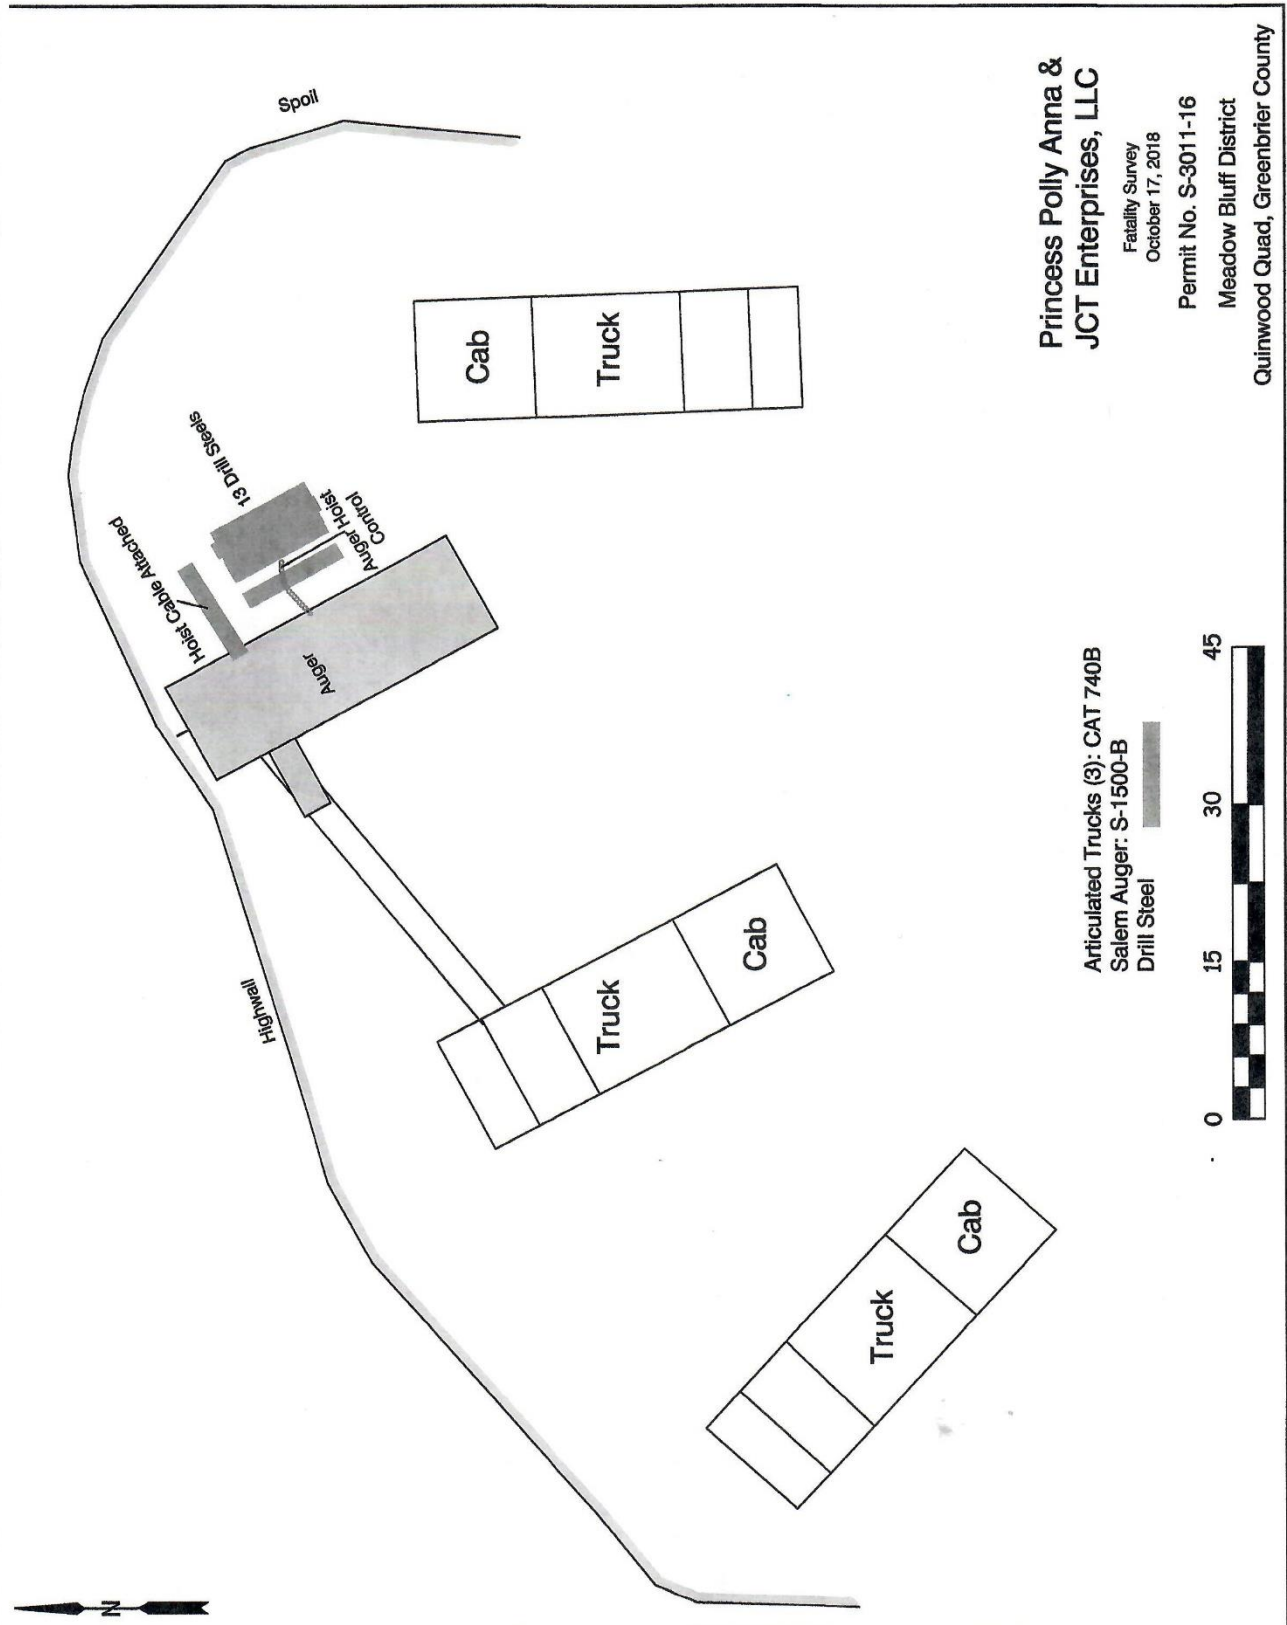
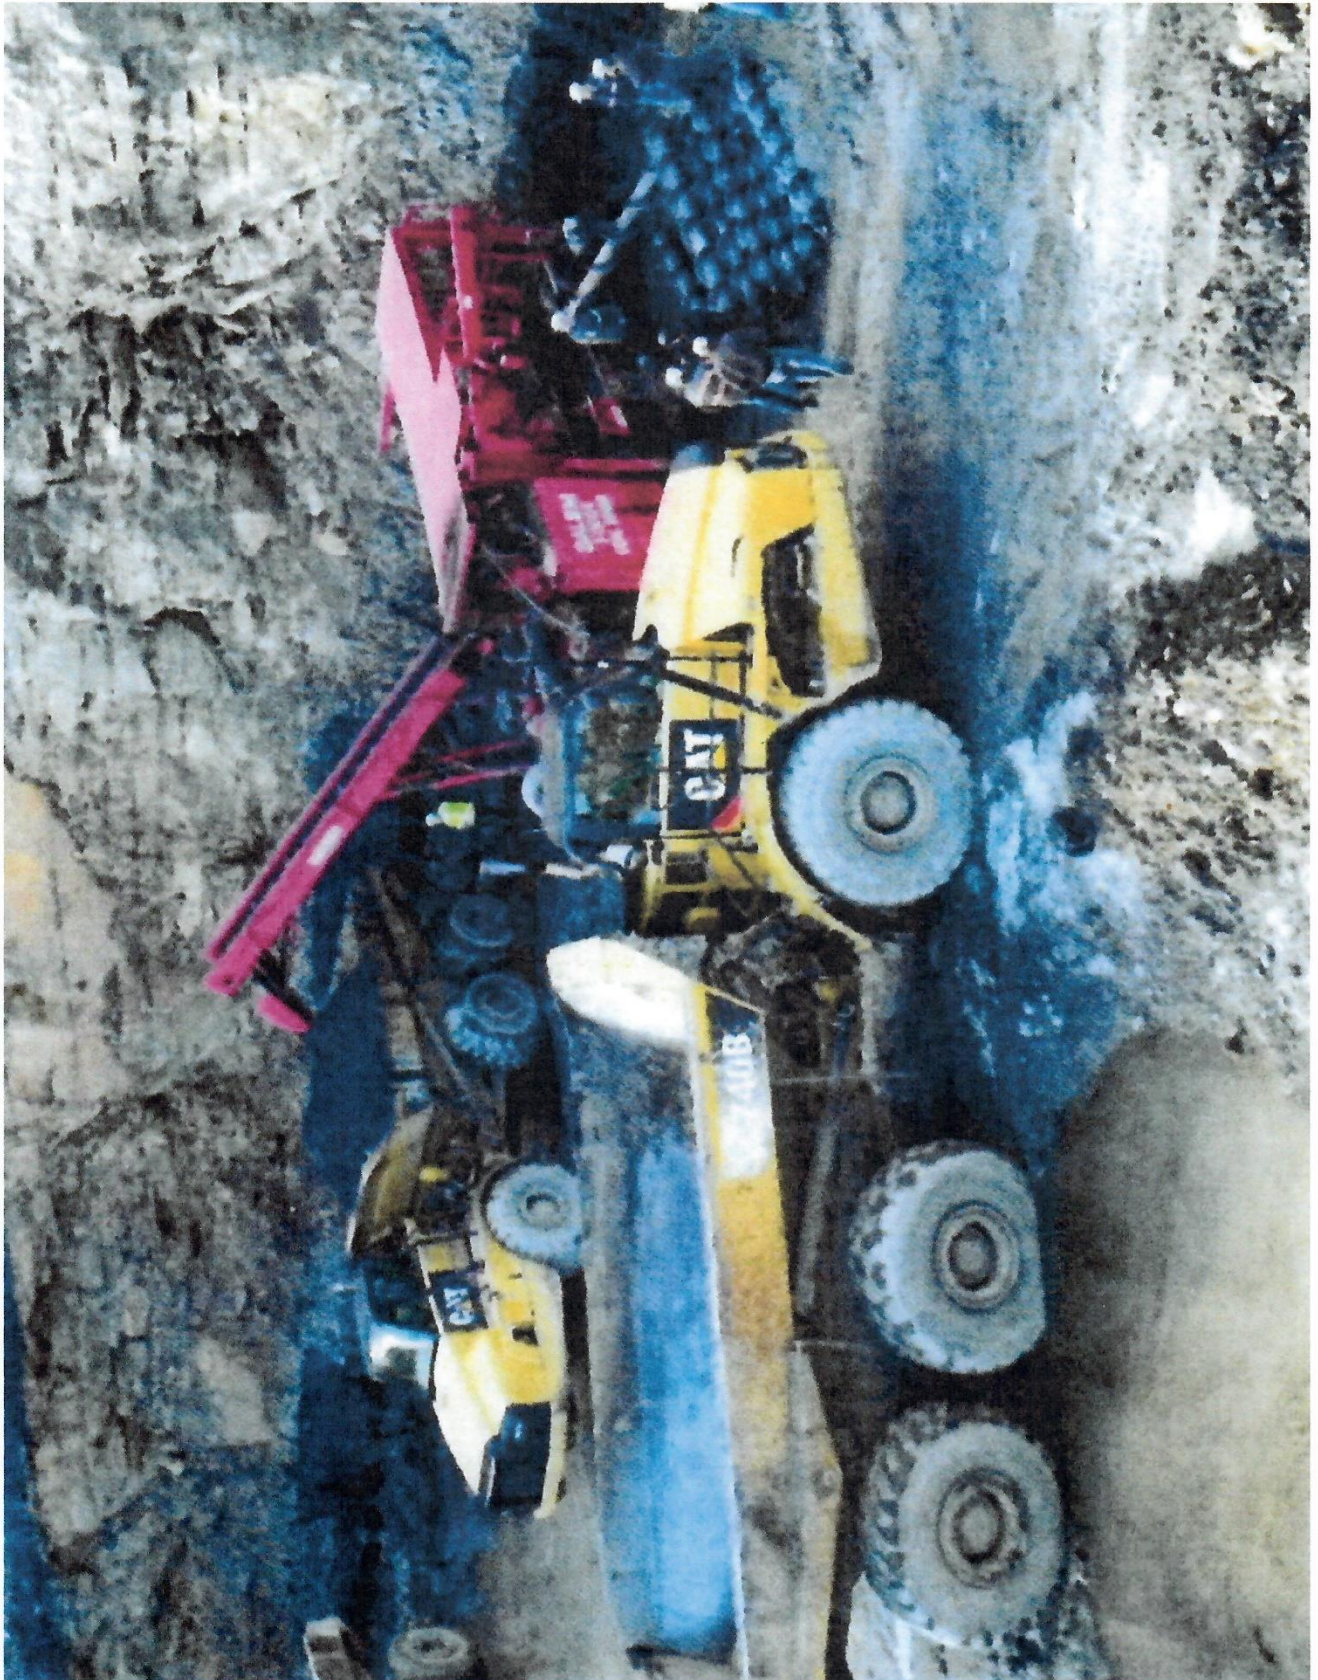
DRAWING & PHOTO OF ACCIDENT SCENE

Mr. Roger Herndon used the handheld control switch to position the auger steel. The auger steel was inadvertently pulled from the auger pan striking Mr. Roger Herndon, knocking him into the stacked pile of auger steel adjacent to the Salem 1500B auger machine. Mr. Bill Herndon witnessed the accident and saw Mr. Roger Herndon fall to the ground. Mr. Bill Herndon immediately rendered assistance then went to get help.

4. At approximately 10:30 a.m. on October 17, 2018 while installing a section of auger steel in the pan of the Salem 1500B auger, Mr. Roger Herndon was struck by the auger steel causing him to fall against the auger steel stacked adjacent to the auger miner.

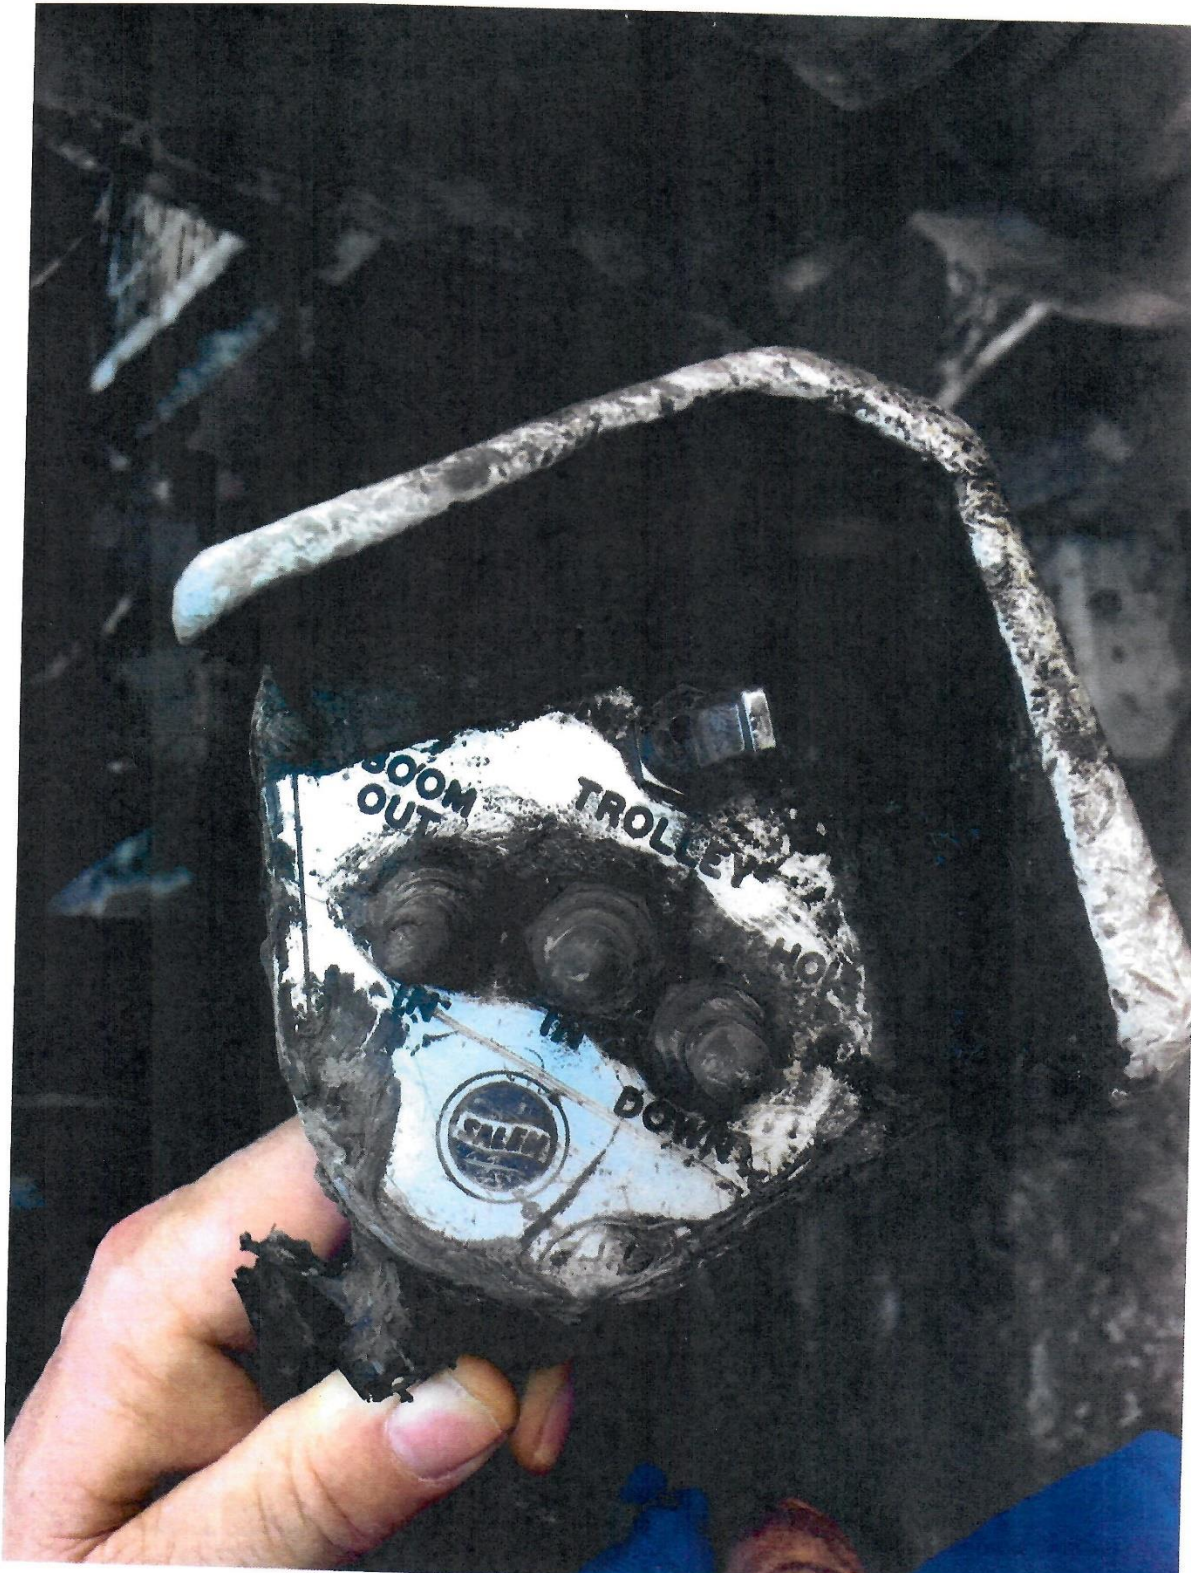
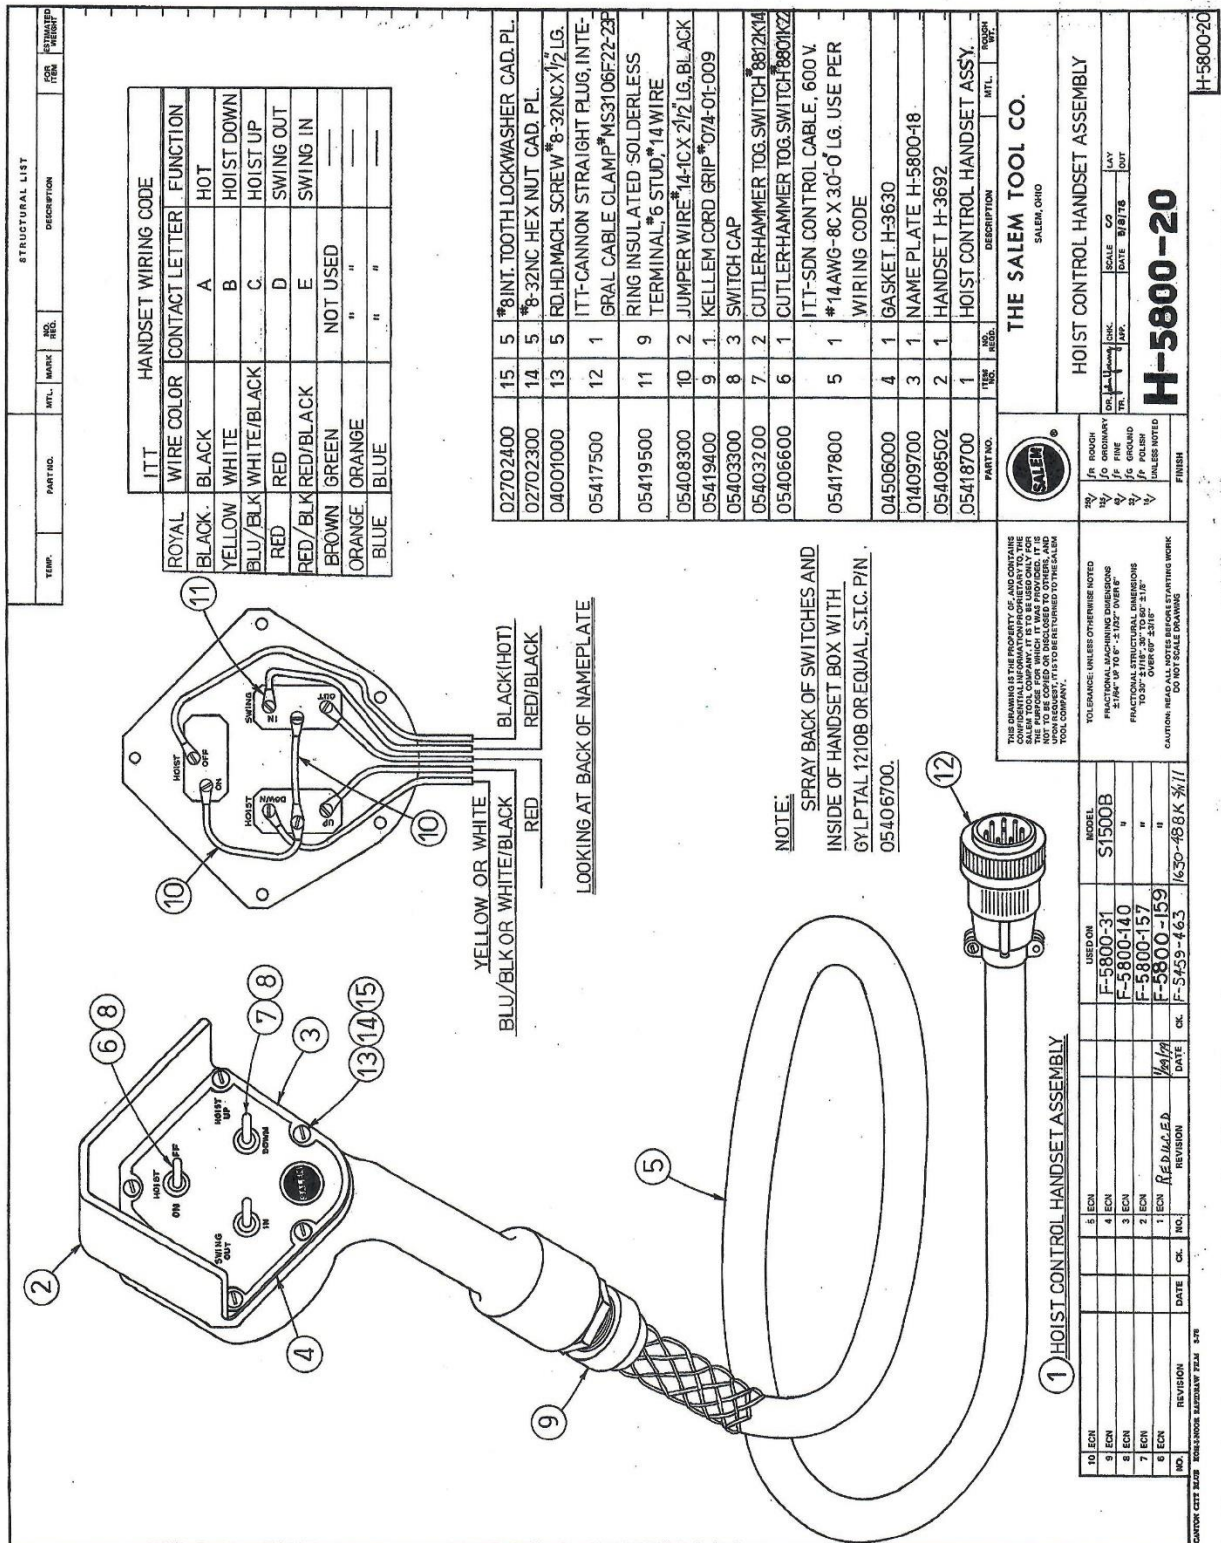
DRAWING & PHOTO OF HANDHELD REMOTE

8. The handheld remote on the Salem 1500B auger was not properly maintained. The switches on the handheld remote were not functioning properly, in that the boom swing was working intermittently and at times did not control the boom swing function. The boom swing on / off switch was not correctly identified. The boom swing switch was energized when it was in the off position and deenergized in the on position. The handheld remote also contained a fourth switch which had no function. The Salem 1500B auger machine was manufactured with a handheld remote containing only 3 functional switches as identified by the manufacturer.

The handheld remote on the Salem 1500B auger machine had not been properly maintained. The switches were not functioning properly. The boom swing was working intermittently and at times

did not control the boom swing function. The boom on-off switch did not function as marked, it is also noted that the remote had an additional switch that had no function.
