West Virginia Office of Miners' Health, Safety and Training

Report of Investigation
Preparation Plant Fatality
(Plate Press Accident)

Midland Trail Energy, LLC
Blue Creek Plant Permit Number L-908

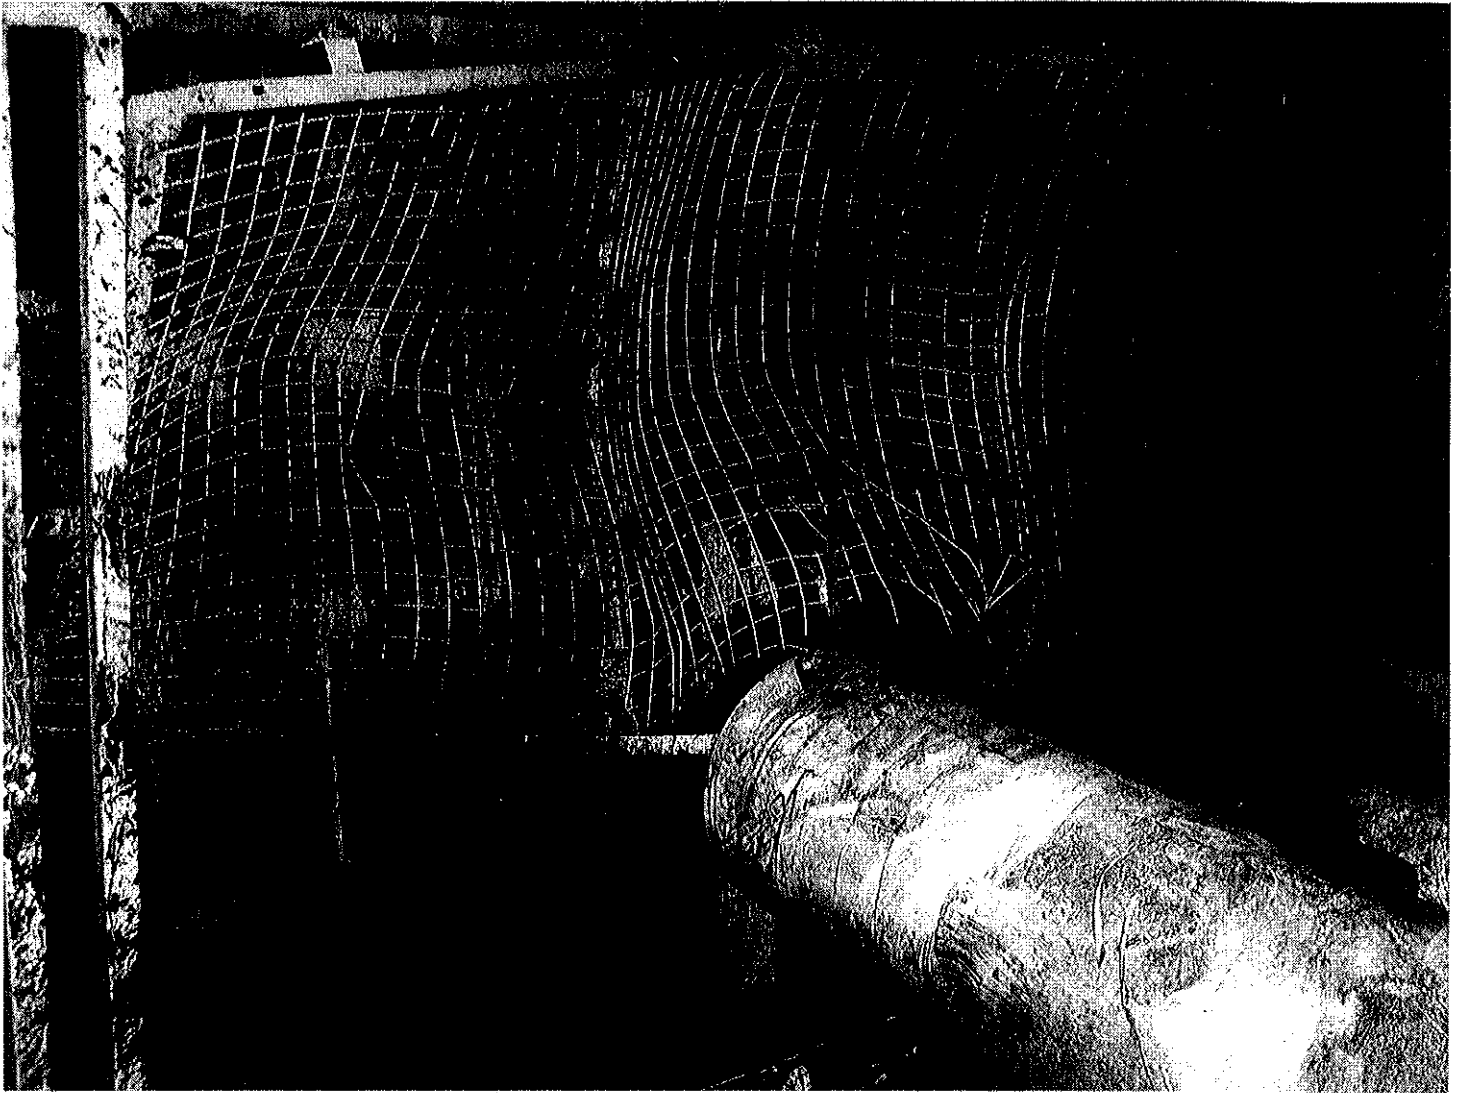
4. The A-side press head frame had excessive cracks/fractures at the cylinder mounting points.
5. The (2) two hydraulic cylinders on the A-side press had excessive cracks/fractures at the mounting flange area that existed prior to the accident.

7. The cylinder flange mounting bolts (8 per cylinder) were found to be excessively loose allowing the cylinders to move/flex during operation.
8. The A-side press was provided with a single non-failsafe switch to shut down the hydraulic system when the maximum hydraulic pressure is achieved. The press is using a normally open set of contacts tips to control the PLC.

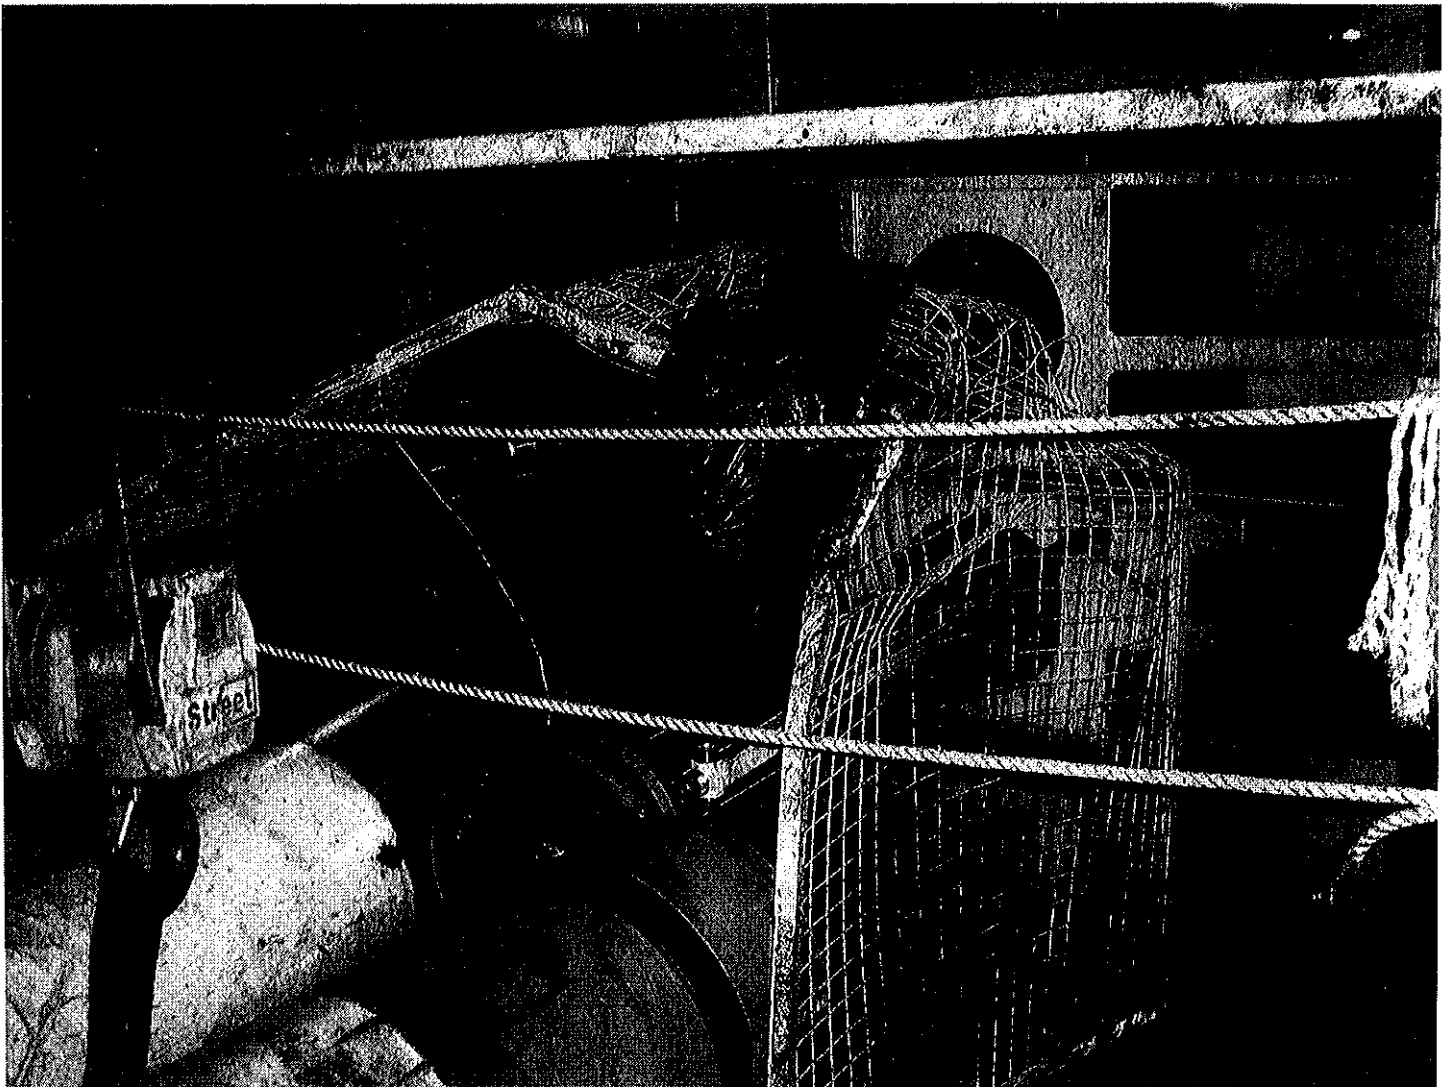
Brandon E. Townsend, an employee for Patriot Coal Company, LLC was fatally injured in a hydraulic accident at approximately 4:00 p.m. on February 6, 2013. Mr. Townsend was positioned directly behind the hydraulic pressing jack when a cylinder failure occurred sending the cylinder body into the walkway where the victim was located pinning the victim between the cylinder body and adjacent plate press.
