West Virginia Office of Miners' Health, Safety & Training

January 4, 2016

**Report of Investigation
Underground Coal Mine Fatality
(Machinery Accident)**

**Greenbrier Minerals, LLC
Lower War Eagle Mine
Permit Number U-4002-99B**

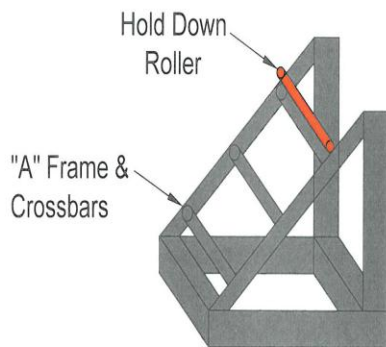
Remote Discharge "A" Frame
With Hold Down Roller

On January 4, 2016, Mr. Peter Sprouse, the midnight shift belt foreman, received fatal injuries when he was caught between a six inch hold down roller and the bottom of the bottom belt located at the No. 1 belt discharge area.

4. Mr. Parsons, the dispatcher, stated that Mr. Sprouse used his hand held radio to notify him that he was entering the mine.
5. The nuts on the two bottom bolts securing the six inch hold down roller's clearance side pillar block bearing had been loosened. A ratchet with a socket matching the two loosened nuts was found on Mr. Sprouse's mantrip.

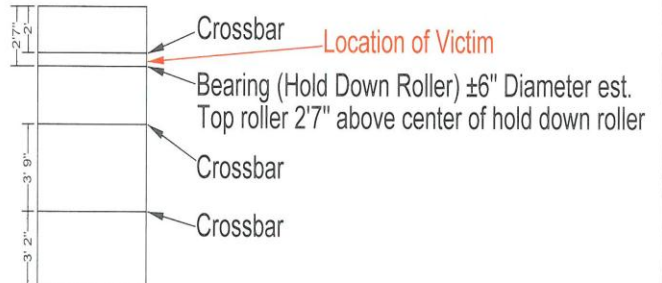
Belt Frame 7' wide X 12' long
Ground to Top of frame - 10'
Ground to Roof - 15'
Ground to Bottom of Belt - 10'3"

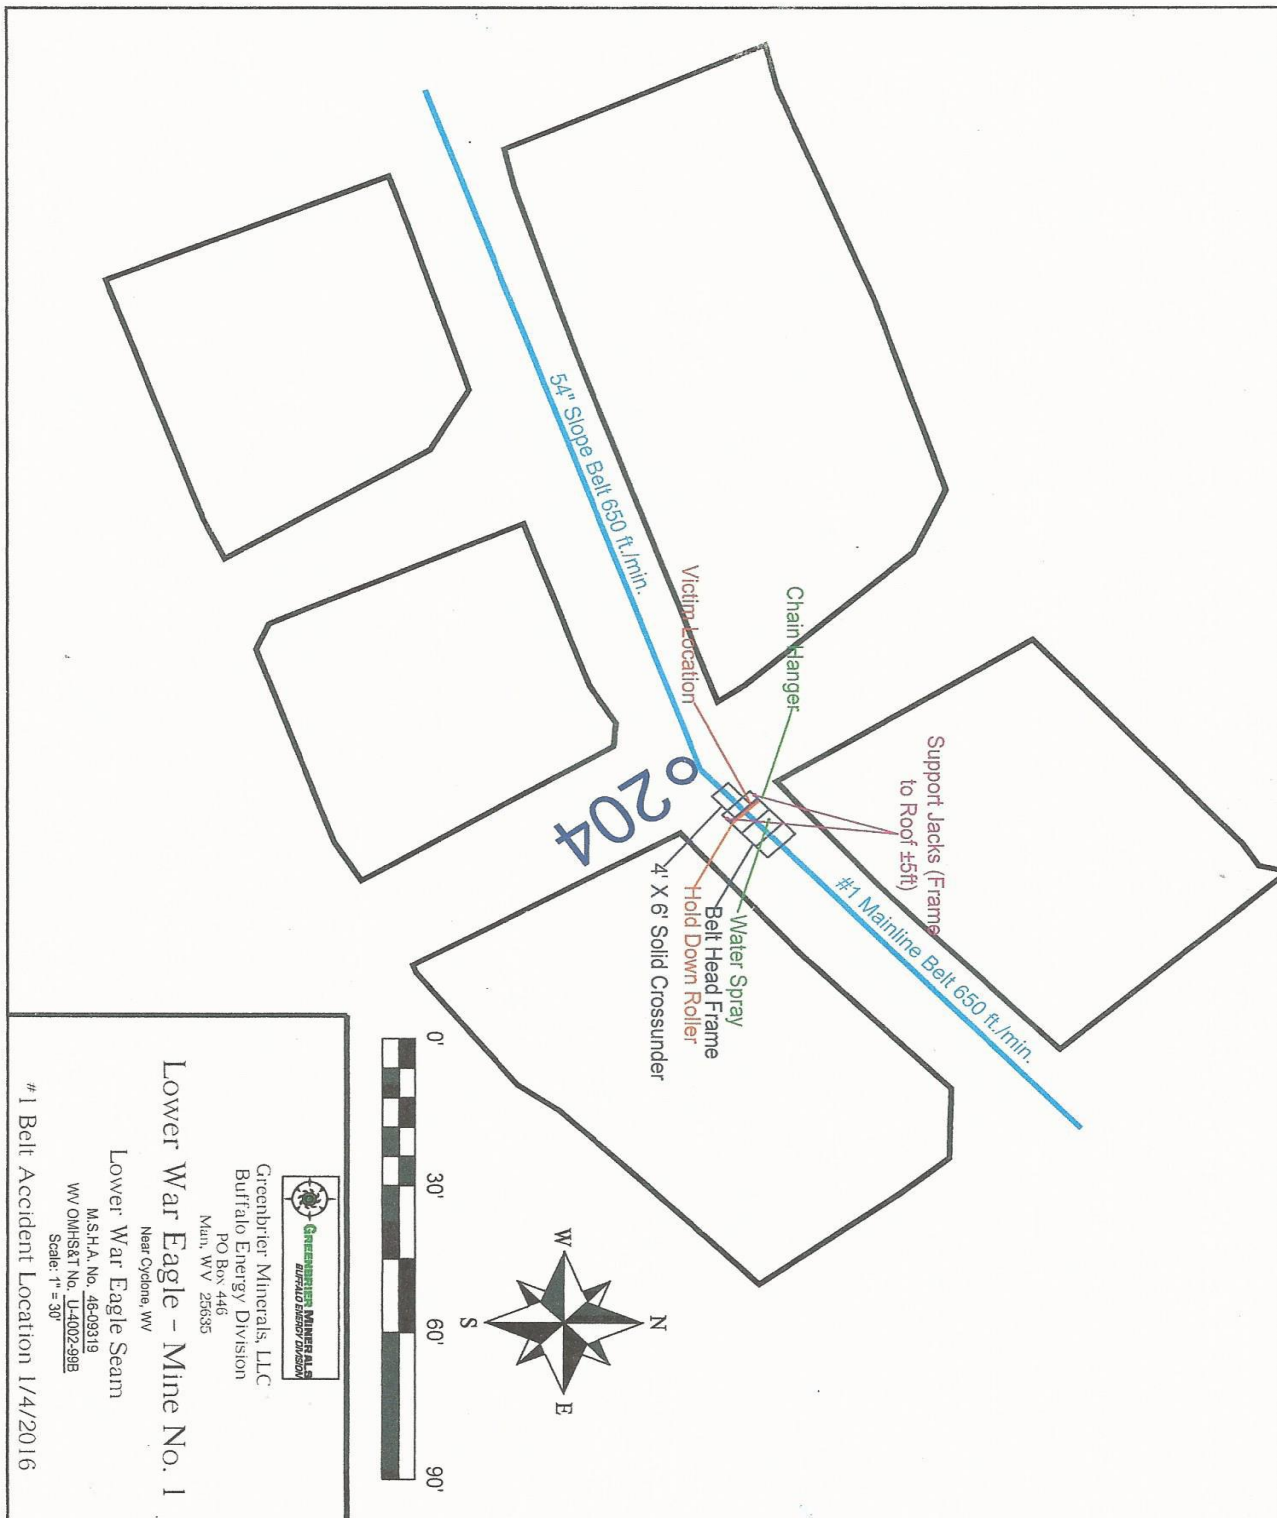
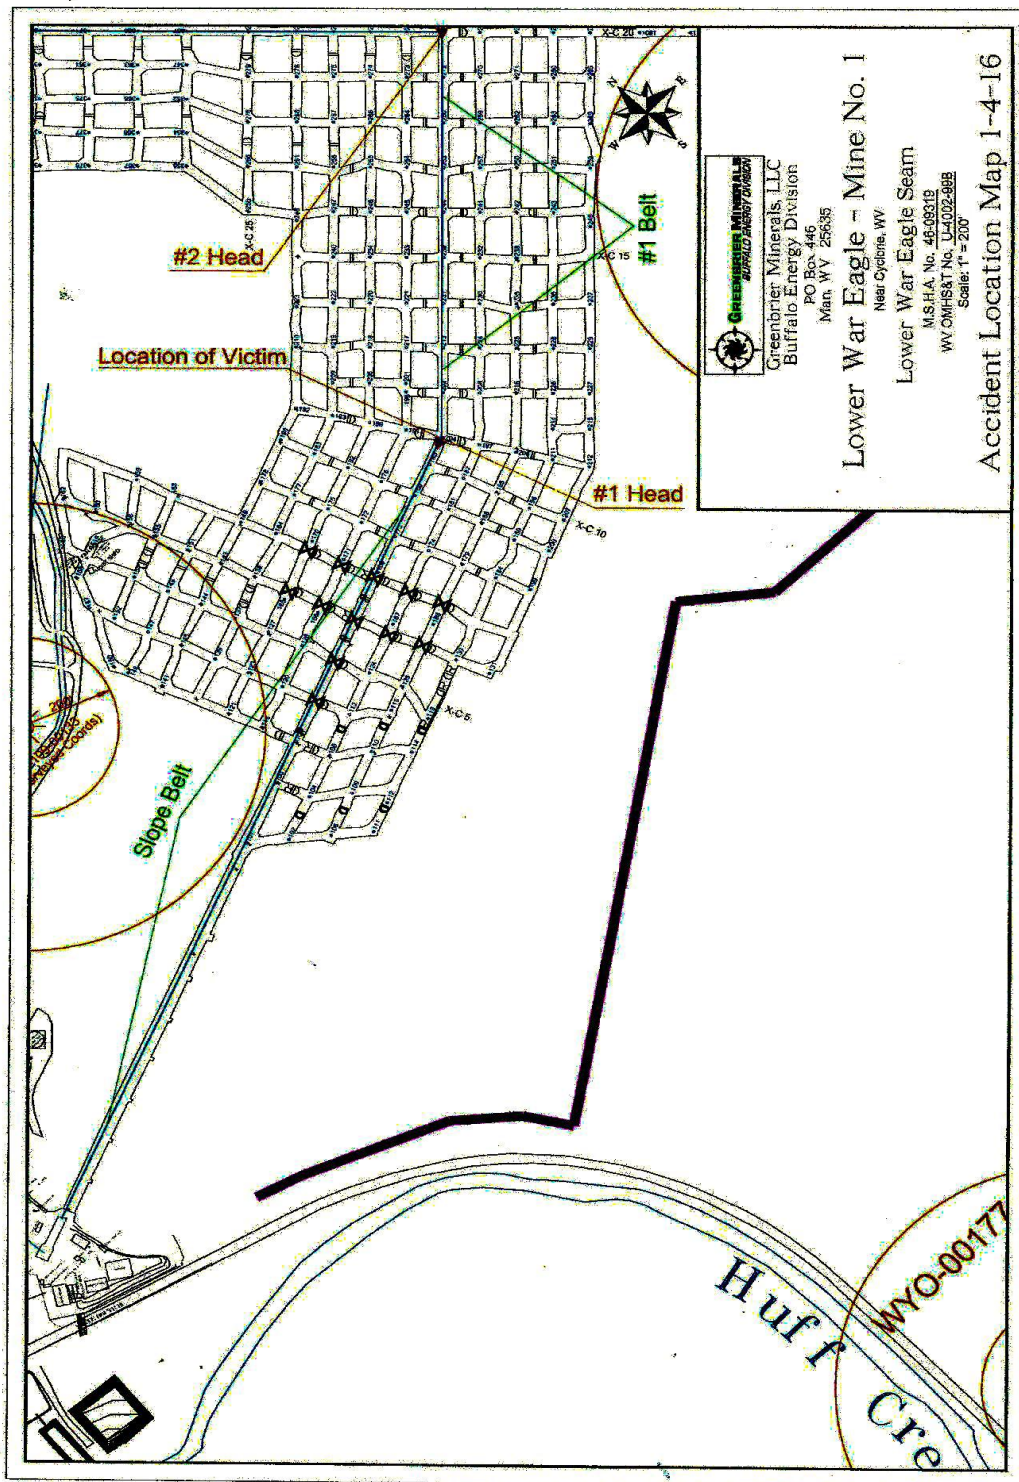
Cross Section #1 Belt Accident Scene 1/4/16

The accident occurred near the No. 1 belt drive when Mr. Peter Sprouse, the midnight shift belt foreman, was caught between the belt and a six inch hold down roller located between the No. 1 drive and the junction head roller. Mr. Sprouse was alone and had arrived at this location at approximately 12:00 a.m. The No. 1 belt was running at the time of his arrival and continued to run until approximately 12:09 a.m. The victim was discovered by Mr. Dave Johnson and Mr. Nick Browning.

It is not entirely clear what exact task Mr. Sprouse was doing at the time of the accident; but, based upon conditions observed in the area, it appears he was preparing for the removal of the hold down roller. Conditions observed during the investigation indicate Mr. Sprouse was working in close proximity to the No. 1 belt which, according to the belt monitoring systems, was running at the time of the accident. The nuts on the two bottom bolts securing the six inch hold down roller's clearance side pillar block bearing were discovered to be loose and it is presumed that Mr. Sprouse loosened these nuts in preparation for removal of the hold down roller. Additionally, no ladder was found at the accident site although the hold down roller is located approximately ten feet off the mine floor.

In accordance with Title 56, Series 8, Section 9.4 of the West Virginia Mining Laws, the comprehensive mine safety program for the Lower War Eagle Mine is to be modified to include beltline safety precautions and guidelines being submitted by the operator to prevent a reoccurrence. In addition, everyone at the mine is to be instructed on the modifications before normal work activities resume.
