**West Virginia Office of Miners' Health Safety and
Training**

February 7, 2013

**Report of Investigation
Underground Coal Mine Fatality
(CRUSHING)**

**Pocahontas Coal Company
Affinity Mine
Permit Number U00015282A**

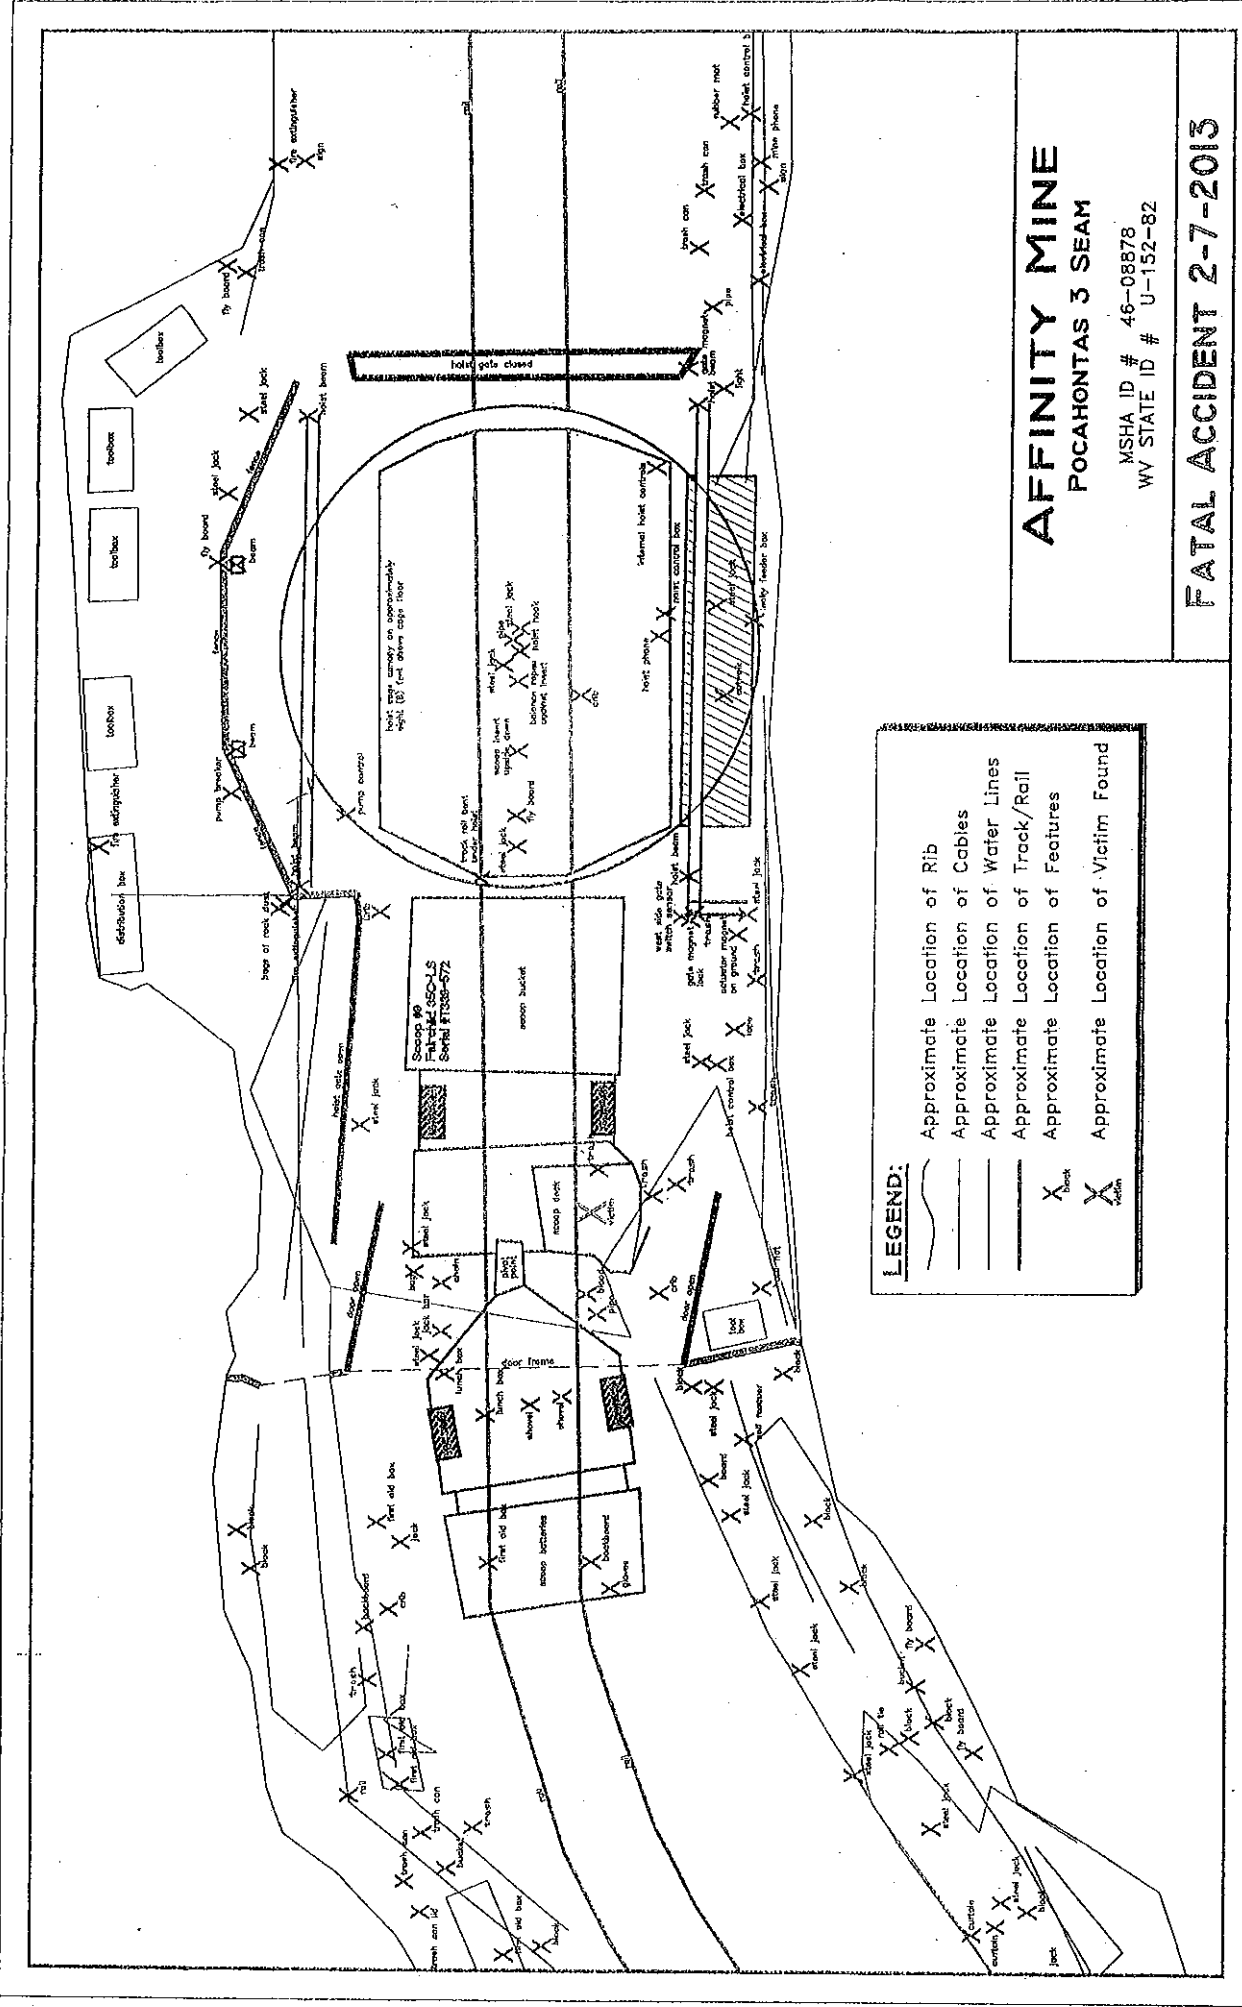
AFFINITY MINE
POCAHONTAS 3 SEAM
 MSHA ID # 46-08878
 WV STATE ID # U-152-82
FATAL ACCIDENT 2-7-2013

According to witness statements, on trip No. 4, the scoop approached the elevator from the west gate side bucket end first. The west gate of the elevator was open, and the air lock door nearest the elevator was open. As the scoop operator was pushing the insert out of the scoop

bucket onto the floor of the elevator, the operation signal (5 second alarm that sounds prior to the elevator moving) started flashing. The operation signal meant that the elevator had been called to the top by Michael Roberts. Chris Donaldson immediately yelled at Edward Finney to get off the scoop or back up the scoop because it was going to go to the top.

The elevator began to ascend and raised the scoop to an almost vertical position. Once the elevator reached a height greater than the length of the scoop, the scoop and insert were released. The scoop fell back to the mine floor. It is not clear if Mr. Finney tried to exit the scoop or was thrown out, but he was found crushed under the deck of the scoop. The insert landed in the sump below the elevator.

1. The set of airlock doors on the west side of the service hoist shaft shall be removed.
2. Every employee shall be re-trained regarding the proper procedures for safely operating the hoist.

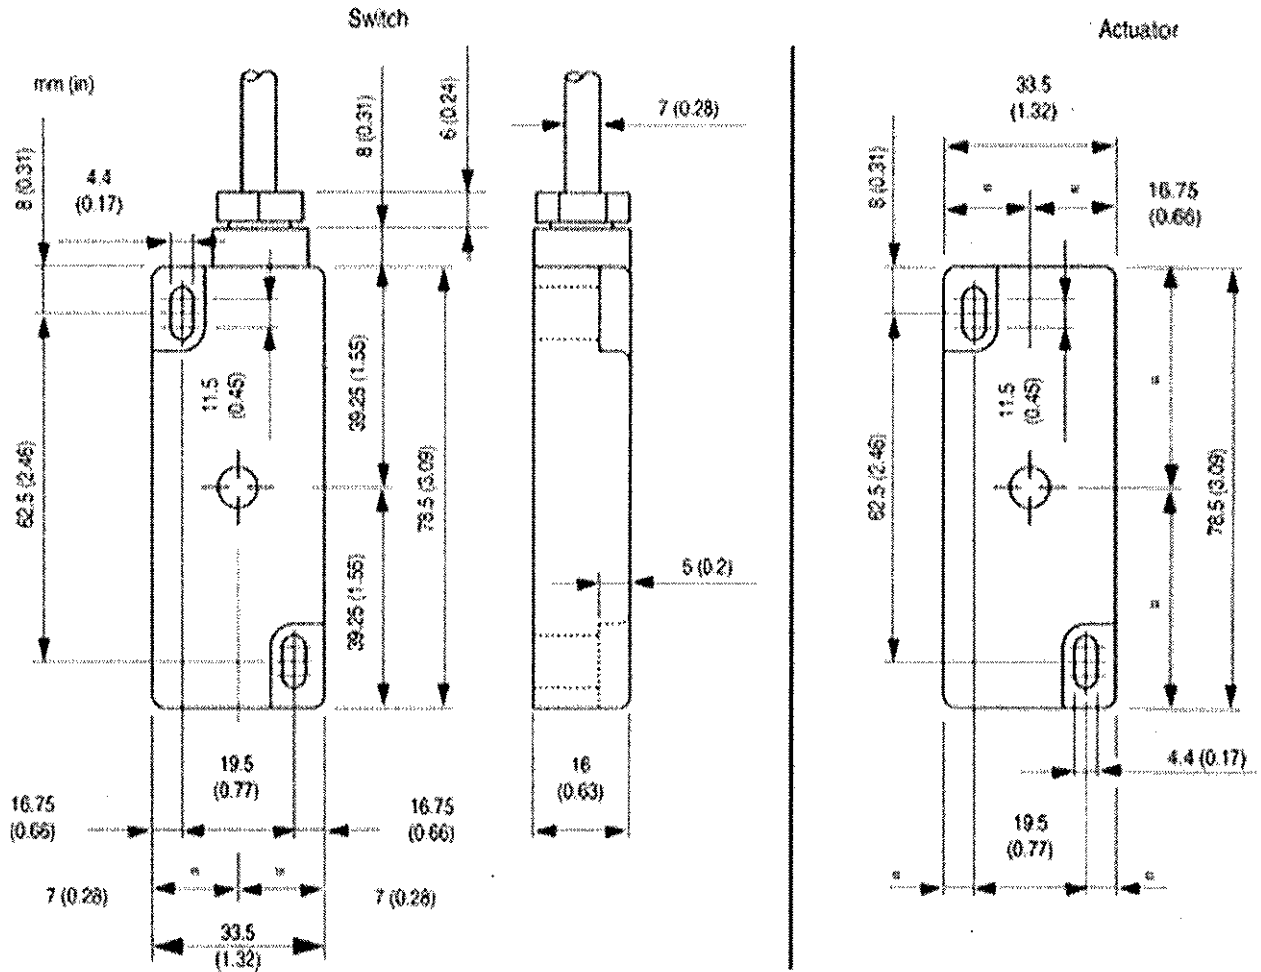
Gate Safety Switch

At some time during these events, Glen Paugh observed the safety switch from the bottom landing west gate attached (taped) to the bottom landing west gate sensor mounted on the west gate post. Glen Paugh proceeded to remove the tape securing the safety switch to the post and let the safety switch and the tape fall to the mine floor. When the west gate safety switch actuator magnet was taped to the sensor on the west gate post, it defeated the fail-safe circuit designed to prevent the elevator from moving if the gate is open. After the tape and switch were removed from the gate post, the elevator would not move. (See sketch – page 7)

16. Inspection of the Fairchild scoop (Co. No. 100 serial No. 239572) revealed four (4) violations, none were contributory to this accident.
17. As per witness testimony the safety switch for the west gate had been removed from the west gate and been taped to the sensor mounted on the west gate post, this action defeated the fail-safe circuit designed to prevent the elevator from moving if the gate is open.

The elevator's bottom landing west gate safety switch had been intentionally defeated. This act allowed the elevator to operate with the bottom landing west gate open. The initial two (2) loads of trash were placed on the elevator with both (east and west) gates open. Because the east gate safety switch was working properly, the elevator was not able to start. The third (3rd) load was placed on the elevator without incident. It is not known if the elevator had been sent to the bottom without a recycle trigger or if the insert was placed on the elevator in less than 5 minutes. Immediately prior to the accident, the elevator was sent to the bottom and a loaded flat

Notice of Violation: Chapter 22A, Article 2, Section 40(29) Special Assessment: The energized electrical/magnetic safety switch in use on the west gate of the main hoist at the mine level is not being properly maintained. This safety switch was intentionally defeated by removing the activator/magnet portion of the switch from the west gate and taping it to the electrical stationary portion of the switch located on the west gate frame assembly.

This created the condition whereby the control system was provided a false indication that the gate was closed when the gate was actually open.

3. The service hoist control circuit will be modified as follows to provide redundant protection to all four gates (two switches per gate) this will be completed by February 18, 2013 as follows:

- a. One gate switch will open when the gate is closed giving the PLC an open permissive.
 - b. One gate switch will open when the gate is closed giving a hardwired circuit to the relay for the PLC permissive.

4. All gate switches of the service hoist will be mounted using tamper resistant hardware.
5. The duration of the service hoist visual and audible alarm (surface and bottom) will be increased from five (5) to fifteen (15) seconds.
