West Virginia Office of Miners' Health, Safety and Training

March 17, 2015

Report of Investigation  
Surface Coal Mine Fatality  
(Haulage Accident)

Rogers Petroleum Services, Inc.  
Contractor ID Number C-00004637  
Contractor for  
Elk Run Coal Company, Inc. dba Republic Energy  
Republic Energy Surface, Permit Number S-3021-95

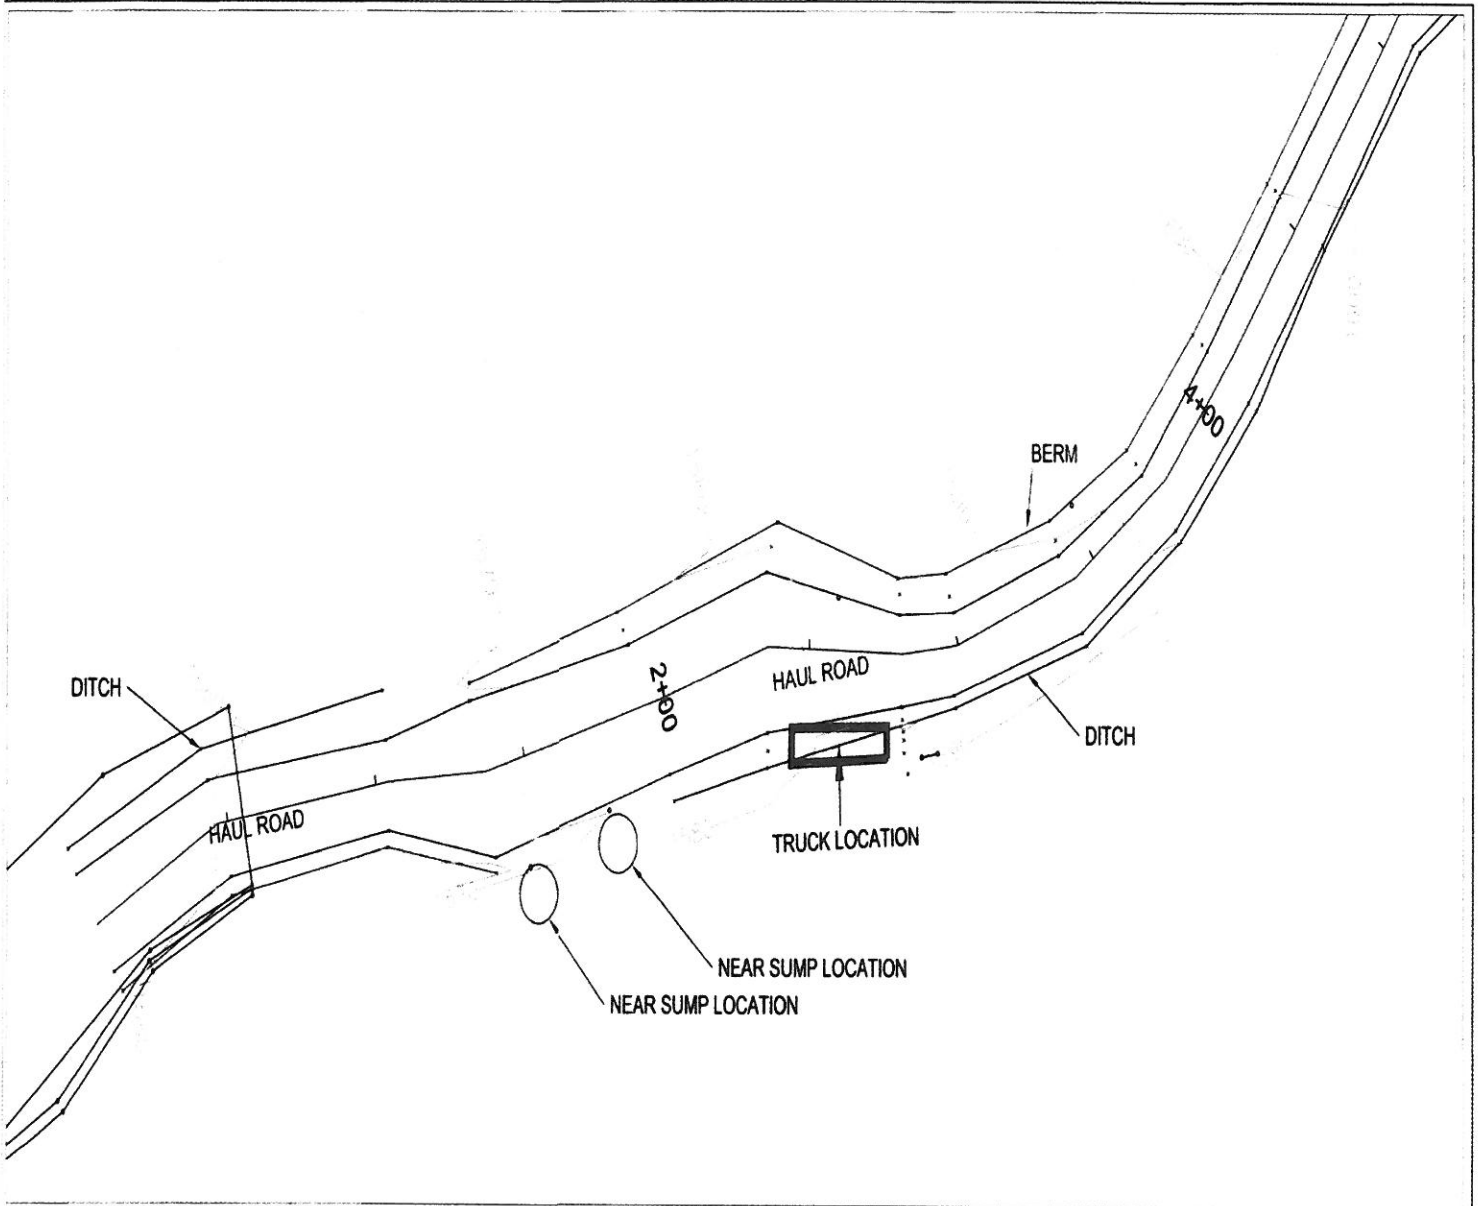
<b>Republic-Pax Group</b>
	4101 State Drive Scenic, WY 29117
	<b>EAGLE LAND NO. 1</b>
	Permit NO. S-3021-05 MSHA ID. 46-08054
Date: 3/17/15	
<b>Fuel Truck Accident 3/17/15</b>

Von E. Bower, an employee for Rogers Petroleum Services, Inc., was fatally injured in a haulage accident at approximately 3:05 a.m. on March 17, 2015. Mr. Bower was driving the No. 101 Kenworth fueling truck on a downhill portion of the Eagle Land haul road between the #27 and #28 marker signs, when he lost control of the vehicle and it overturned. Mr. Bower died from injuries he sustained during the accident.

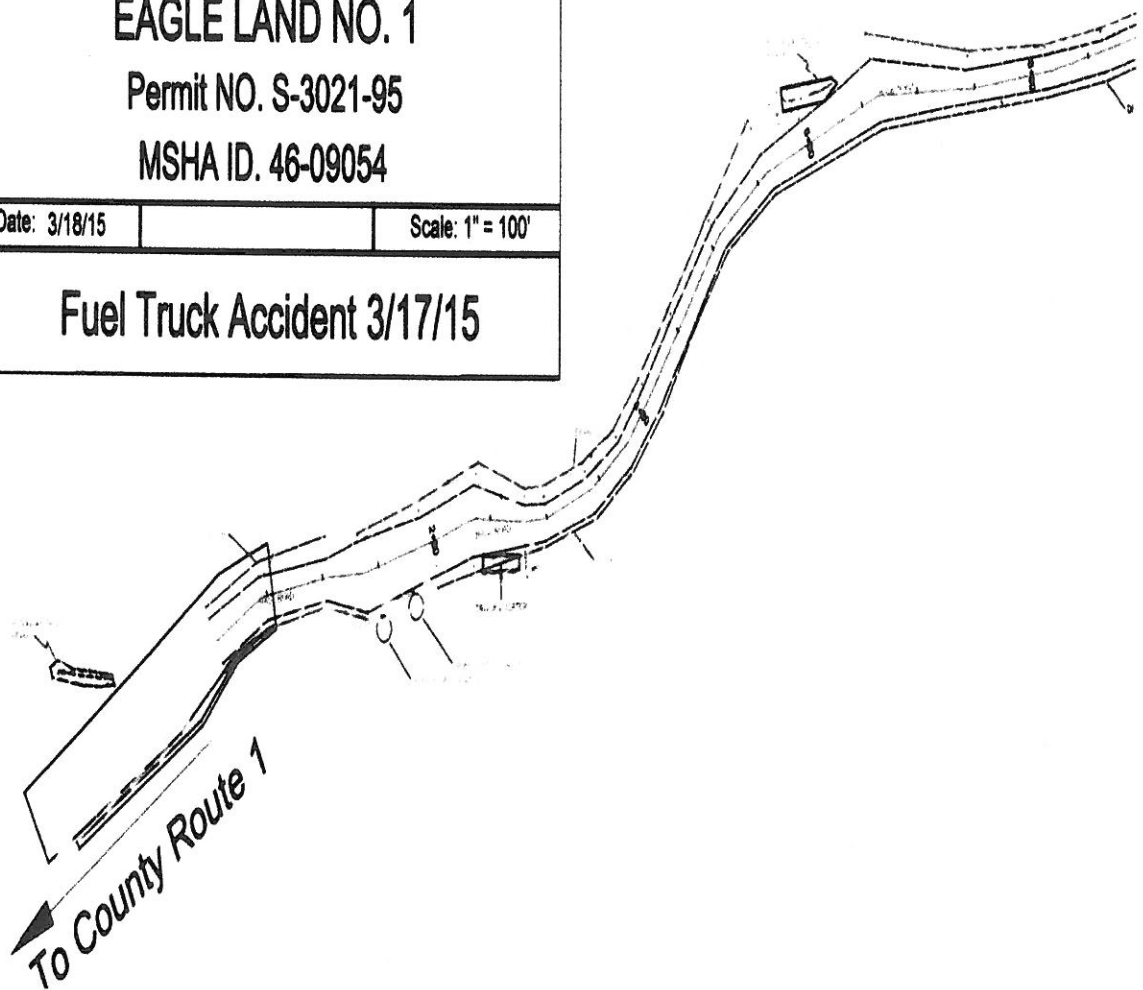
# Planametric View

2. On March 17, 2015, the action taken to correct the hazardous condition was to have a grader blade the road to remove the roughness.
3. The downhill portion of the Eagle Land haulage road between the #27 and #28 road markers had a slope of 13.1%. Witnesses stated that the condition of the haul road at the time of the accident was good.
