**REPORT OF FATALITY**

**CONSOLIDATION COAL COMPANY**

**LOVERIDGE MINE**

# Accident 2-12-13 Main West Haulage Motor trip from 124 to 126 block

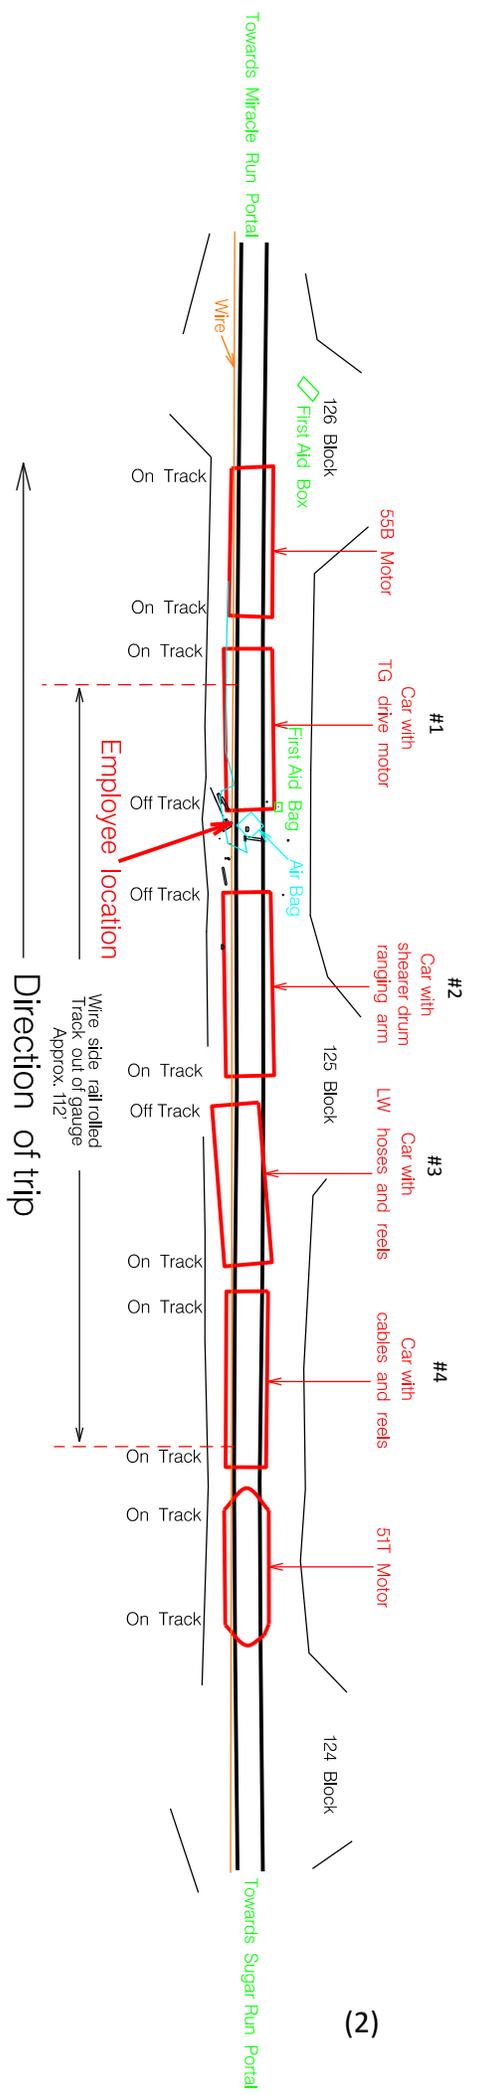
11. The total weight of the Irwin supply cars were: #1 car approximately 68,200 lbs., #2 car approximately 53,000 lbs., #3 car approximately 43,200 lbs. and #4 car approximately 28,200 lbs. (see sketch) The weight of a supply car when empty/unloaded was approximately 28,000 lbs.

12. The track conditions at the accident site were dry and level. The wire side rail rolled out for a distance of approximately 112 ft.
13. The proper track gauge is approximately 42 in. The track gauge where the rail rolled was approximately 44-46 in.
14. The 85 lb. track haulage has been installed/attached with wooden ties and spikes on both sides of the bottom rail flange.
15. The spikes were not properly securing the rail flange to the wooden ties for approximately 112 ft. when measured at the accident scene.
16. No violations or defects were detected during the inspections of the supply cars, locomotives, trolley wire and the haulage clearances.
17. No violations/hazardous conditions at the scene of the accident were recorded in the pre-shift and on-shift examination books prior to the accident.

The victim and a co-worker attempted to rerail a loaded supply car. The two miners used a pneumatic lifting bag along with a crib block and a half header board to raise and support the elevated car. Mr. Clutter bent over to examine the wheels to determine the correct alignment. While bending over, Mr. Clutter used a slate bar to raise or align the wheels when the car suddenly shifted and slid across the rail. The weight and the movement of the car propelled the slate bar striking him above the right eye and across the bridge of the nose, resulting in fatal injuries.

An enhanced inspection of the gauge and general maintenance of the track rails shall be conducted from the Miracle Run bottom to the Sugar Run bottom. Proper repairs of the rails, ties and spikes shall be performed where required. The company must train or retrain motormen and any other employee who would be expected to use lifting bags for the purpose of rerailing haulage equipment according to the manufacturer's recommendations for safe and proper usage. The company must add an addendum to their Comprehensive Mine Safety Program concerning track haulage safety and review with all employees.
