West Virginia Office of Miners' Health, Safety and Training

MARCH 13, 2013

**Report of Investigation
Underground Coal Mine Fatality
(Roof Fall Accident)**

**Newtown Energy Inc.
Peerless Rachel Mine
Permit Number U-00500504**

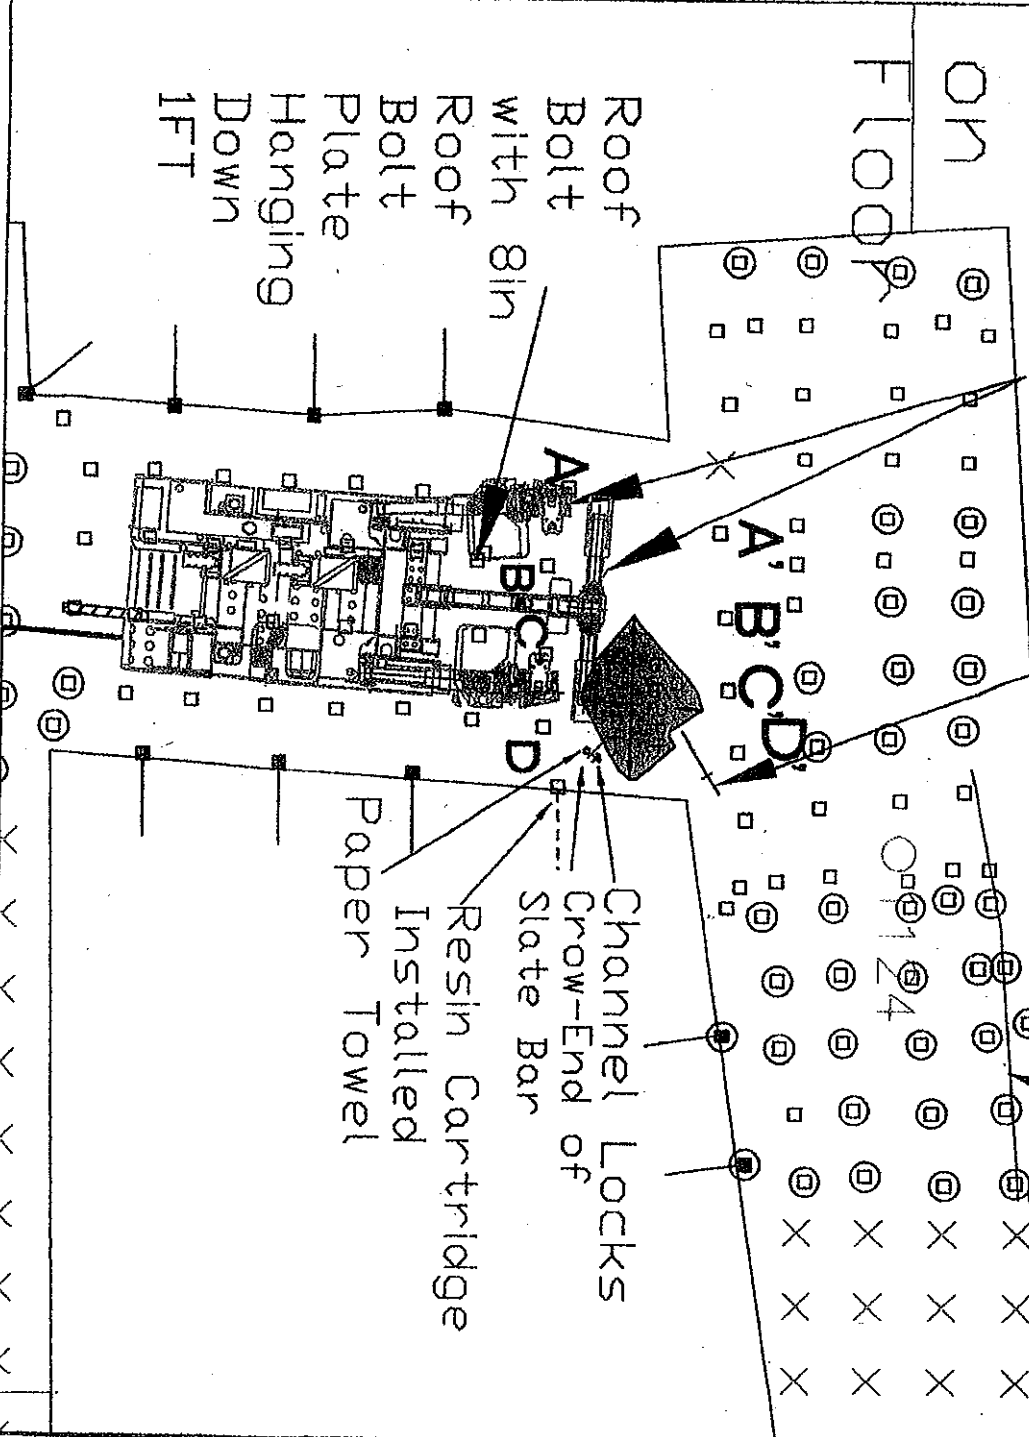
Incident Print

Roof Bolt Line Curtain In Place Hanging from Bolts Along Rib

Roof Bolt with 8in Roof Bolt Plate Hanging Down 1FT

Channel Locks
 Crow-End of Slate Bar
 Resin Cartridge Installed
 Paper Towel

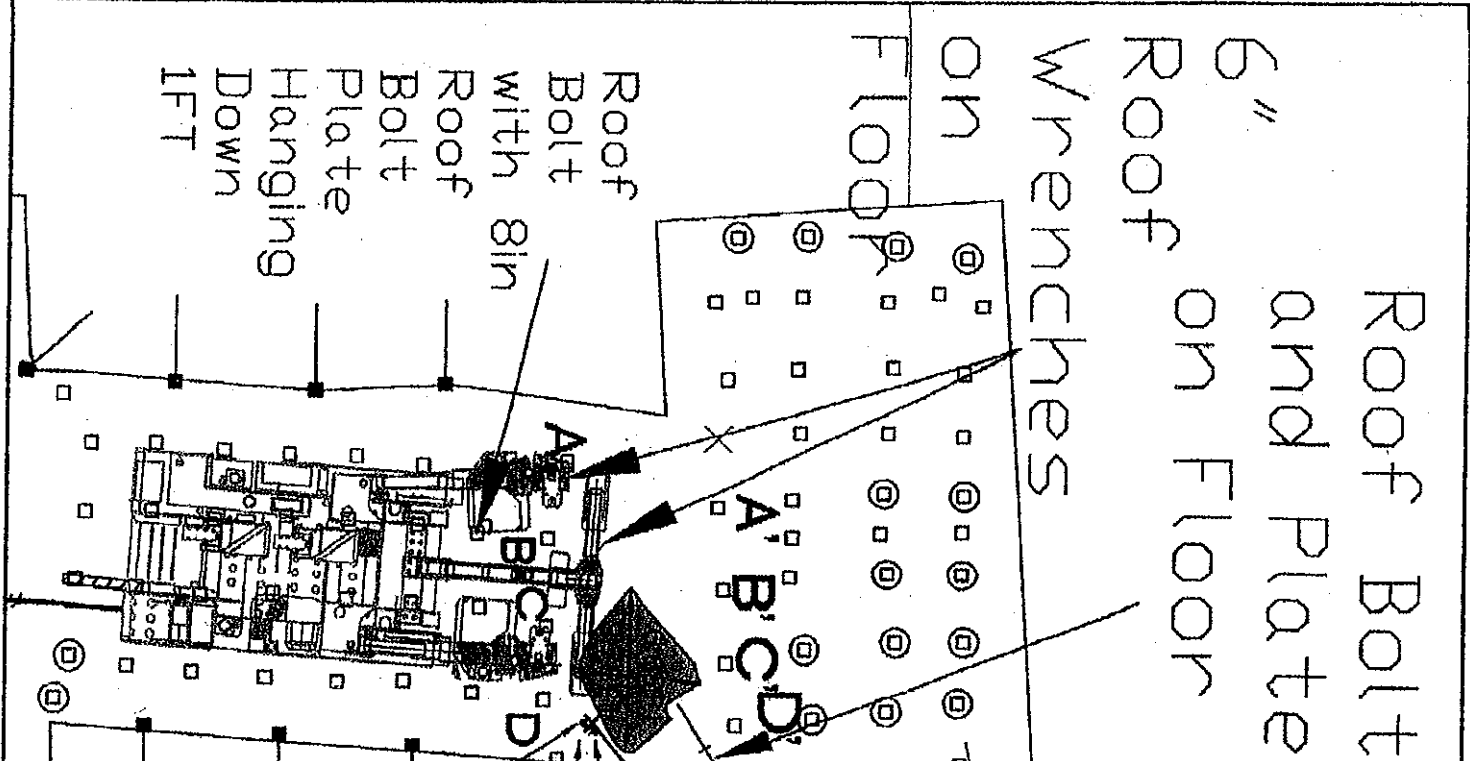
NOTES:
X Approximate Location Of Victim

Based on the information provided during the interviews of witnesses who were present at the time of the accident or shortly thereafter the West Virginia Office of Miners' Health, Safety & Training marked this drawing with the symbol - X identifying the approximate location where it concluded the victim was found immediately after the accident.
