West Virginia Office of Miners' Health, Safety and Training

JUNE 13, 2017

**Report of Investigation
Underground Coal Mine Fatality
Machinery / Crushing**

**Rockwell Mining LLC
Gateway Eagle Mine
Permit Number D00008482C**

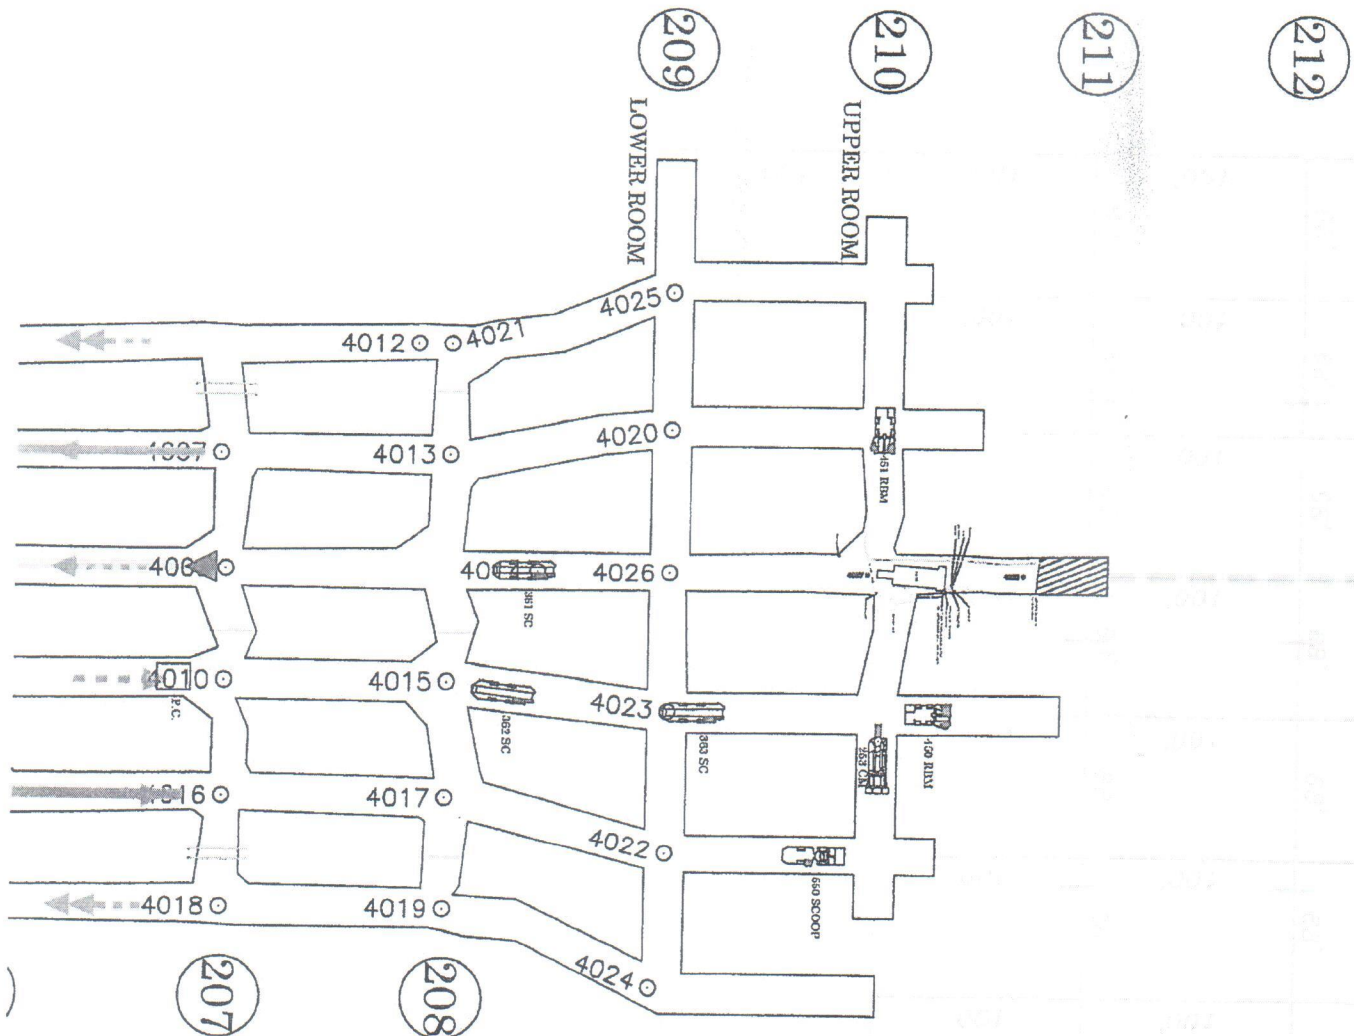
MMU-011-0

shuttle car outby and proceeded back to the No. 3 entry to help with the move of the continuous miner. Mr. Blankenship walked up to the continuous miner conveyor boom and observed Mr. Osborne pinned between the continuous miner cutter head and the coal rib on the operator's side. Mr. Blankenship then went to the left side roof bolter and informed Mr. Christopher Atkins (Section Foreman), Mr. Steve Elswick (Left Side Roof Bolt Operator) and Mr. Jarrod Terrell (Left Side Roof Bolt Operator) what he observed. Mr. Atkins and Mr. Elswick went to the continuous miner and saw Mr. Osborne pinned between the continuous miner cutter head and the coal rib. Mr. Elswick then checked for a pulse and testified, "none was found". At that time, Mr. Elswick stated that Mr. Atkins became overwhelmed and he left the scene and went to the section mine phone to report the accident and to help retrieve first aid equipment. The first aid equipment was brought to the No. 3 entry from the section power center by Mr. Mark Stepp (Right Side Shuttle Car Operator). Mr. Elswick asked for a few men who can handle this kind of event to assist him. Mr. Elswick asked Mr. Dave Havey (Right Side Continuous Miner Operator) to help. Mr. Havey replied "I don't know if I can do this". Mr. Elswick then said, "you must, I don't have a PTO (Power Take Off) to operate the continuous miner, I need you". Mr. Elswick removed Mr. Osborne's remote control box and gave it to Mr. Havey. Mr. Elswick then went to the front of the continuous miner with Mr. Rusty Nelson (Electrician) and Mr. Daniel Moore (Right Side Roof Bolter Operator). On the count, of 3 Mr. Elswick instructed Mr. Havey to move the continuous miner to the left away from Mr. Osborne. Utilizing the ESO (Emergency Stop Override) to bypass the proximity detection system, Mr. Havey moved the continuous miner. Mr. Elswick and Mr. Jarrod Terrall lowered Mr. Osborne to the mine floor. Mr. Elswick then instructed Mr. Havey to move the continuous miner away from them. While moving the continuous miner, Mr. Havey stated that "he noticed that one of the cats had spun and tried to kick back in the direction of the right rib". Mr. Osborne was then placed on a backboard and loaded onto a Brookville mantrip that was located at the outby end of the continuous miner. Boone County Ambulance Unit 60 arrived at the mine site at 9:16 p.m. The mantrip arrived on the surface at 9:22 p.m. An Electrocardiogram was performed by the Boone County Ambulance Authority Medics. Boone County Ambulance Authority Unit 60 then transported Mr. Osborne from mine property. Mr. Osborne was pronounced deceased by Dr. Marie Nowak, M.D. at 9:37 p.m. through Central Med Base.

8. The mine floor in No. 3 entry where the accident occurred was wet with irregularities (ledges) on the left side of the entry.
9. After completing the mining cut in the No. 3 entry, Mr. Osborne was alone and tramming/place changing the continuous miner out of the No. 3 entry when the accident occurred.

10. Mr. Osborne was operating the Joy Model 14CM15-JM5801 while standing beside the cutter head on the operator's side in a restricted red zone at the time of the fatal accident.

On June 13, 2017 at approximately 8:47 p.m. coal was being mined on the evening shift at the Rockwell Mining LLC, Gateway Eagle Mine. Mr. Rodney Osborne, No. 1 section left side continuous miner operator was tramming/place changing the continuous miner out of the No. 3 entry while the ESO (Emergency Stop Override) was engaged (based on downloaded information from the Joy Smartzone Generation 2 Proximity Detection System) and was in the restricted red zone area of operation. Mr. Osborne was pinned between the continuous miner cutter head and the right side coal rib and received fatal crushing injuries.

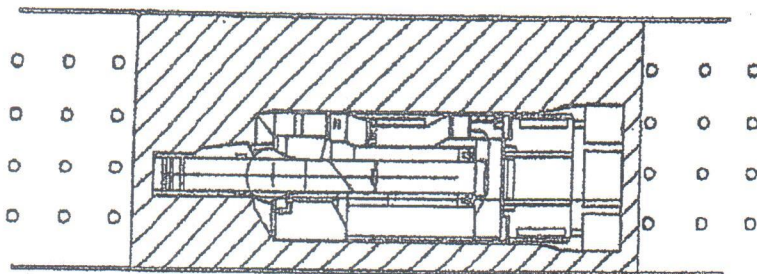
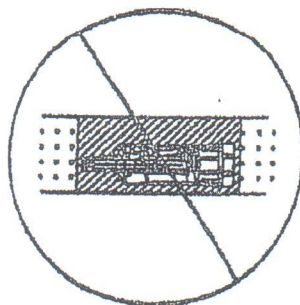
Restricted Red Zone Area

No person will go in by the continuous miner operator's work position while the continuous miner is being operated.

When trimming the continuous mining machine to the next place, other than when cutting or loading coal, no one will be located along either side of the continuous mining machine, and they will be in a safe location out by the boom and head. All personnel shall remain at least 4 feet outside the Red Zone in all directions.
