**WEST VIRGINIA OFFICE OF MINERS' HEALTH, SAFETY AND TRAINING**

**REPORT OF FATALITY  
BELT CONVEYOR  
UNDERGROUND COAL MINE**

**August 25, 2017**

**CARTER ROAG COAL COMPANY  
PLEASANT HILL MINE  
PERMIT #U00104391B**

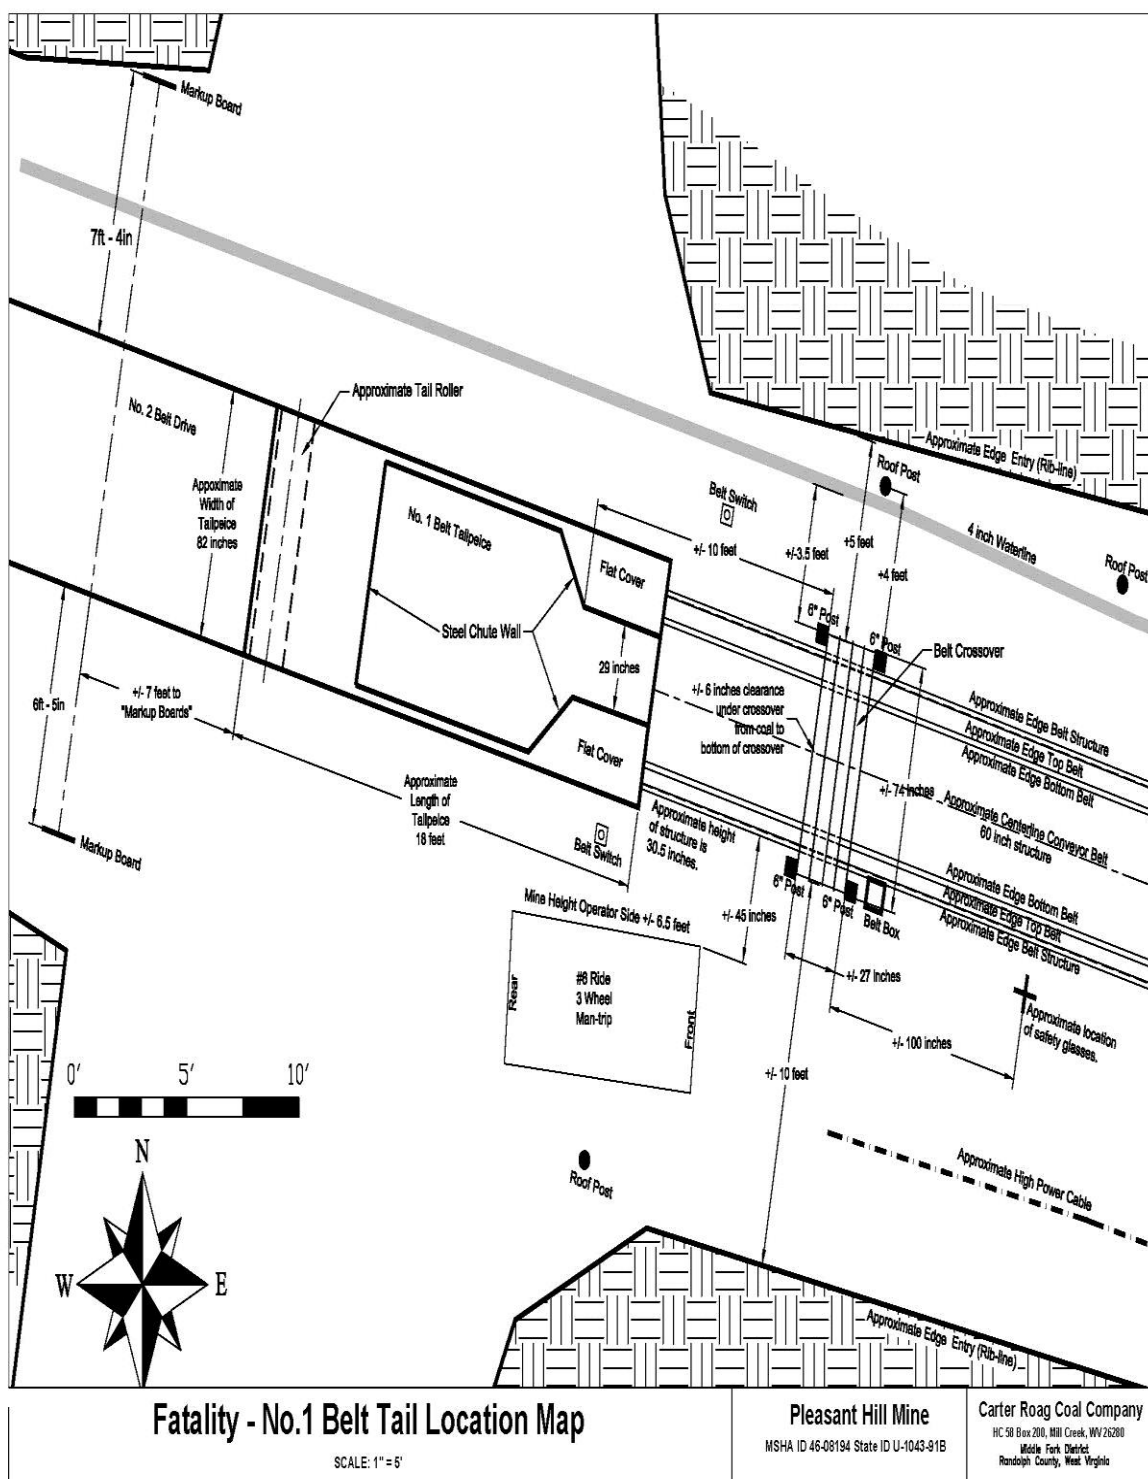
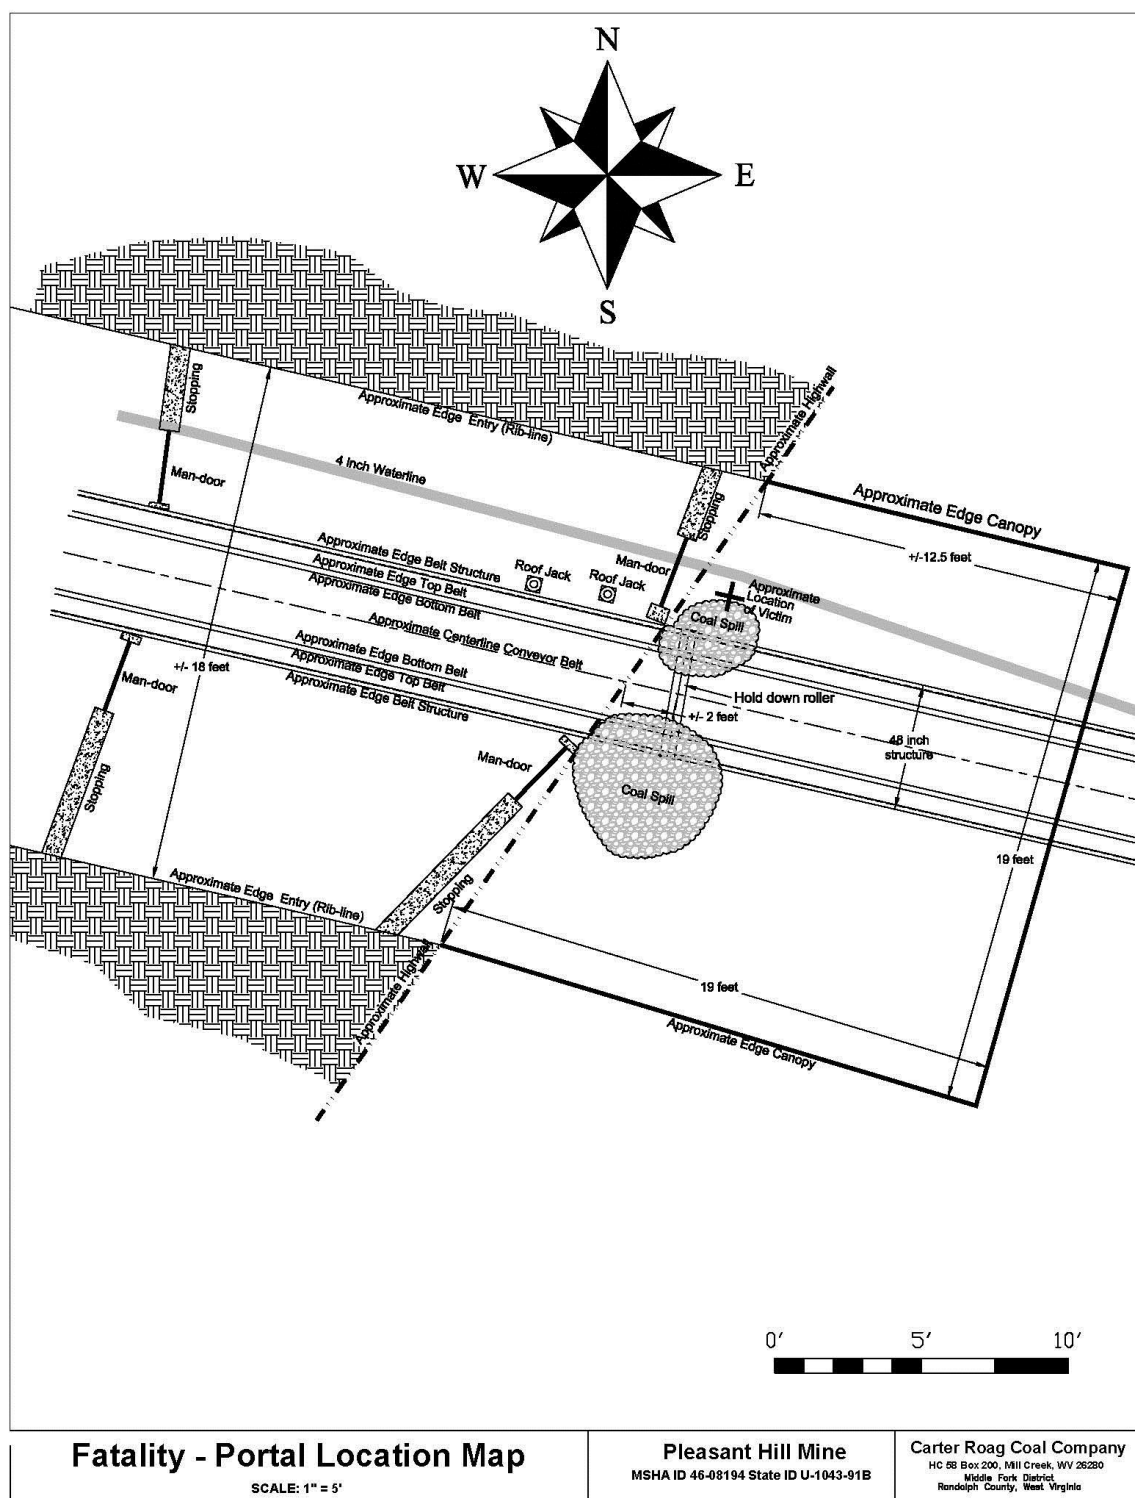
Based upon the above observations, it is believed the victim fell from the No. 1 belt tailpiece onto the No. 1 conveyor belt and then came in contact with a conveyor belt crossover located outby 10 feet from the tailpiece. The conveyor belt crossover is constructed of four 6 inch x 6 inch square wooden posts on the corners. The flooring, steps and hand rail are 1 inch rough cut lumber secured by nails. The distance from the top/center of the conveyor belt, without coal, measured 15 inches to the bottom of the conveyor belt crossover. The distance from coal on top/center of the conveyor belt to the bottom of the conveyor belt crossover measured 7 inches. Evidence indicates that the victim was on top of the belt when he came in contact with the bottom of the crossover. This contact dislodged flooring boards and moved the entire crossover structure 1 1/8 inches outby. Additionally, there was evidence that the victim came in contact with the mine roof at other locations along the belt, where there was close clearance. Tracking information reveals that the victim's hard hat was temporarily caught at the inby side of the hold down roller, located on the surface. The victim was at this location until enough coal was built up at this hold down roller spilling coal and ejected him to the offside of the conveyor belt.

19. Evidence indicated that Mr. Jones attempted to step across the energized/operating No. 1 conveyor belt tailpiece outby the steel chute walls where it measured 29 inches across the exposed area of the belt.

21. The conveyor belt crossover is located 10 feet outby the No. 1 belt tailpiece. Evidence indicates that usage of the crossover was infrequent.
22. The conveyor belt crossover is constructed of wooden materials and sustained considerable damage when the victim passed under it.

23. The conveyor belt crossover measured 27 inches wide. The vertical clearance from the deck of the crossover to the mine roof varied and measured 31 inches to 42 inches. The deck of the crossover measured 74 inches in length and 46 ½ inches from the mine floor.

24. The distance from the center of the top/center of the empty No. 1 conveyor belt to the bottom of the crossover measured 15 inches.
25. The distance from the center of the top of the No. 1 conveyor belt with coal present to the bottom of the crossover measured 7 inches.

1. Install a physical barrier/guarding at all the affected belt tailpieces to prohibit persons from traveling across the belt/tailpiece.
2. Until physical barrier/guarding is in place at each tailpiece and/or the crossover repairs are made, employees will be trained to utilize belt switches when necessary to travel to the offside of a belt.
3. Repair existing belt crossover located outby the #2 belt drive.
4. Evaluate all belt crossovers and where necessary make proper repairs to ensure they are adequate in width where height may complicate travel.
