Report of Investigation
Underground Coal Mine Fatality
(Crushing)

ICG Beckley, LLC
Beckley Pocahontas Mine
U-3011-95A

Region IV Office
550 Industrial Drive
Oak Hill, WV 25901
McKennis P. Browning, Inspector-at-Large

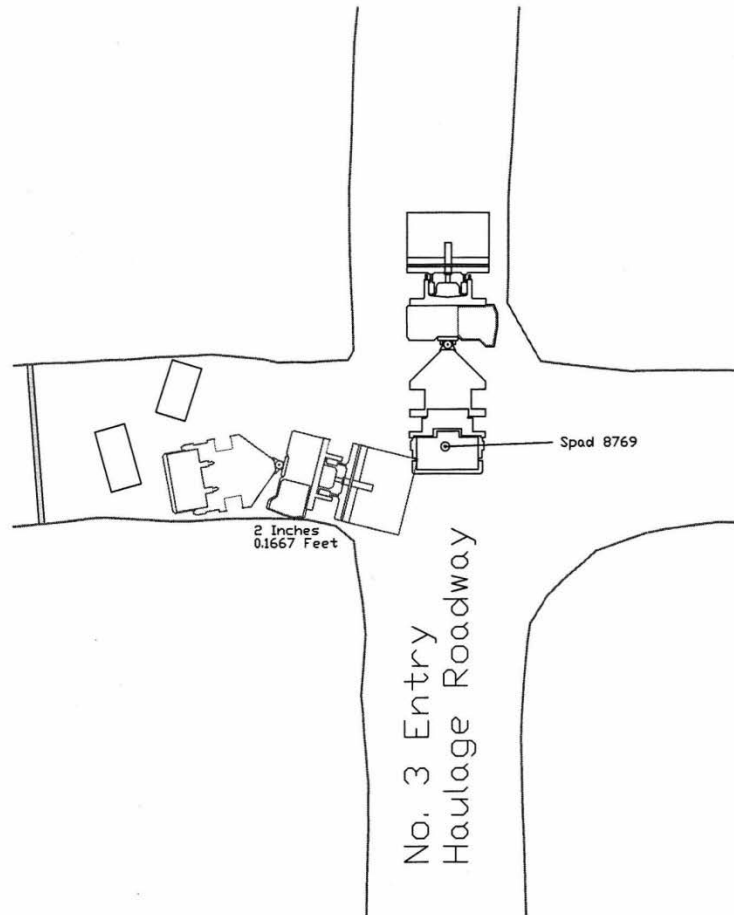
Re-Enactment of Fatal Accident
ICG Beckley, LLC
Beckley Pocahontas Mine
U-3011-95A

9. The left rear battery tray arm of the No. 11 scoop struck the front left corner of the No. 8 scoop bucket. This action moved the No. 8 scoop resulting in Mr. Byers being pinned between the mine rib and the operator's compartment of the No. 8 scoop.

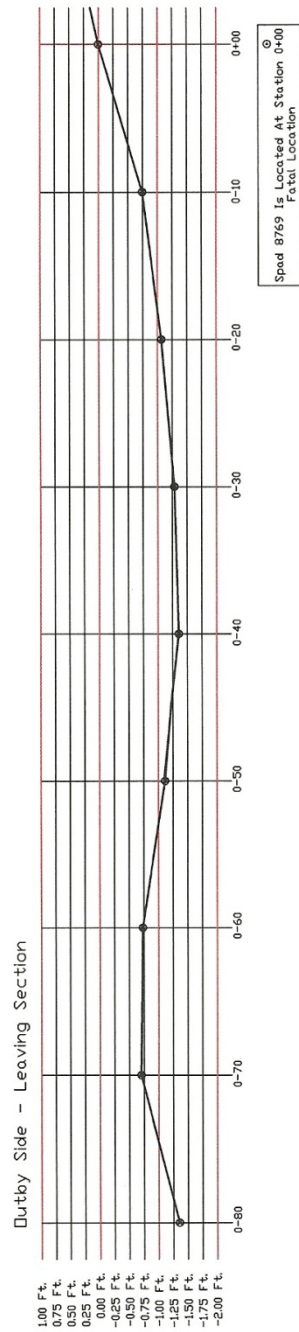
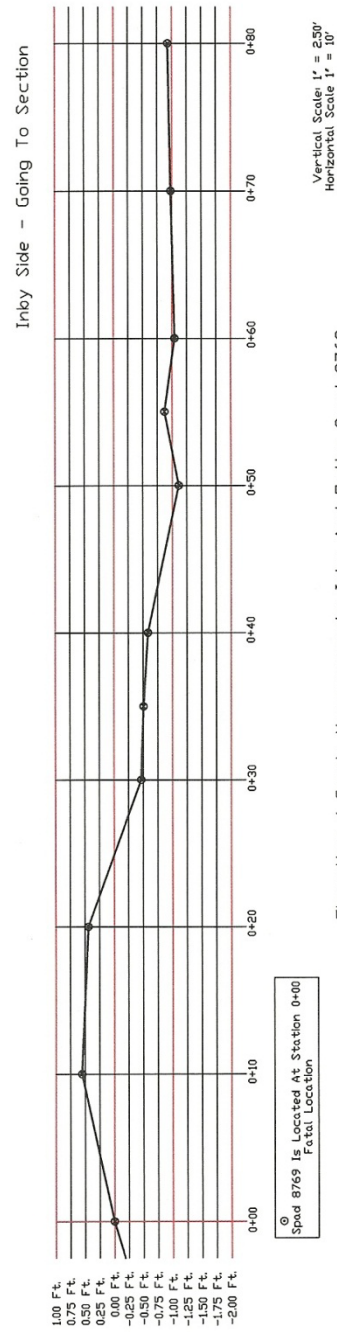
Grade Measurements Of No. 3 Entry Roadway

Elevation / Grade Measurements Inby And Outby Spad 8769,
At Intersection Of Fatal Accident In The ICG - Beckley Pocahontas Mine

Vertical Scale Is Exaggerated By A Factor Of 4

5. The crosscut located at the No. 8 scoop charging station overall height is approximately 72 inches and the average width is 19 feet 6 inches.
6. The No. 8 scoop charging station in the crosscut is located at the top of an incline in the No. 3 entry haulage roadway that starts approximately 50 feet inby the charging station and crests at the inby corner of the charging station.
