WEST VIRGINIA OFFICE OF MINERS' HEALTH, SAFETY AND TRAINING

**ROOF FALL FATALITY
(UNDERGROUND MINE)**

SEPTEMBER 13, 2012

**CONSOLIDATION COAL COMPANY
BLACKSVILLE #2 MINE
PERMIT NO. D-5744**

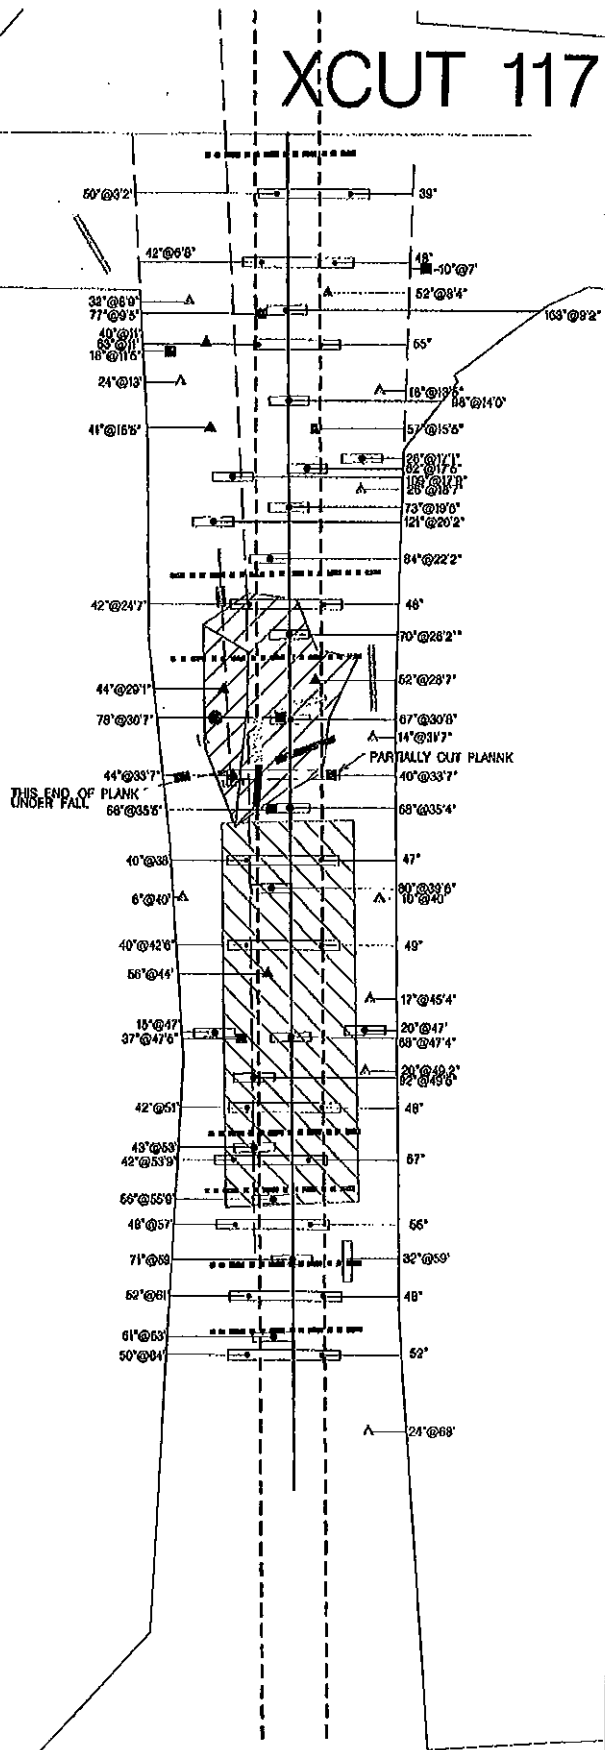
MAP OF ACCIDENT SITE 2

The victim was fatally injured when he cut a permanent roof support/roof bolt installed through a two hole plank that was supporting a large piece of mine roof. When the bolt was

cut, the plank and roof rock fell pinning the victim against the mine floor and rib resulting in fatal injuries.
