West Virginia Office of Miners' Health, Safety and Training

November 4, 2007

Report of Investigation  
Coal Preparation Plant  
Fatal Fall of Person Accident

Weatherby Processing Corporation  
Remington Preparation Plant  
Permit Number L-732

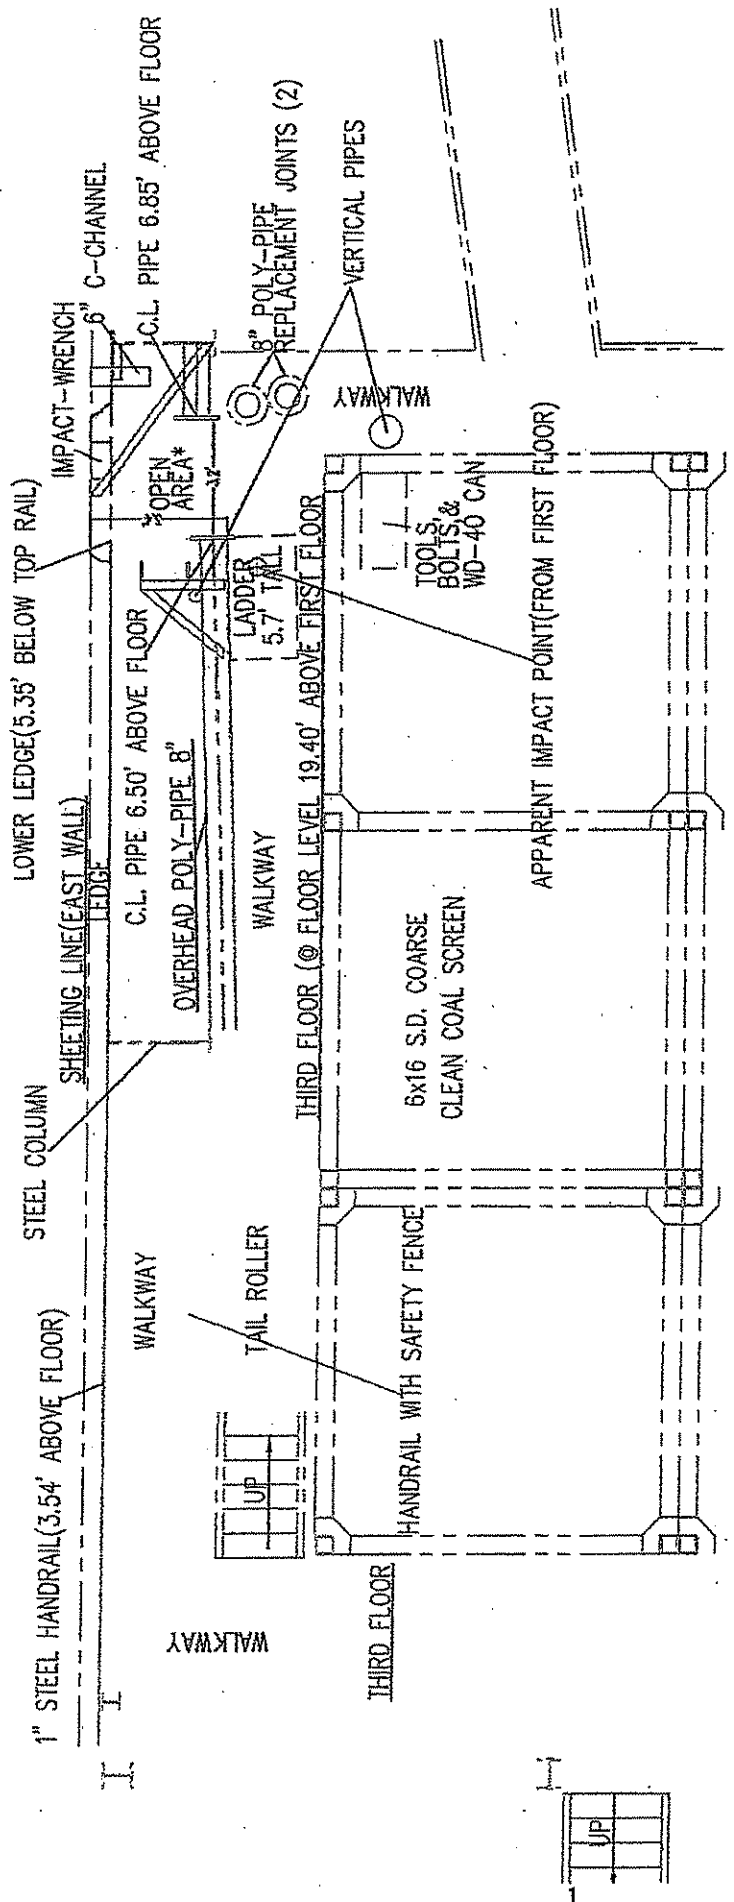
Weatherby Processing  
 MSHA ID NO.: 46-08685  
 MHS&T ID NO.: L-732  
 Accident Location Drawing - 3rd. Floor  
 Accident Date: 11/04/07  
 Accident Victim: Larry Bird  
 Drawn: 11/05/07-11/06/07  
 Sheet: 1 of 2  
 Scale: 1"=5'

\*NOTE: OPEN AREA TO GROUND FLOOR\*

The piece of pipe being worked on was located 6.50 to 6.85 feet above the third floor walkway. It extended 6 ½ to 10 ½ inches past the handrail and was located over an opening (between the outside wall of the plant and the walkway) from the third floor to the ground floor. This opening, measuring 18 feet x 3.4 feet, had originally had a vertical ladder with a back guard that extended from the ground floor to the fourth floor, but was removed after several renovations.

Larry W. Bird was fatally injured as a result of falling from the third floor of the preparation plant. Based on the testimony received, it is believed that the victim was attempting to retrieve the battery-powered impact wrench when he fell to the ground floor.

1. All employees and contractors working at Weatherby Processing Corporation, Remington Preparation Plant will be reinstructed on the importance and proper use of fall protection. The reinstruction will include the use of fall protection when using ladders that are positioned near an area where the potential of falling more than six (6) feet is possible.

2. All employees and contractors working at Weatherby Processing Corporation, Remington Preparation Plant will be reinstructed on the importance of securing objects that have the potential to fall into an active work area. The area below the installation or removal site will be cordoned-off.
