WV Miners' Health, Safety and Training

January 22, 2003

Fatal Shaft Explosion Report Investigation
McElroy Coal Company
McElroy Mine
Permit No. U-33-83

Central Cambria Drilling Company
Contractor No. C-618

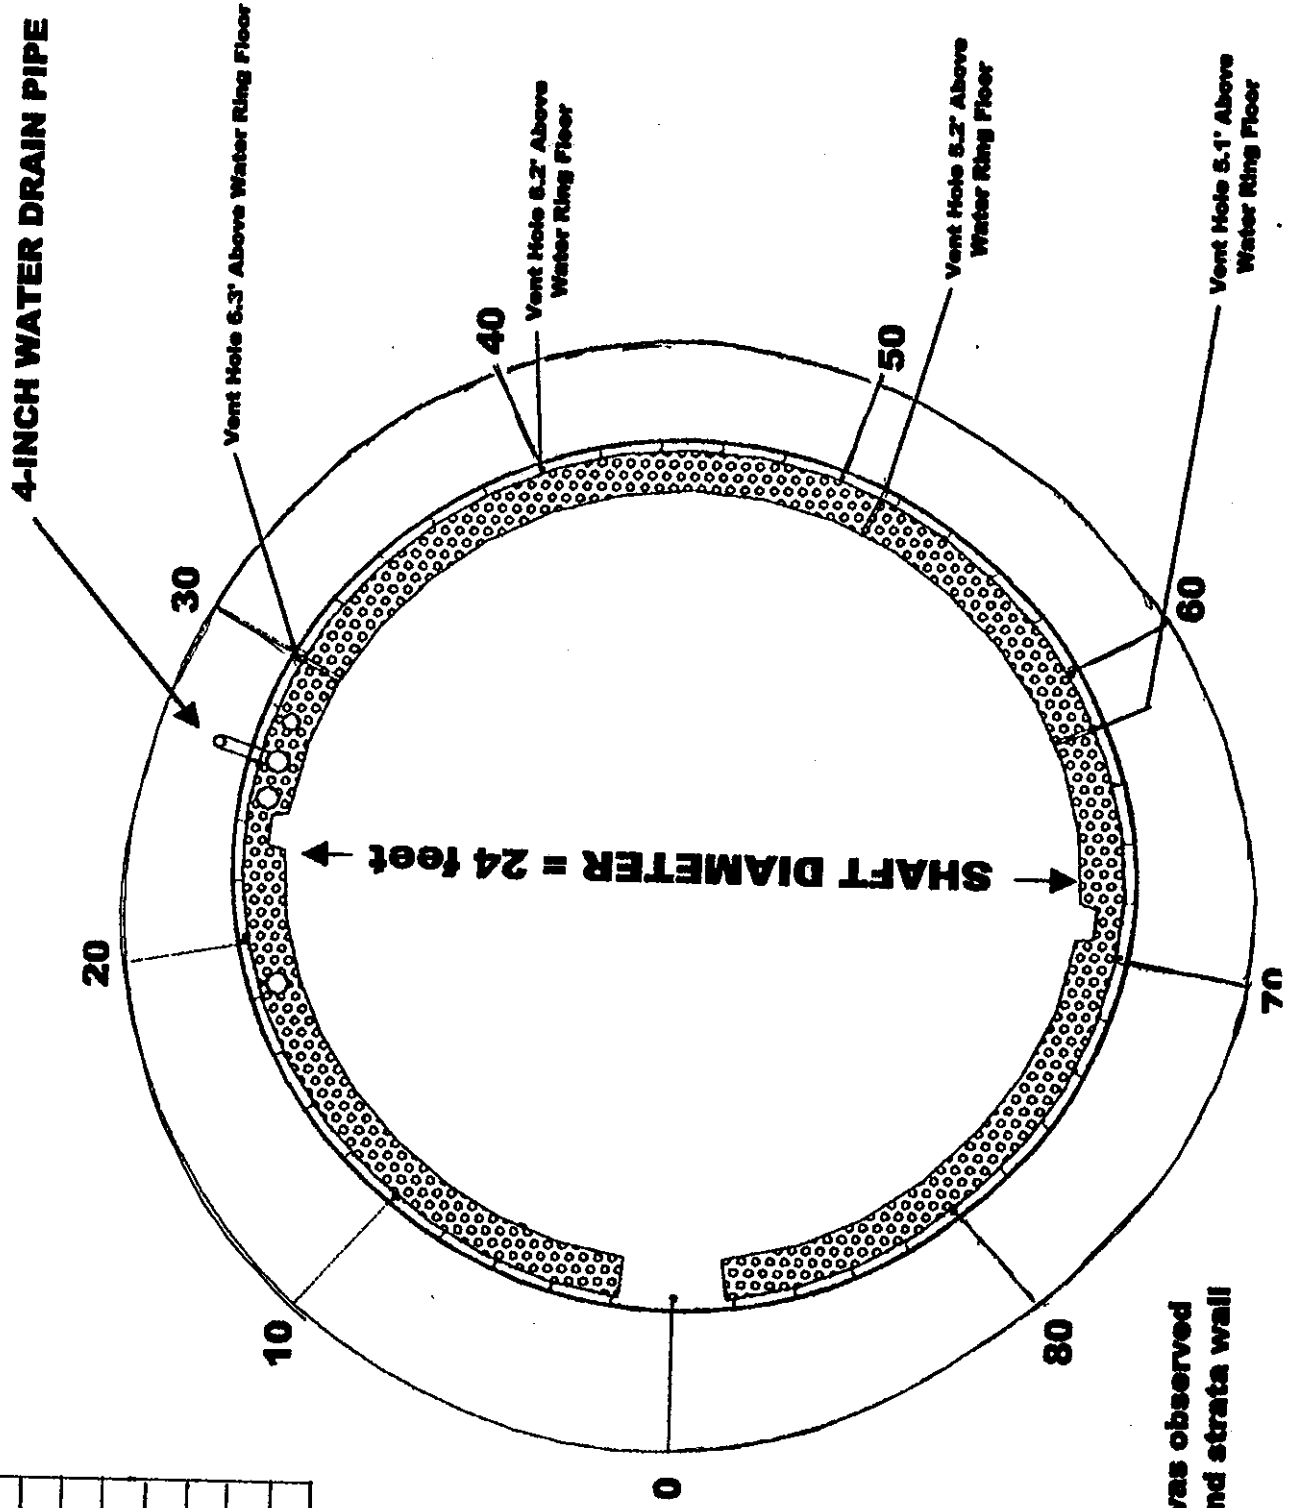
MCELROY MINE CENTRAL CAMBRIA SHAFT

REFERENCE DISTANCES
MEASURED CLOCKWISE
FROM MIDDLE OF OPENING

Note: A 5-inch to 6-inch gap was observed between shaft wall tin lining and strata wall

6. The investigation revealed that the four ventilation holes drilled in the return side of the shaft and completed within an hour prior to the explosion were found as follows: (See Diagram) One hole was clean and opened. A second hole was full of debris and obstructed. The two other holes had not been drilled through the panning tin and were ineffective. No attempt was made to clear the ventilation holes before the explosion. A pneumatic tool airline was provided at the shaft bottom and could have been used to ventilate the water ring.

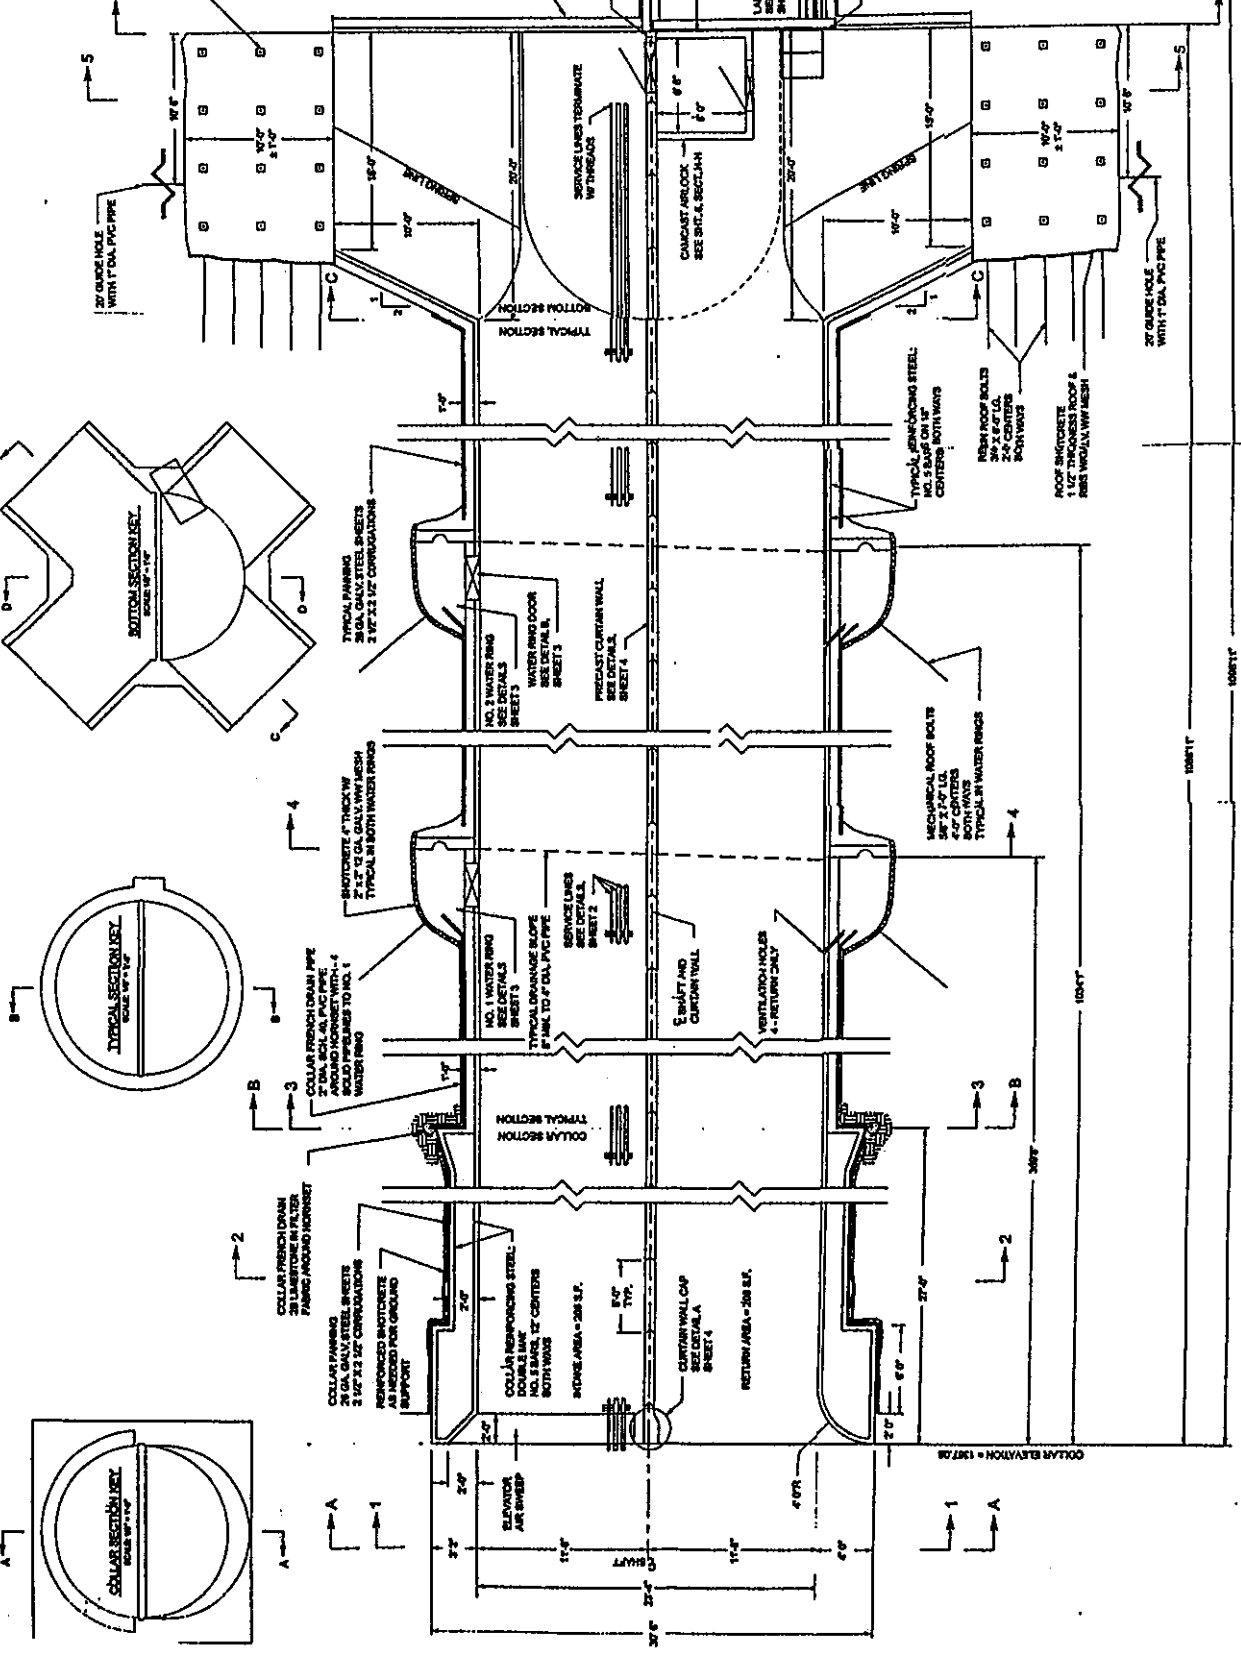
1. The explosion originated in water ring number 2 located at a depth of approximately 942 feet in the 5 South, #2 Shaft. The water ring was constructed around the shaft, and its measurements ranged from 2.8 to 4.45 feet in width by 6.5 to 7.5 feet high. Please see attachments for diagrams of the shaft and water ring.
