West Virginia Office of Miners' Health, Safety and Training

Fatal Roof Fall Investigation Report
Independence Coal Company, Inc.
Justice No. 1 Mine
Permit No. U-5013-98

Region Three - Danville Office
425 Lick Creek Road
Danville, West Virginia 25053
Harry Linville, Inspector-at-Large

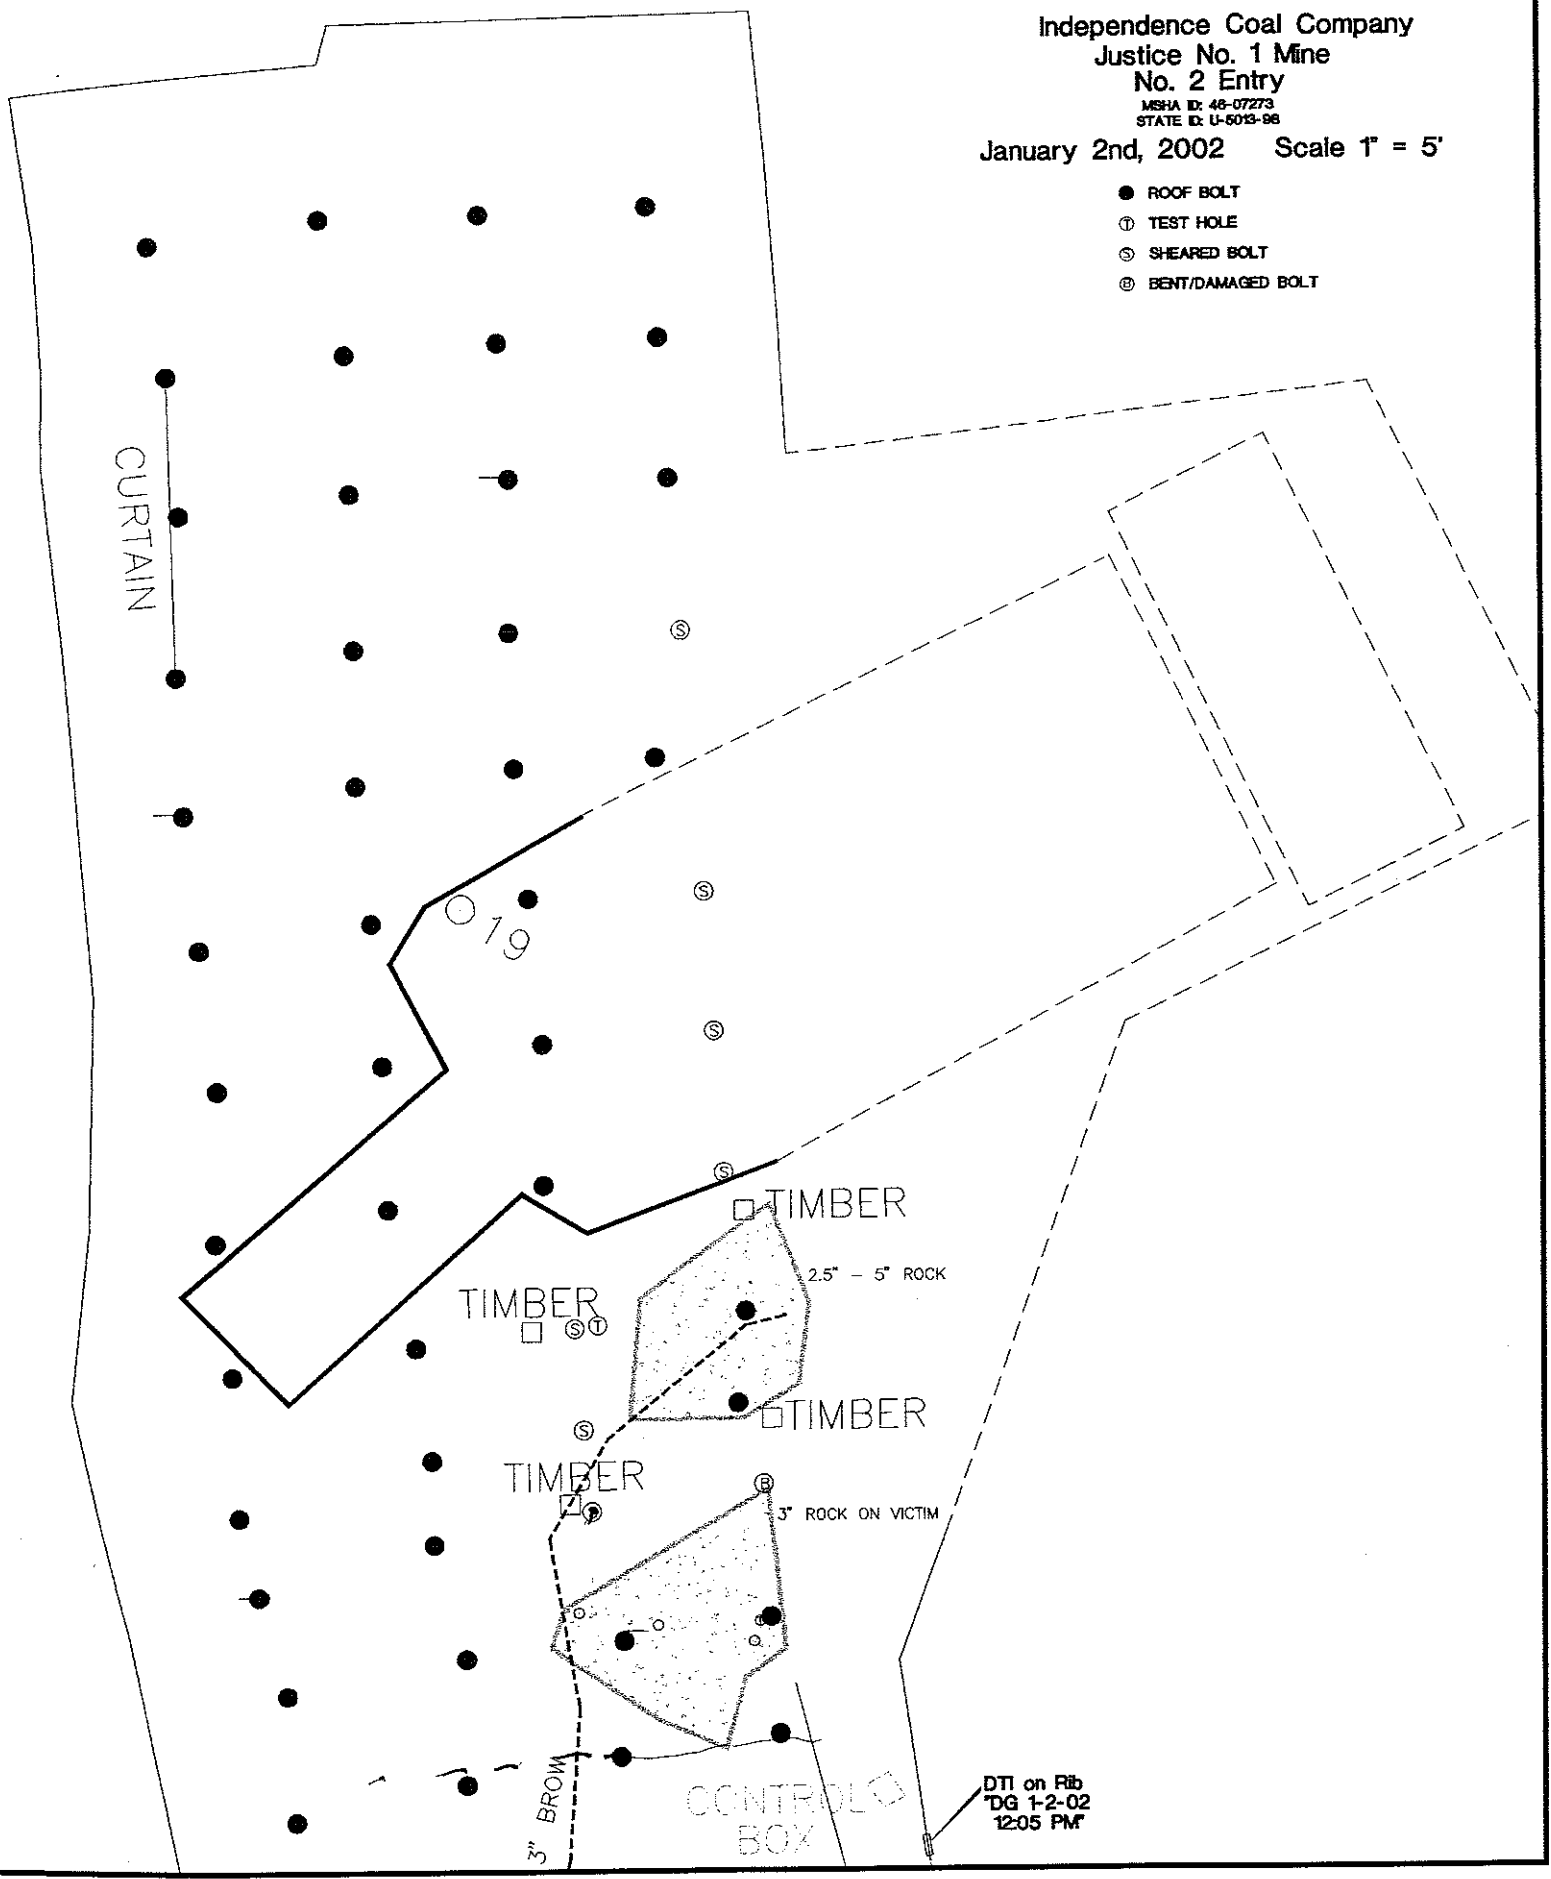
Independence Coal Company
Justice No. 1 Mine
No. 2 Entry

1. The victim was struck by a section of draw rock, which measured approximately 5 feet by 5 feet by 3 inches thick while operating a continuous mining machine via remote control in a crosscut turned to the right in the no. 2 entry.
2. The continuous mining machine was a 12 CM12 Joy.
3. The mining at the accident site measured 85 inches.
4. The no. 2 entry had been roof bolted with 6-foot torque tension bolts.
5. A total of seven (7) roof bolt plates and tension locking nuts were sheared off and/or rendered ineffective by the continuous mining machine as the crosscut was mined.

6. Four (4) of the damaged roof bolts were located in the last row adjacent to the crosscut turned to the right. Three (3) damaged roof bolts were located in the next to last row adjacent to the crosscut.
7. The roof fall, as described by eyewitness Roger Cox, started in the unsupported face area of the crosscut and extended outby into the area where the roof bolts were damaged.
8. The victim was located under the area where the three (3) roof bolts had been damaged in the next to last row when the fall occurred.
9. Those involved in the recovery indicated that the victim was completely covered by the fallen roof material and was found with his feet pointed toward the crosscut.

- 2. The continuous mining machine will be removed from the turn and spot bolting done when a roof bolt is damaged between the operator's position and the centerline of the crosscut being mined. This provision will also be included in the operator's comprehensive mine safety program.

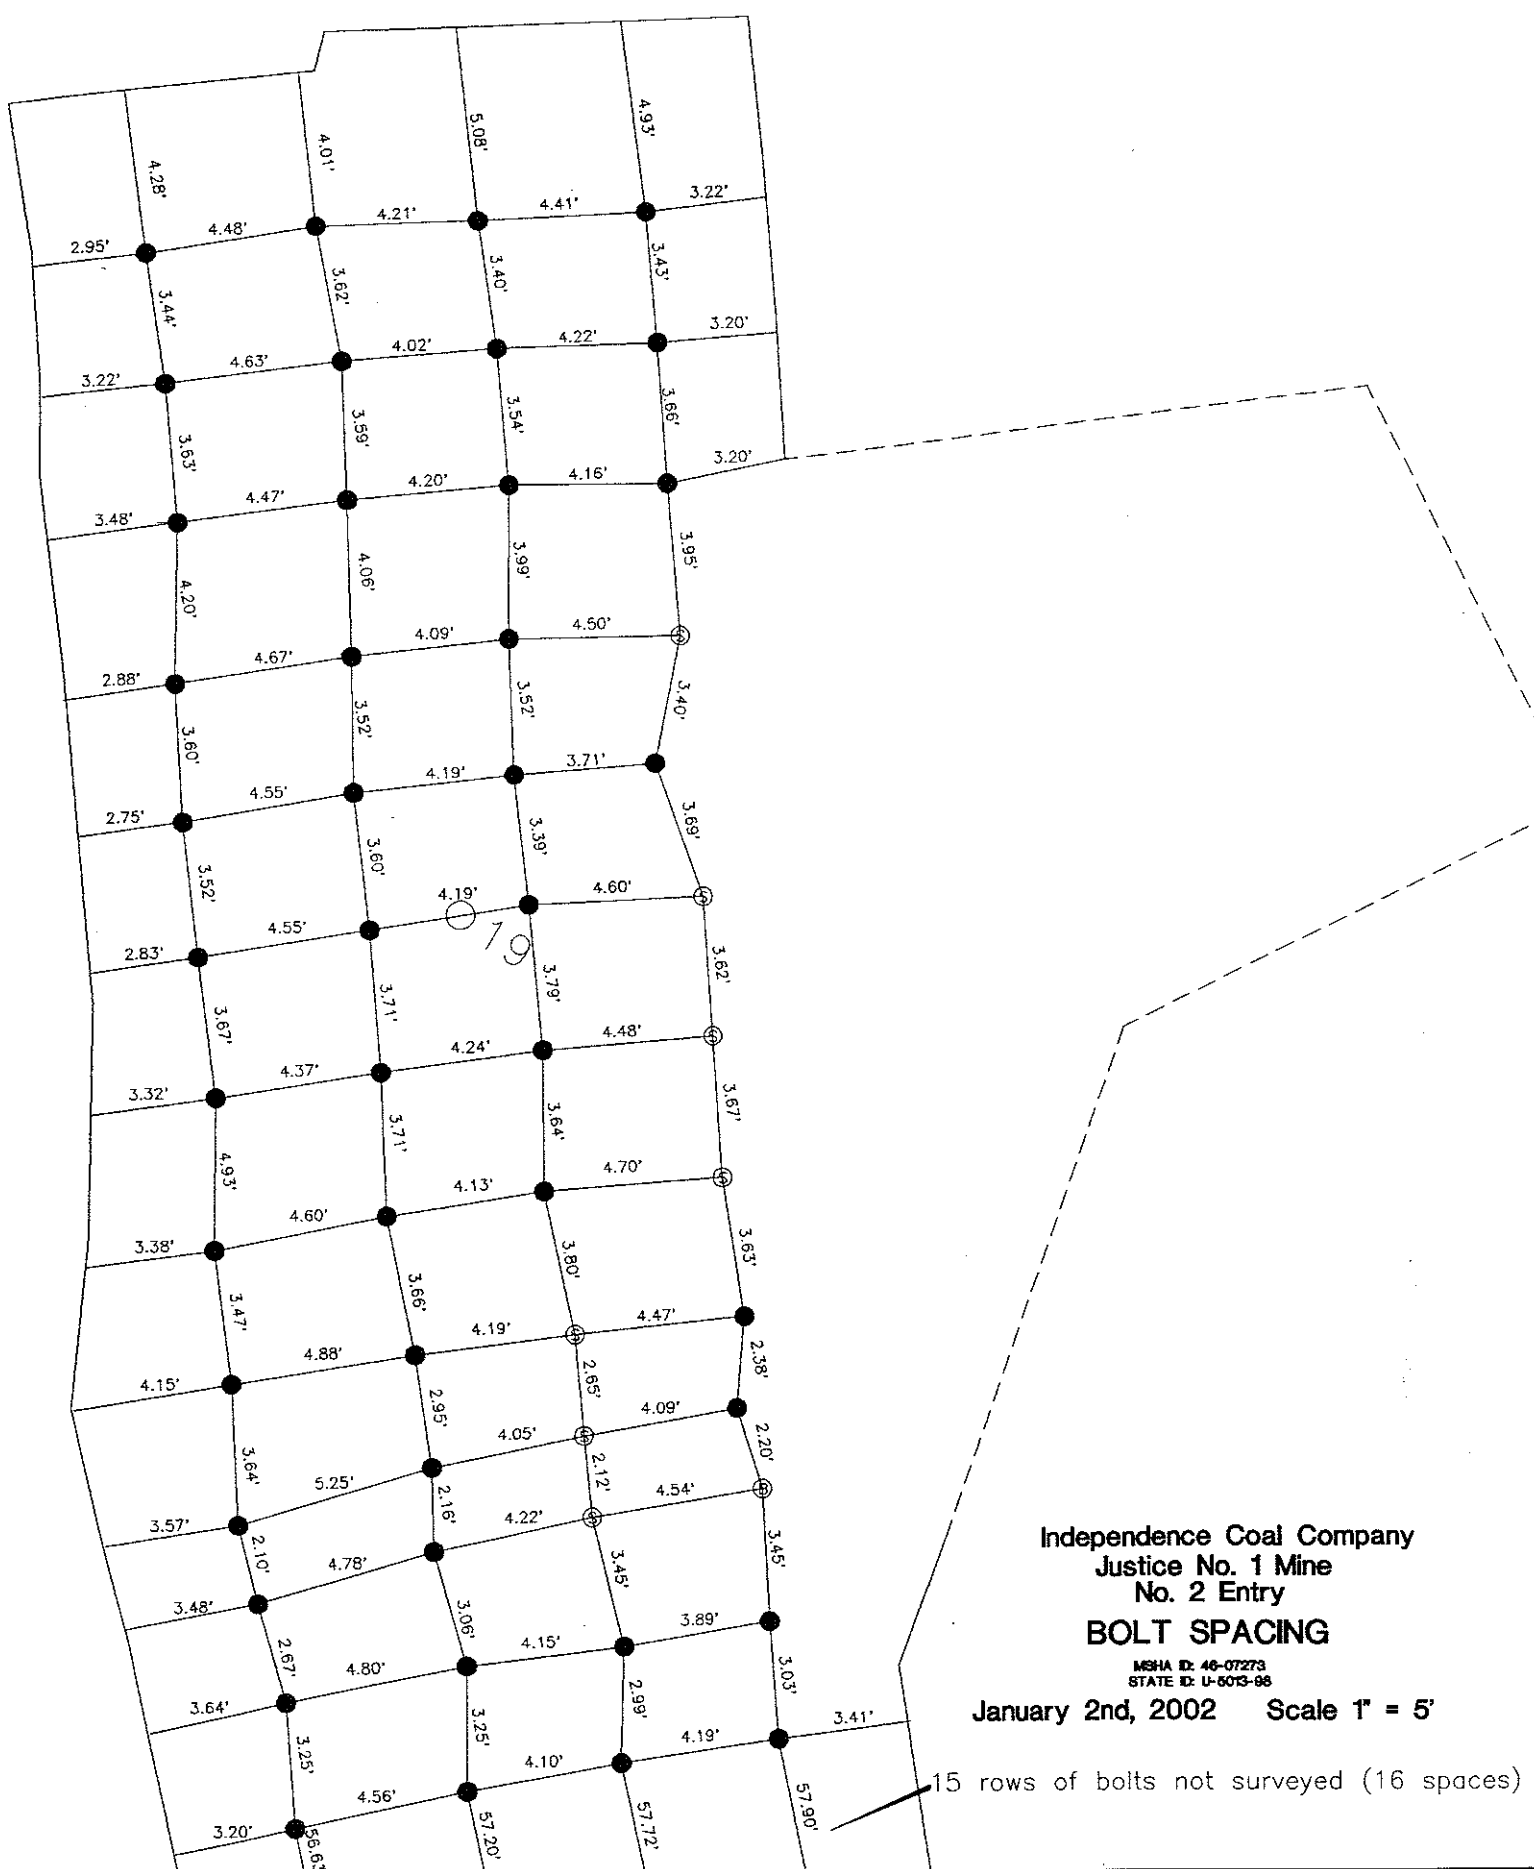
Independence Coal Company
 Justice No. 1 Mine
 No. 2 Entry
BOLT SPACING

15 rows of bolts not surveyed (16 spaces)
