West Virginia Office of Miners' Health, Safety and Training

February 5, 2004

Underground Mine Fatality Investigation Report
Spartan Mining Company
Ruby Energy Mine
Permit No. U-5019-96-A

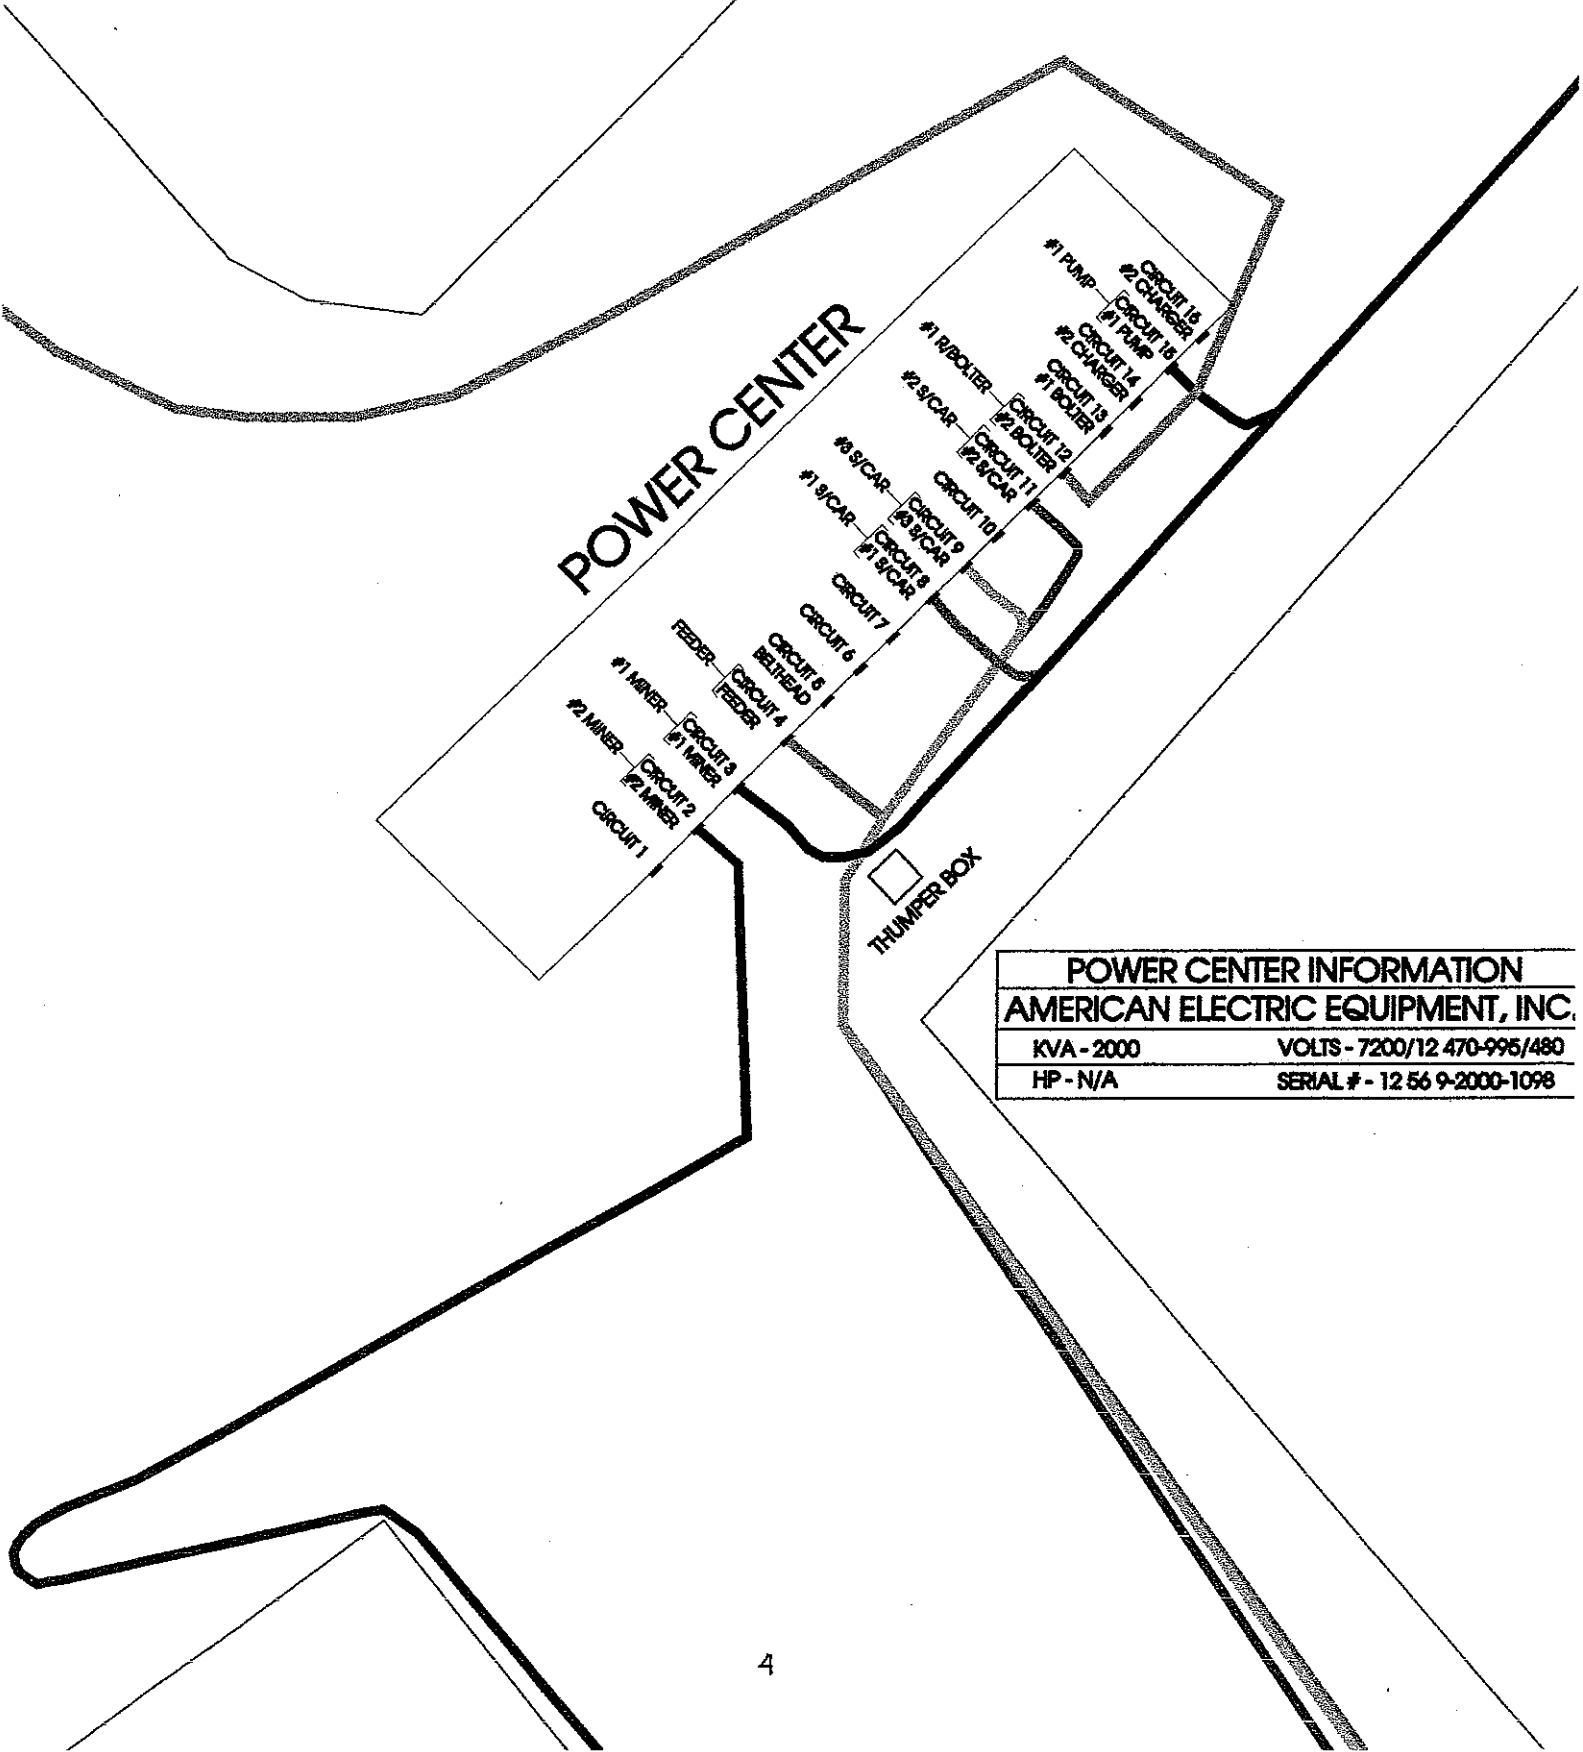
**SPARTAN MINING COMPANY
RUBY ENERGY #2 SECTION**

POWER CENTER INFORMATION	
AMERICAN ELECTRIC EQUIPMENT, INC.	
KVA - 2000	VOLTS - 7200/12 470-995/480
HP - N/A	SERIAL # - 12 56 9-2000-1098

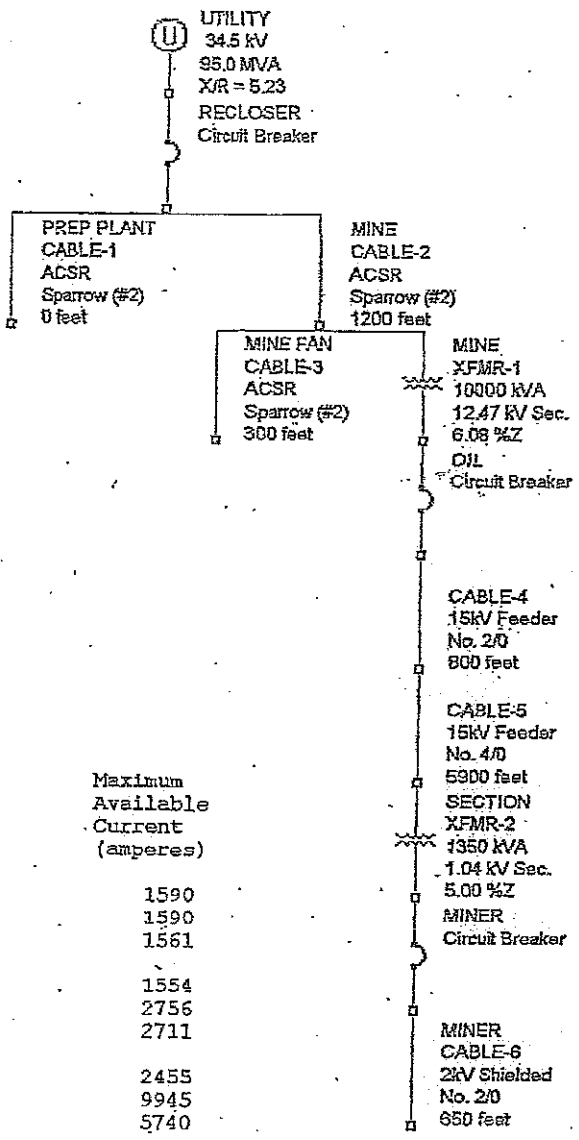
FIGURE 1

When the line-to-line short circuit occurred on the miner trailing cable, the miner circuit breaker, the oil circuit breaker, and the re-closer opened. The miner circuit breaker is the only one that should have opened.

The "MSHA, short circuit" computer program was used to determine the magnitude of the short circuit current flowing through each circuit breaker when the short circuit occurred. Peak loading data from the utility record and the observed load distributions at the mining complex were used to estimate the load currents flowing through each circuit breaker. These currents were summed to get total current through each circuit breaker at the time of the fault. The total current through each circuit breaker was compared to the trip setting of the circuit breaker to determine trip status. The response time of each circuit breaker was obtained from appropriate technical publications.

- (1) The Miner circuit breaker probably tripped because the total current through it (4061 amps) exceeded its trip setting of 1500 amperes.
- (2) The oil circuit breaker did not trip because the total current through it (375 amps) did not exceed its trip setting of 945 amperes. The oil circuit breaker probably tripped from the under-voltage condition created when the re-closer opened.
- (3) The re-closer probably tripped because the total current through it exceeded its trip setting of 140 amperes.
- (4) At the calculated current levels, the re-closer should not have tripped if the miner circuit breaker tripped in 0.02 seconds and the time characteristic of the re-closer control corresponds to published data.

(1) The time margin between the re-closer and the miner circuit breaker is not sufficient to preclude tripping of the recloser.
