West Virginia Office of Miners' Health, Safety and Training

March 31, 2005

Fatal Roof Fall Investigation Report
Coal River Mining, LLC
Tiny Creek No. 2 Mine
Permit No. U-5037-98B

Region Three – Danville Office
137 Peach Court, Suite 2
Danville, West Virginia 25053
Harry Linville, Inspector-at-Large

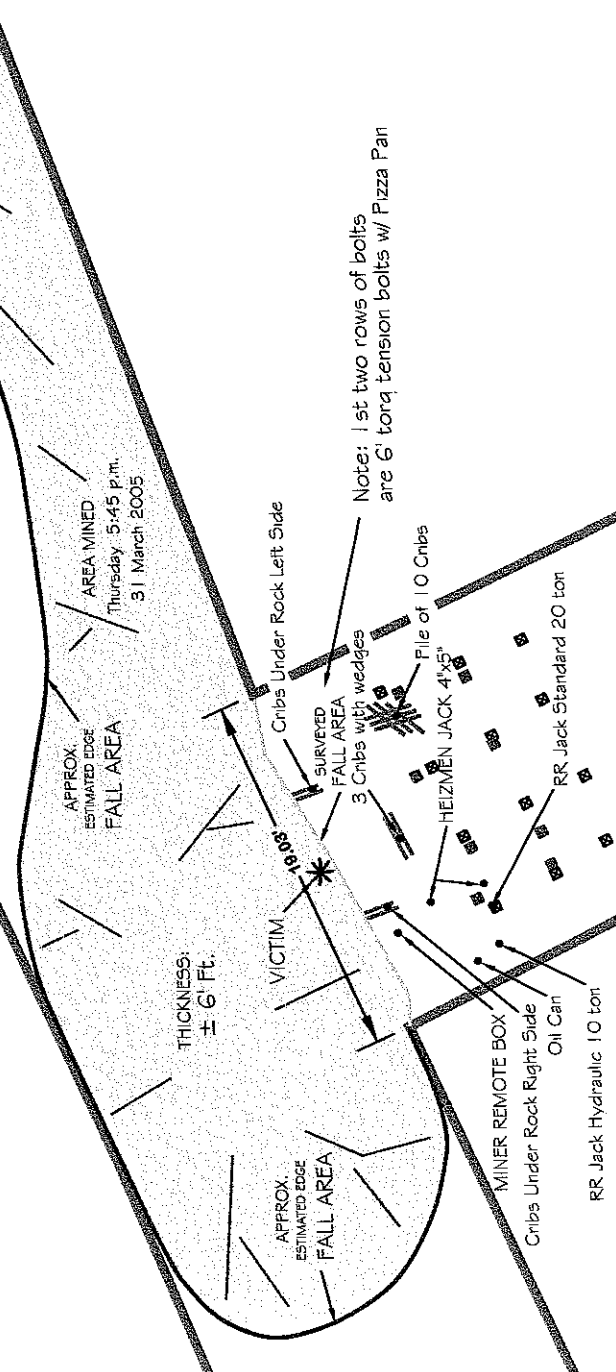
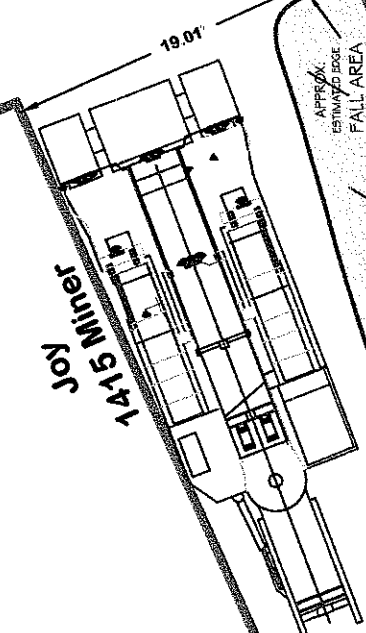
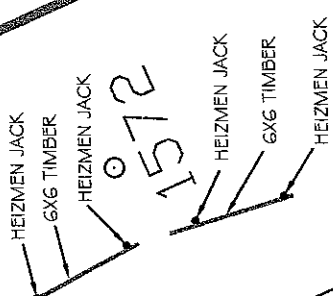
**COAL RIVER ENERGY
TINY CREEK MINE NO. 2
001 SECTION MMU 003-0
FATALITY AREA
31st March 2005**

**#7 Entry
AREA BOLTED
NOT SHOWN**

**#6 Entry
AREA BOLTED
NOT SHOWN**

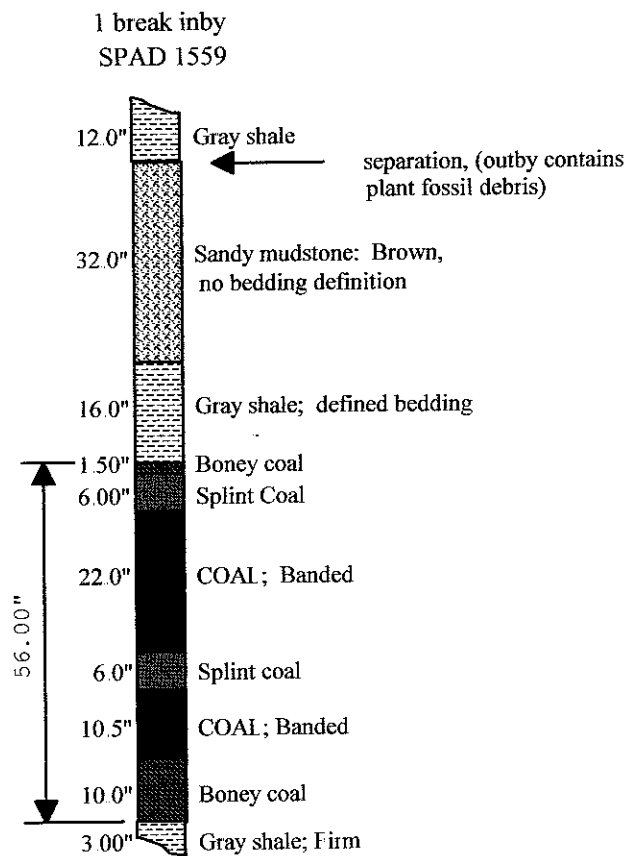
Figure 1. Stratigraphic section measured ½ break outby site of accident. The slab that fell was comprised mostly of the “sandy mudstone” unit, which is bounded on top by a horizontal separation containing plant debris, and bounded on three sides by sub-vertical slickensided slip planes (see Figure 2).

As shown, the immediate roof is approximately 16-in. of gray shale which in #6 entry appeared to have been taken down on-cycle as drawslate. Overlying it is a sandstone unit that on first appearances looks competent, but in actuality it is more like a “sandy mudstone” exhibiting poor tensile strength due to high clay content and lack of conspicuous horizontal (bedding) structure. Attempts were made to hold this unit in the entries, but in #6 entry this was largely unsuccessful. It is overlain by a firm, gray shale containing ¼-in. siderite bands which contains abundant plant fossil debris at this contact.

The rock slab that fell was approximately 65-ft. in length and is comprised primarily of the sandy mudstone unit. It’s thickness measured approximately 32-in. on the outby side of the fall, increasing to approximately 60-in. thick on the inby side of the x-cut, although the latter is estimated because the area was not accessible.

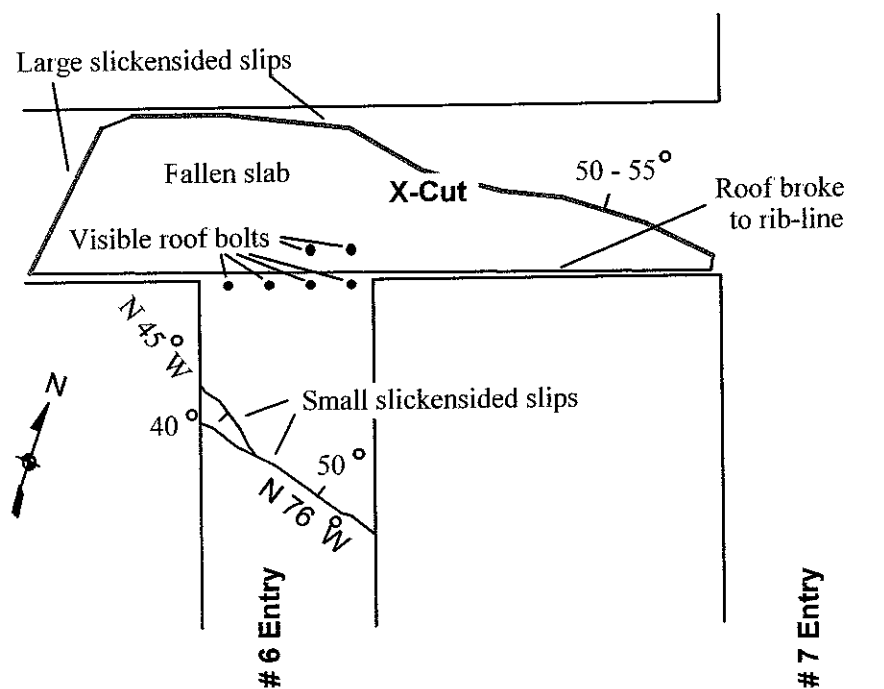
As shown in Figure 2, below, the roof cavity left by the fallen slab is bounded on all sides except the pillar line by a series of inter-connected high-angle slickensided slip planes which I believe is the point at which the slab failure initiated. The characteristically polished and slippery slickensided slips are related to differential compaction, but more specific details are not available at this point. Together with a bedding separation at the top of the sandy mudstone unit, these created a large “kettlebottom-like” structure that, without the benefit of bolting, was supported only by the tensile strength of the cantilevered rock mass on the outby side against the line of pillars.

Figure 2. Plan view of fallen slab geometry. The slickensided failure plane around the inby edges of the fall are shown in red. Similar slips were noted outby the fall in #6 entry. The last row of surviving bolts in this entry were directly in line with the ribline.

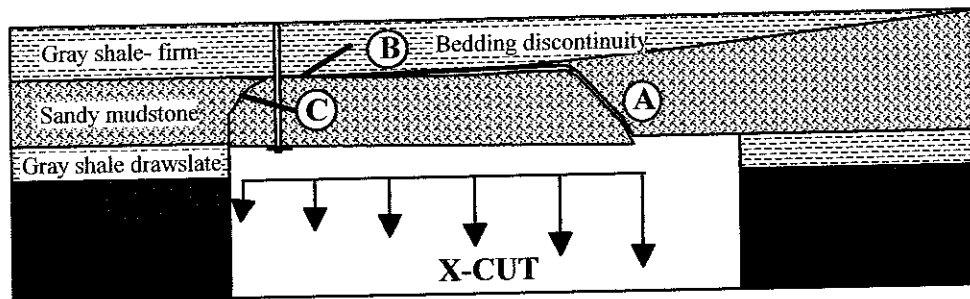
Figure 3, below, is a generalized illustration from the vantage point of #7 entry, looking back toward #6 entry along the x-cut (right side of the x-cut is in by the fall).

The weight of the essentially-unbolted rock slab appears to have induced separation along the adjacent zones of weakness.

The result was a sudden drop-out of the rock slab, probably detaching simultaneously at the sub-vertical slickensided slips (A) and at the roof (B), and creating a cantilever of rock hinged along the line of pillars (C).

Figure 3. This generalized view looking SW down the x-cut from #7 entry intersection illustrates how the "sandy mudstone" unit may have detached in simultaneous shear failure along the high-angle slickensided plane (A) and tensile failure at or near the overlying gray shale contact (B), creating a beam cantilevered along the pillar edge (C).

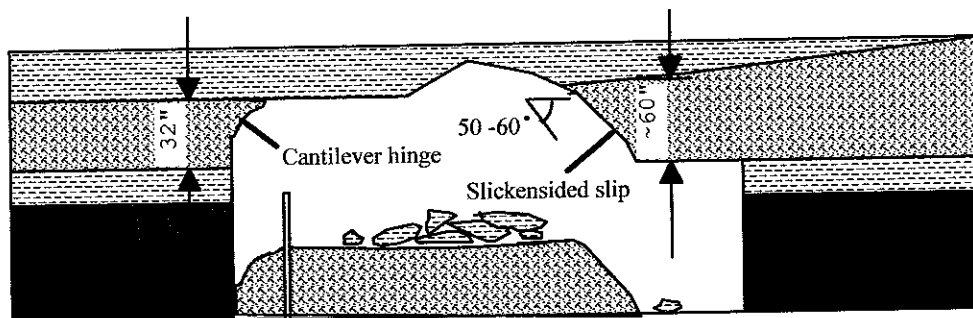
The cantilever then failed at its hinge (Figure 4). When it did so it pulled down the several roof bolts installed part-way up #6 entry before the x-cut was driven.

Figure 4. The rock slab fell when the stress at the cantilever hinge exceeded the rock's tensile strength (see Photo 1, reverse view)

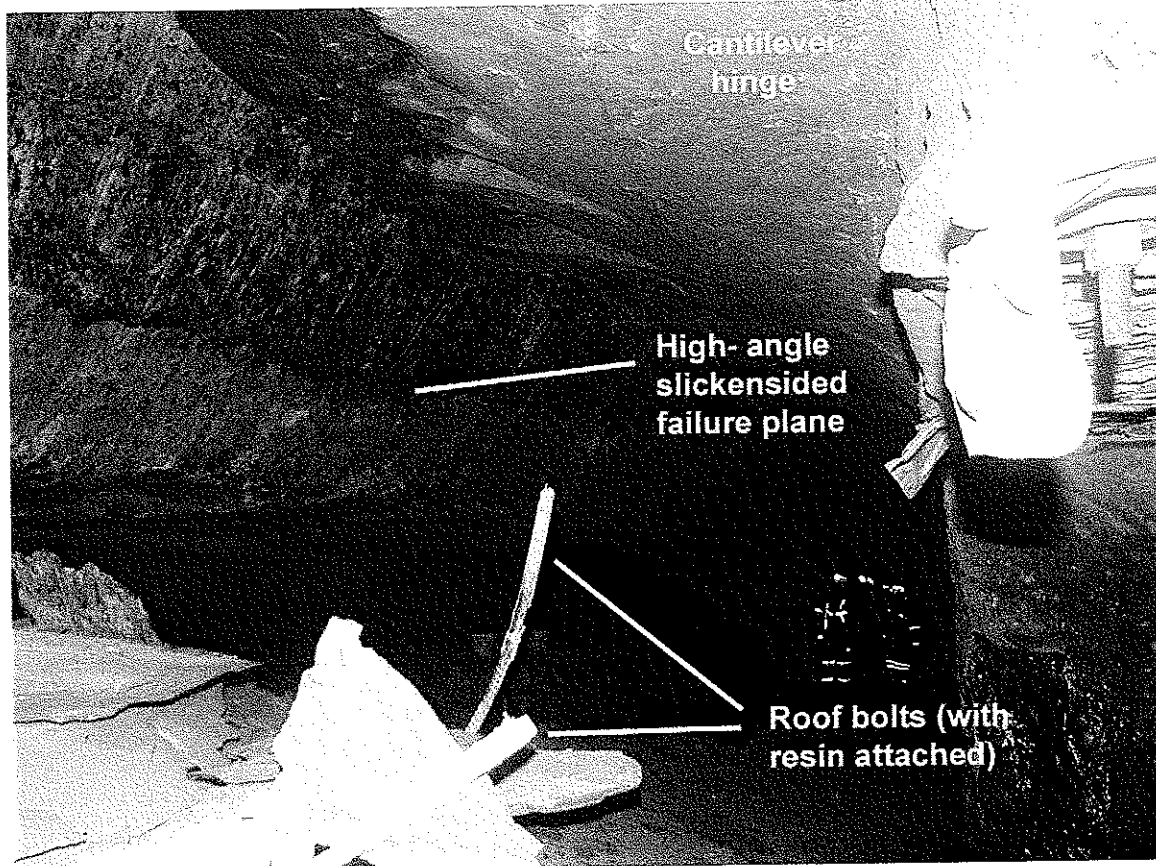
Two (2) roof bolts were visible protruding from the top of the rock slab in the #6 entry intersection (Photo 1) with resin still attached. Other bolts were also visible in the fallen rock slab.

Photo 1. View from accident site, looking NE down cross-cut between # 6 and # 7 entries. Note the high-angle slip plane dipping away from the fall, allowing the roof slab to behave like a large “kettlebottom.” This created a cantilevered rock beam in the immediate roof along the coal pillar (top right) which failed when the stresses exerted at the cantilever hinge exceeded the tensile strength of the rock.

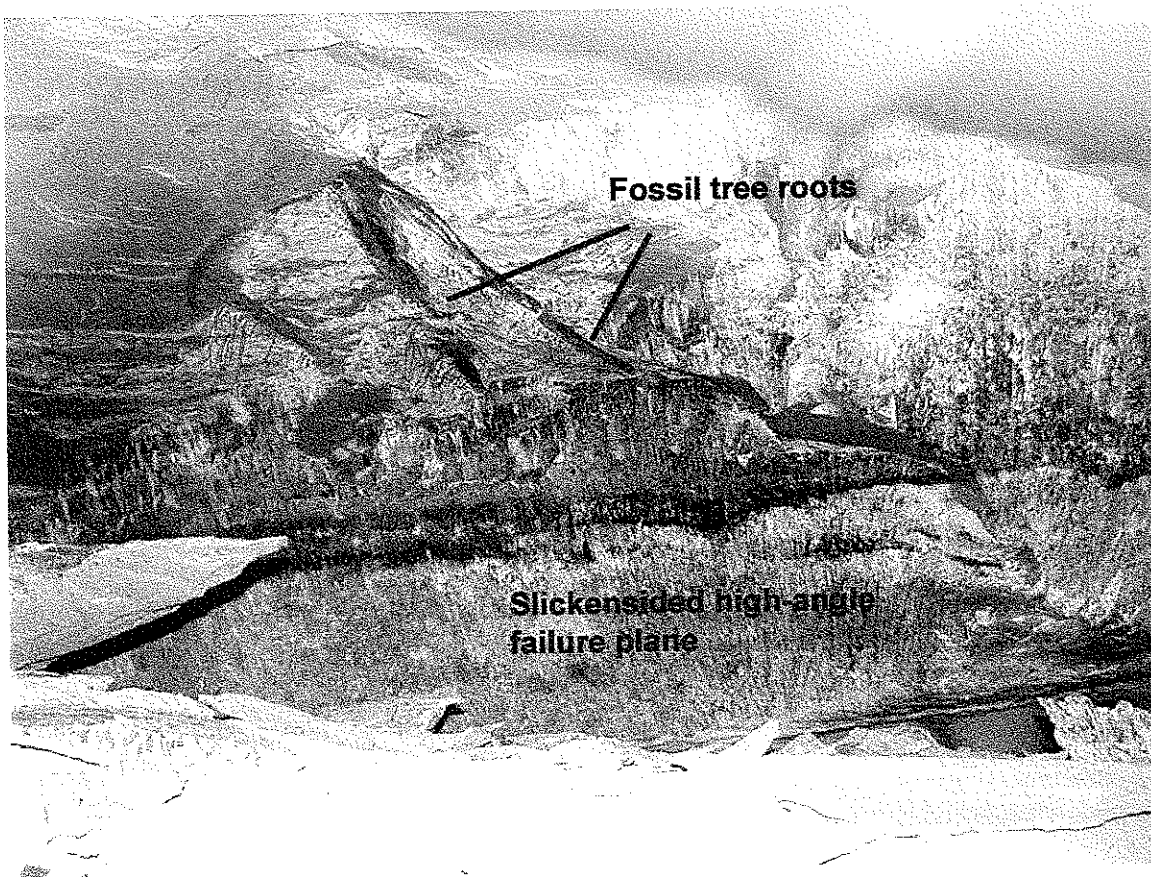
Photo 3. View from accident site looking inby down entry across rock fall. Prominent high-angle failure plane visible. The dark, diagonal structures are fossil tree roots. Although not visible in this photo the rootlets radiating off these roots can cause significant bedding disruption and loss of effective rock strength.
